## Profile/Photo Observation Report

Date:	<b>04/14/2018</b>	Weather:		Coding:	<b>PACP 6.0</b>
Pipe Length (ft):	<b>303.6</b>	Owner:	<b>NA</b>	Pre Clean:	<b>No Pre-Cleaning</b>
P.O.#:		Surveyor:	<b>Jen Costello</b>	PSR:	<b>P-505-086-087</b>
Customer:		Clean Date:	<b>01/01/1900</b>	Shape:	<b>C</b>

Street:	<b>W 4TH PL</b>	Flow Control:	<b>Not Controlled</b>
City:	<b>Hobart, IN</b>	Year Renewed:	
Location:	<b>Yard</b>	Tape/Media #:	
Purpose:	<b>Routine Assessment</b>	Dia/Height:	<b>10"</b>
Use:	<b>Sanitary</b>	Material:	<b>VCP</b>
Drain Area:	<b>NA</b>	Lining:	
Category:	<b>NA</b>		
Comment:			
Location Details:		Direction of Survey:	<b>Upstream</b>
US MH:	<b>M-505-086</b>	DS MH:	<b>M-505-087</b>
		Total Length Surveyed (ft):	<b>21.6</b>

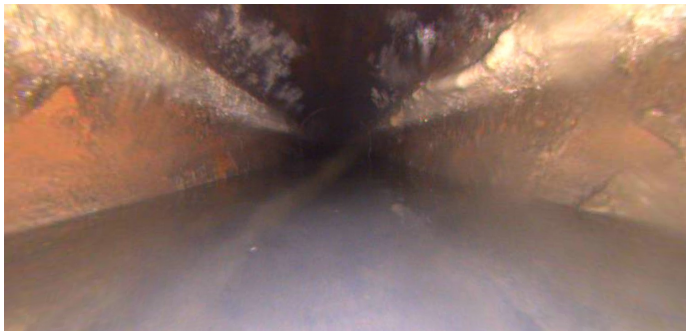
Code: **AMH**  
Description: **Manhole**

Distance (ft): **.0**  
Structural Grade: **0**  
O&M Grade: **0**  
Clock Start/From:  
Clock To:  
1st Value:  
2nd Value:  
Value Percent:  
Continuous Index:  
Within 8" of Joint: **NO**  
Remarks: **M-505-087**

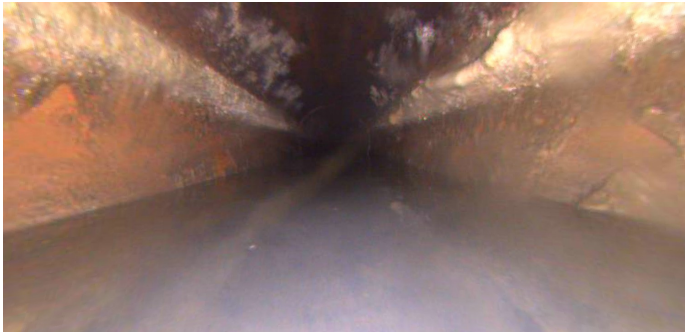
Code:	<b>MWL</b>
Description:	<b>Water Level</b>

Distance (ft):	<b>.0</b>
Structural Grade:	<b>0</b>
O&M Grade:	<b>0</b>
Clock Start/From:	
Clock To:	
1st Value:	
2nd Value:	
Value Percent:	<b>30.000</b>
Continuous Index:	
Within 8" of Joint:	<b>NO</b>
Remarks:

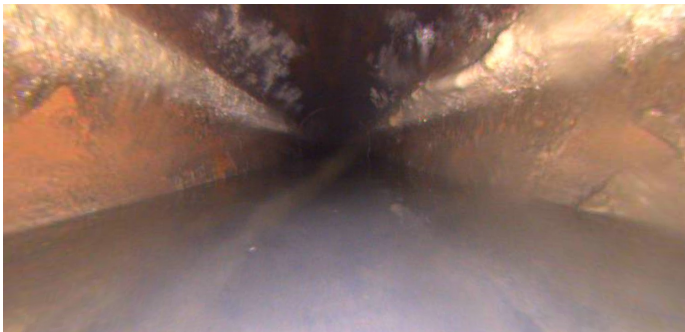
Code:	<b>DAGS</b>
Description:	<b>Deposits Attached Grease</b>

Distance (ft):	<b>.0</b>
Structural Grade:	<b>0</b>
O&M Grade:	<b>2</b>
Clock Start/From:	<b>8</b>
Clock To:	<b>4</b>
1st Value:	
2nd Value:	
Value Percent:	<b>10.000</b>
Continuous Index:	<b>S01</b>
Within 8" of Joint:	<b>NO</b>
Remarks:

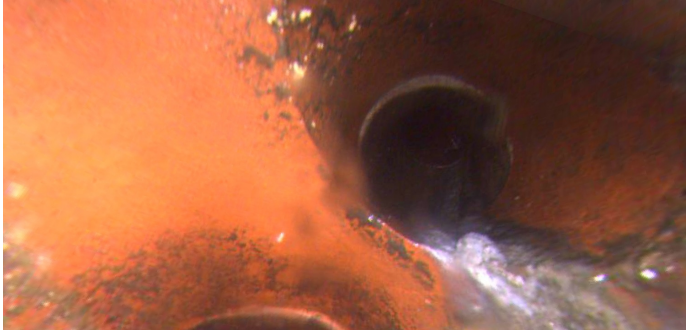
Code: **TF**  
Description: **Tap Factory**

Distance (ft): **10.4**  
Structural Grade: **0**  
O&M Grade: **0**  
Clock Start/From: **1**  
Clock To:  
1st Value: **4.000**  
2nd Value:  
Value Percent:  
Continuous Index:  
Within 8" of Joint:  
Remarks:

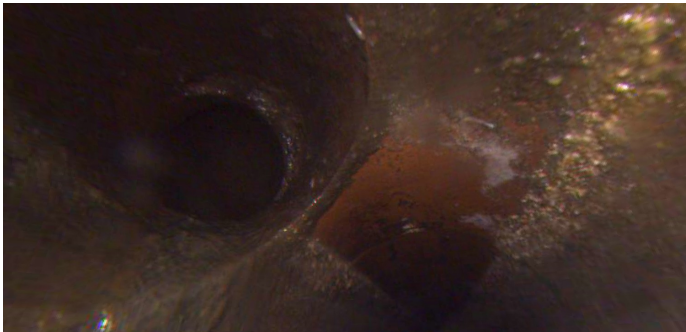
Code: **TF**  
Description: **Tap Factory**

Distance (ft): **17.1**  
Structural Grade: **0**  
O&M Grade: **0**  
Clock Start/From: **10**  
Clock To:  
1st Value: **4.000**  
2nd Value:  
Value Percent:  
Continuous Index:  
Within 8" of Joint:  
Remarks:

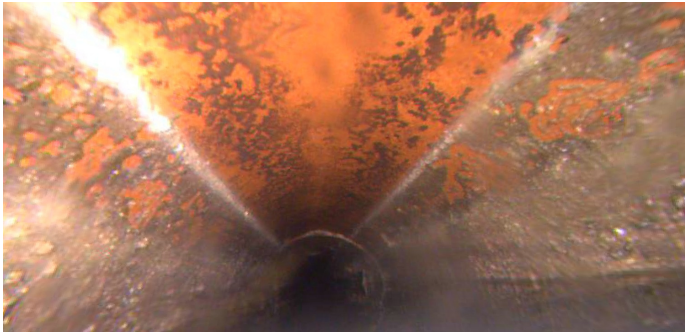
Code: **MSA**  
Description: **Abandoned Survey**

Distance (ft): **21.6**  
Structural Grade: **0**  
O&M Grade: **0**  
Clock Start/From:  
Clock To:  
1st Value:  
2nd Value:  
Value Percent:  
Continuous Index:  
Within 8" of Joint: **NO**  
Remarks: **DAGS**

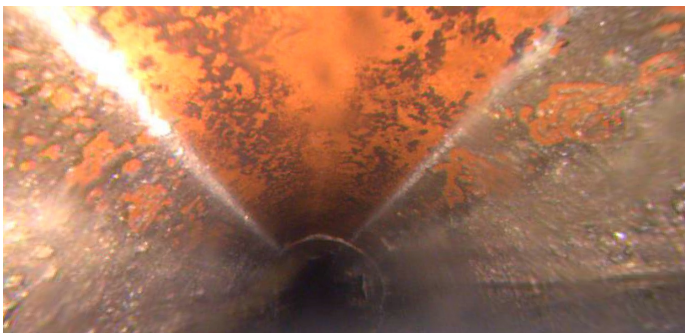
Code: **DAGS**  
Description: **Deposits Attached Grease**

Distance (ft): **21.6**  
Structural Grade: **0**  
O&M Grade: **2**  
Clock Start/From: **8**  
Clock To: **4**  
1st Value:  
2nd Value:  
Value Percent: **10.000**  
Continuous Index: **F01**  
Within 8" of Joint: **NO**  
Remarks:
