Profile/Photo Observation Report

Street:	FOXCROFT STREET	Flow Control:	Not Controlled
City:	Hobart, IN	Year Renewed:	
Location:	Yard	Tape/Media #:	
Purpose:	Routine Assessment	Dia/Height:	10"
Use:	Sanitary	Material:	VCP
Drain Area:	NA	Lining:	
Category:	NA		
Comment:

Location Details:		Direction of Survey:	Upstream
US MH:	M-505-086	DS MH:	M-505-087
		Total Length Surveyed (ft):	21.6

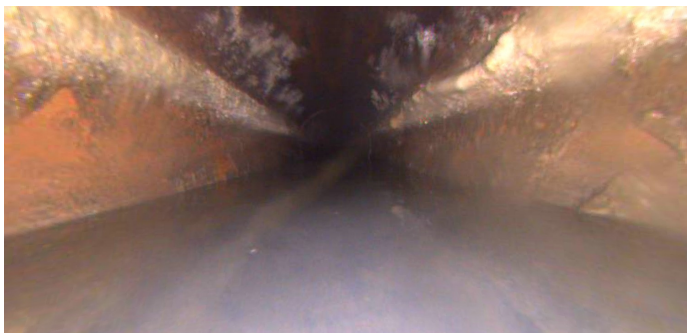
Code: **AMH**
Description: **Manhole**

Distance (ft): **.0**
Structural Grade: **0**
O&M Grade: **0**
Clock Start/From:
Clock To:
1st Value:
2nd Value:
Value Percent:
Continuous Index:
Within 8" of Joint: **NO**
Remarks: **M-505-087**

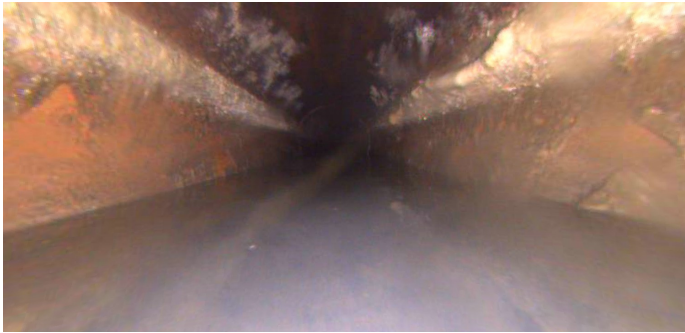
Code:	MWL
Description:	Water Level

Distance (ft):	.0
Structural Grade:	0
O&M Grade:	0
Clock Start/From:	
Clock To:	
1st Value:	
2nd Value:	
Value Percent:	30.000
Continuous Index:	
Within 8" of Joint:	NO
Remarks:

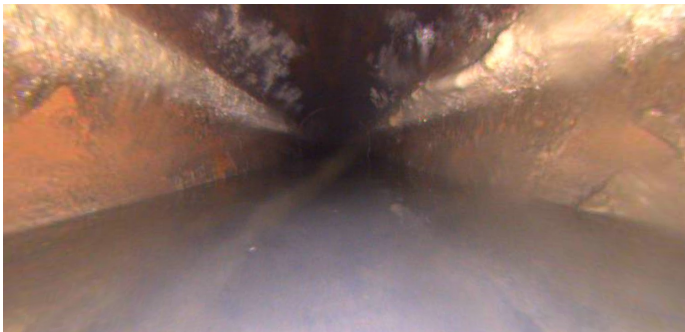
Code:	DAGS
Description:	Deposits Attached Grease

Distance (ft):	.0
Structural Grade:	0
O&M Grade:	2
Clock Start/From:	8
Clock To:	4
1st Value:	
2nd Value:	
Value Percent:	10.000
Continuous Index:	S01
Within 8" of Joint:	NO
Remarks:

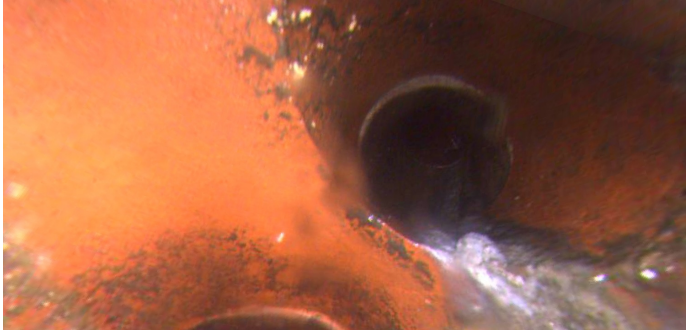
Code: **TF**
Description: **Tap Factory**

Distance (ft): **10.4**
Structural Grade: **0**
O&M Grade: **0**
Clock Start/From: **1**
Clock To:
1st Value: **4.000**
2nd Value:
Value Percent:
Continuous Index:
Within 8" of Joint:
Remarks:

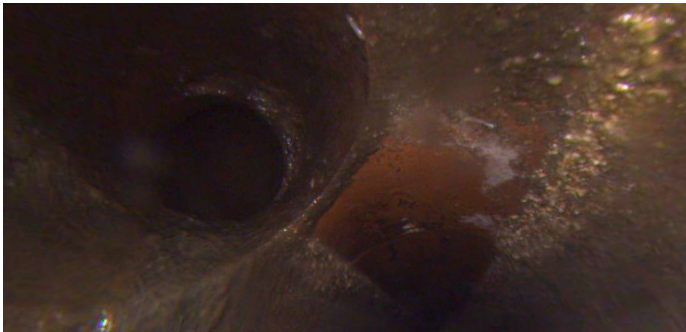
Code: **TF**
Description: **Tap Factory**

Distance (ft): **17.1**
Structural Grade: **0**
O&M Grade: **0**
Clock Start/From: **10**
Clock To:
1st Value: **4.000**
2nd Value:
Value Percent:
Continuous Index:
Within 8" of Joint:
Remarks:

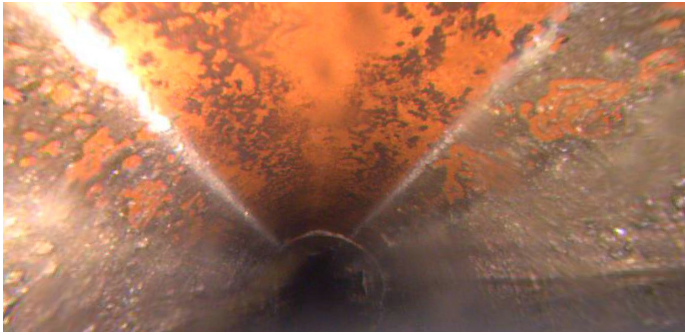
Code: **MSA**
Description: **Abandoned Survey**

Distance (ft): **21.6**
Structural Grade: **0**
O&M Grade: **0**
Clock Start/From:
Clock To:
1st Value:
2nd Value:
Value Percent:
Continuous Index:
Within 8" of Joint: **NO**
Remarks: **DAGS**

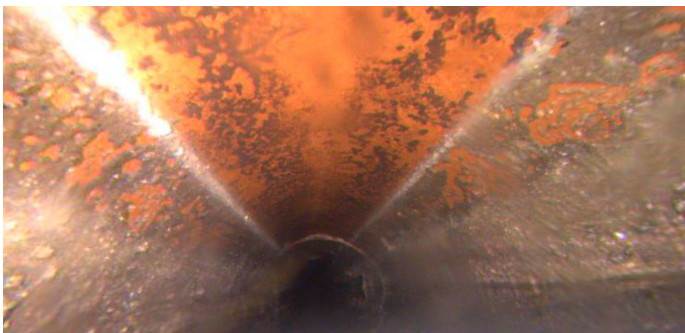
Code: **DAGS**
Description: **Deposits Attached Grease**

Distance (ft): **21.6**
Structural Grade: **0**
O&M Grade: **2**
Clock Start/From: **8**
Clock To: **4**
1st Value:
2nd Value:
Value Percent: **10.000**
Continuous Index: **F01**
Within 8" of Joint: **NO**
Remarks:
