Profile/Photo Observation Report

Street:	W 4TH PL	Flow Control:	Not Controlled
City:	Hobart, IN	Year Renewed:	
Location:	Yard	Tape/Media #:	
Purpose:	Routine Assessment	Dia/Height:	10"
Use:	Sanitary	Material:	VCP
Drain Area:	NA	Lining:	
Category:	NA		
Comment:

Location Details:		Direction of Survey:	Downstream
US MH:	M-505-087	DS MH:	M-505-088
		Total Length Surveyed (ft):	12.0

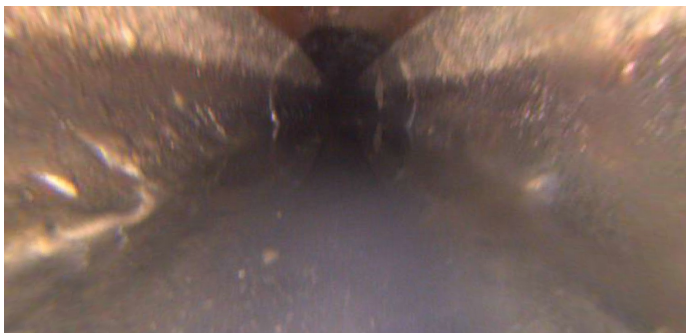
Code: **AMH**
Description: **Manhole**

Distance (ft): **.0**
Structural Grade: **0**
O&M Grade: **0**
Clock Start/From:
Clock To:
1st Value:
2nd Value:
Value Percent:
Continuous Index:
Within 8" of Joint: **NO**
Remarks: **M-505-087**

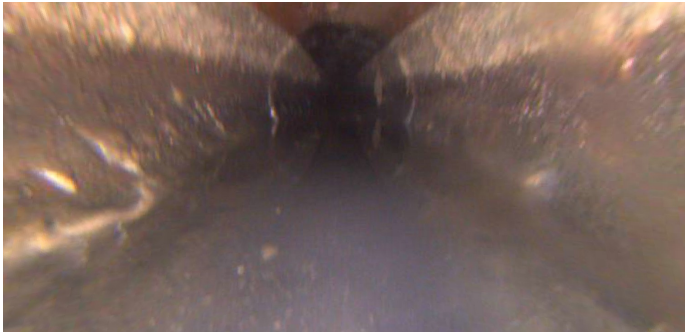
Code:	MWL
Description:	Water Level

Distance (ft):	.0
Structural Grade:	0
O&M Grade:	0
Clock Start/From:	
Clock To:	
1st Value:	
2nd Value:	
Value Percent:	20.000
Continuous Index:	
Within 8" of Joint:	NO
Remarks:

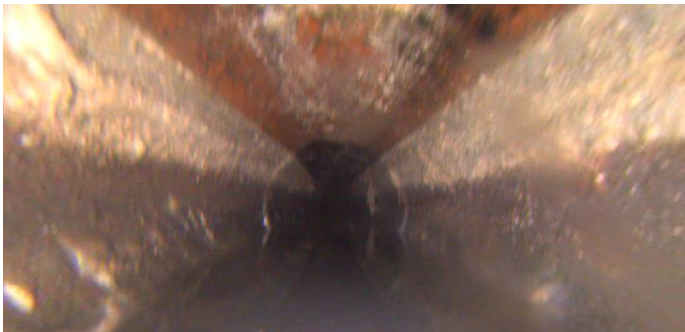
Code:	DAGS
Description:	Deposits Attached Grease

Distance (ft):	.0
Structural Grade:	0
O&M Grade:	2
Clock Start/From:	8
Clock To:	4
1st Value:	
2nd Value:	
Value Percent:	5.000
Continuous Index:	S01
Within 8" of Joint:	NO
Remarks:
