Profile/Photo Observation Report

Street:	FOXCROFT STREET	Flow Control:	Not Controlled
City:	Hobart, IN	Year Renewed:	
Location:	Yard	Tape/Media #:	
Purpose:	Routine Assessment	Dia/Height:	10"
Use:	Sanitary	Material:	VCP
Drain Area:	NA	Lining:	
Category:	NA		
Comment:

Location Details:		Direction of Survey:	Downstream
US MH:	M-505-087	DS MH:	M-505-088
		Total Length Surveyed (ft):	12.0

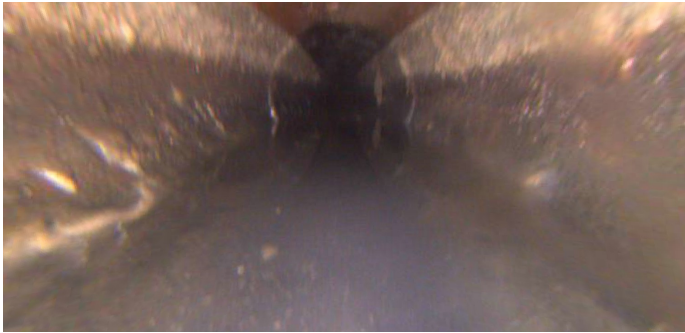
Code:	MWL
Description:	Water Level

Distance (ft):	.0
Structural Grade:	0
O&M Grade:	0
Clock Start/From:	
Clock To:	
1st Value:	
2nd Value:	
Value Percent:	20.000
Continuous Index:	
Within 8" of Joint:	NO
Remarks:

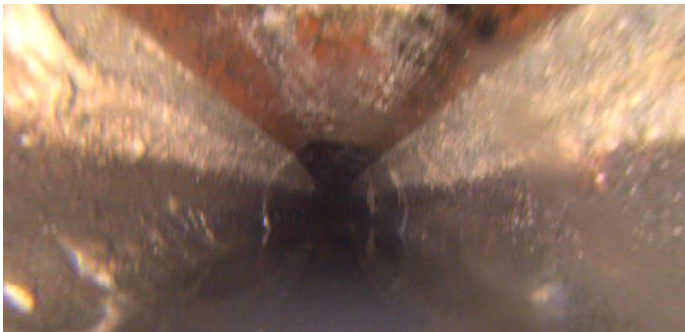
Code:	DAGS
Description:	Deposits Attached Grease

Distance (ft):	.0
Structural Grade:	0
O&M Grade:	2
Clock Start/From:	8
Clock To:	4
1st Value:	
2nd Value:	
Value Percent:	5.000
Continuous Index:	S01
Within 8" of Joint:	NO
Remarks:

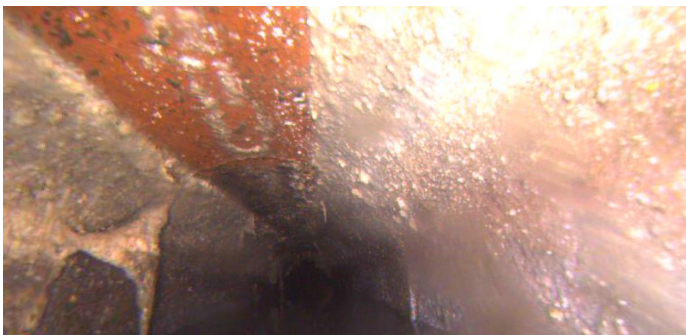
Code: **MSA**
Description: **Abandoned Survey**

Distance (ft): **12.0**
Structural Grade: **0**
O&M Grade: **0**
Clock Start/From:
Clock To:
1st Value:
2nd Value:
Value Percent:
Continuous Index:
Within 8" of Joint: **NO**
Remarks: **DAGS**
