## Profile/Photo Observation Report

Date:	<b>04/26/2018</b>	Weather:		Coding:	<b>PACP 6.0</b>
Pipe Length (ft):		Owner:	<b>City of Hobart</b>	Pre Clean:	<b>No Pre-Cleaning</b>
P.O.#:	<b>95</b>	Surveyor:	<b>M. Pielacha</b>	PSR:	<b>P-505-092-016</b>
Customer:	<b>City of Hobart</b>	Clean Date:		Shape:	<b>C</b>

Street:	<b>3rd Street</b>	Flow Control:	<b>Not Controlled</b>
City:	<b>Hobart, IN</b>	Year Renewed:	
Location:	<b>Light Highway</b>	Tape/Media #:	<b>DEP 95</b>
Purpose:	<b>Routine Assessment</b>	Dia/Height:	<b>18"</b>
Use:	<b>Sanitary</b>	Material:	<b>CP</b>
Drain Area:		Lining:	
Category:	<b>NA</b>		
Comment:	<b>YES501824 Submittal 2</b>		
Location Details:		Direction of Survey:	<b>Downstream</b>
US MH:	<b>M-505-092</b>	DS MH:	<b>M-505-016</b>
		Total Length Surveyed (ft):	<b>263.4</b>

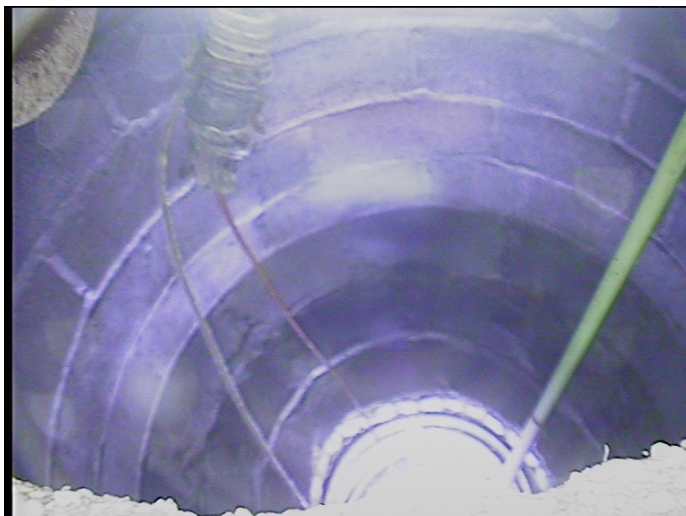
Code: **AMH**  
 Description: **Manhole**

Distance (ft): **.0**  
 Structural Grade: **0**  
 O&M Grade: **0**  
 Clock Start/From:  
 Clock To:  
 1st Value:  
 2nd Value:  
 Value Percent:  
 Continuous Index:  
 Within 8" of Joint: **NO**  
 Remarks: **M-505-092**

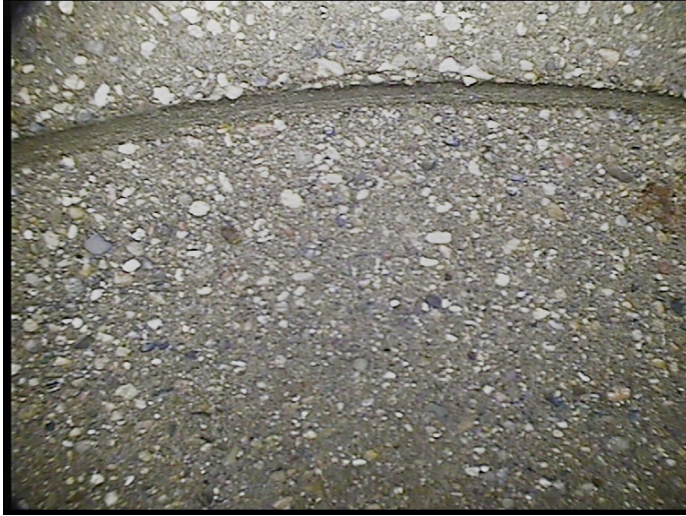
Code:	<b>SAV</b>
Description:	<b>Surface Aggregate Visible</b>
Distance (ft):	<b>.0</b>
Structural Grade:	<b>3</b>
O&M Grade:	<b>0</b>
Clock Start/From:	<b>8</b>
Clock To:	<b>4</b>
1st Value:	
2nd Value:	
Value Percent:	
Continuous Index:	<b>S01</b>
Within 8" of Joint:	<b>YES</b>
Remarks:

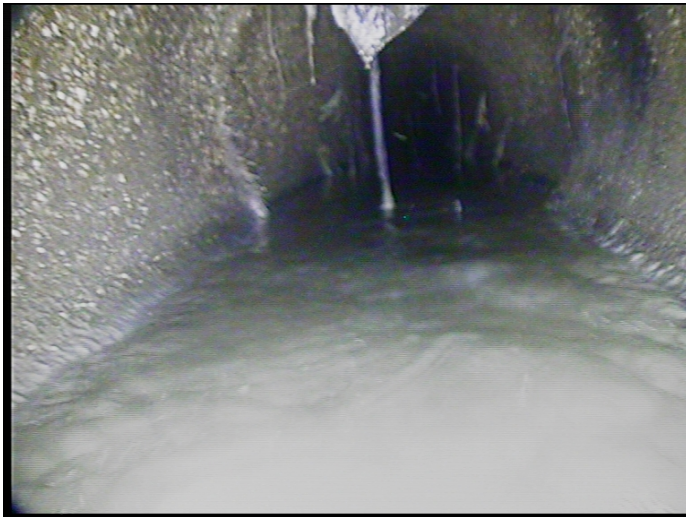
Code:	<b>MWL</b>
Description:	<b>Water Level</b>
Distance (ft):	<b>.0</b>
Structural Grade:	<b>0</b>
O&M Grade:	<b>0</b>
Clock Start/From:	
Clock To:	
1st Value:	
2nd Value:	
Value Percent:	<b>10.000</b>
Continuous Index:	
Within 8" of Joint:	<b>NO</b>
Remarks:

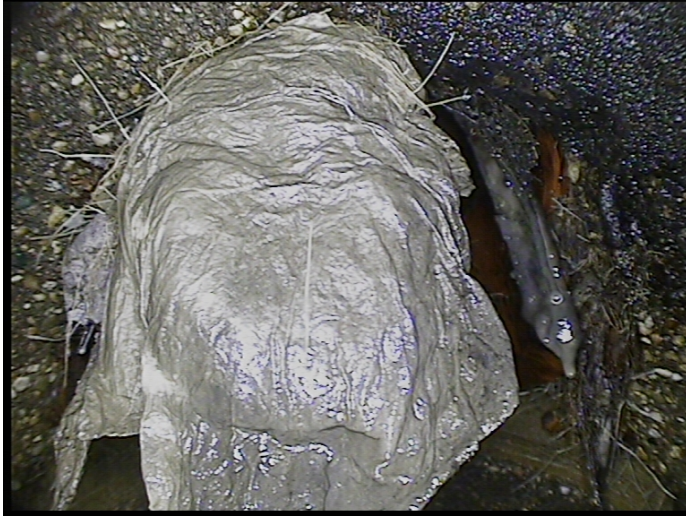
Code: **TB**  
Description: **Tap Break-in**

Distance (ft): **2.8**  
Structural Grade: **0**  
O&M Grade: **0**  
Clock Start/From: **12**  
Clock To:  
1st Value: **4.000**  
2nd Value:  
Value Percent:  
Continuous Index:  
Within 8" of Joint: **NO**  
Remarks:

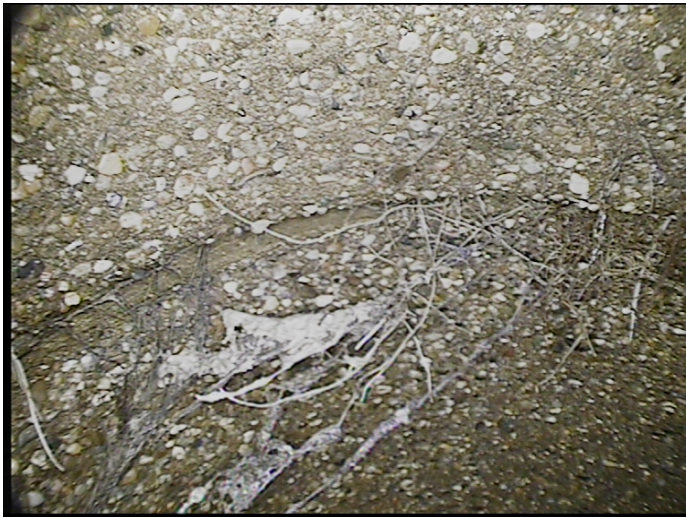
Code: **RFJ**  
Description: **Roots Fine Joint**

Distance (ft): **5.8**  
Structural Grade: **0**  
O&M Grade: **1**  
Clock Start/From: **8**  
Clock To: **4**  
1st Value:  
2nd Value:  
Value Percent:  
Continuous Index: **S02**  
Within 8" of Joint: **YES**  
Remarks:

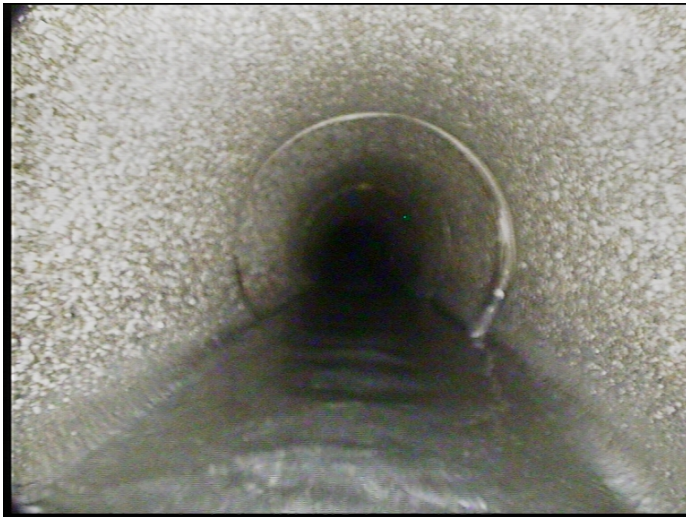
Code: **RFJ**  
Description: **Roots Fine Joint**

Distance (ft): **17.3**  
Structural Grade: **0**  
O&M Grade: **1**  
Clock Start/From: **8**  
Clock To: **4**  
1st Value:  
2nd Value:  
Value Percent:  
Continuous Index: **F02**  
Within 8" of Joint: **YES**  
Remarks:

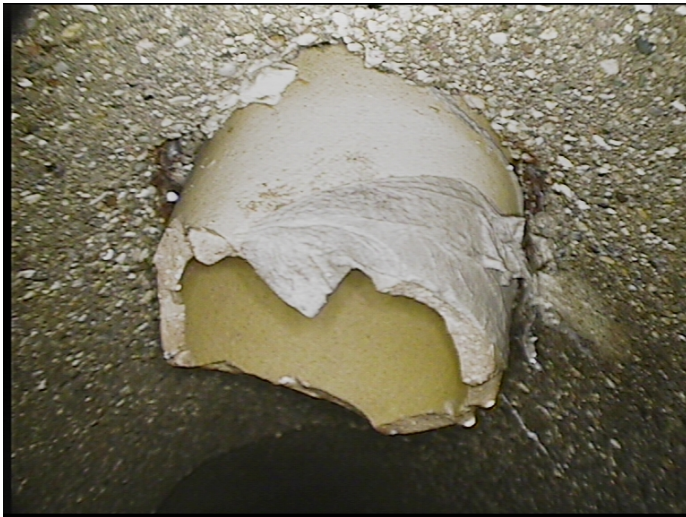
Code: **TBI**  
Description: **Tap Break-in Intruding**

Distance (ft): **63.7**  
Structural Grade: **0**  
O&M Grade: **2**  
Clock Start/From: **2**  
Clock To:  
1st Value: **4.000**  
2nd Value: **2.000**  
Value Percent:  
Continuous Index:  
Within 8" of Joint: **NO**  
Remarks:

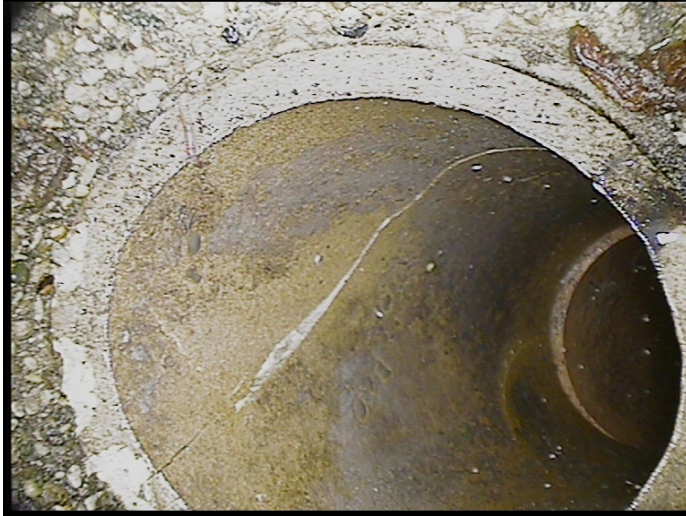
Code: **TB**  
Description: **Tap Break-in**

Distance (ft): **74.0**  
Structural Grade: **0**  
O&M Grade: **0**  
Clock Start/From: **1**  
Clock To:  
1st Value: **4.000**  
2nd Value:  
Value Percent:  
Continuous Index:  
Within 8" of Joint: **NO**  
Remarks:

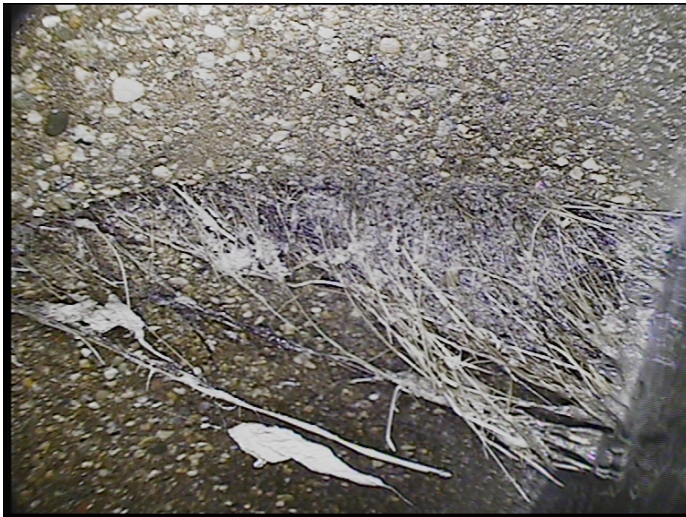
Code: **RFJ**  
Description: **Roots Fine Joint**

Distance (ft): **108.5**  
Structural Grade: **0**  
O&M Grade: **1**  
Clock Start/From: **9**  
Clock To: **3**  
1st Value:  
2nd Value:  
Value Percent:  
Continuous Index: **S03**  
Within 8" of Joint: **YES**  
Remarks:

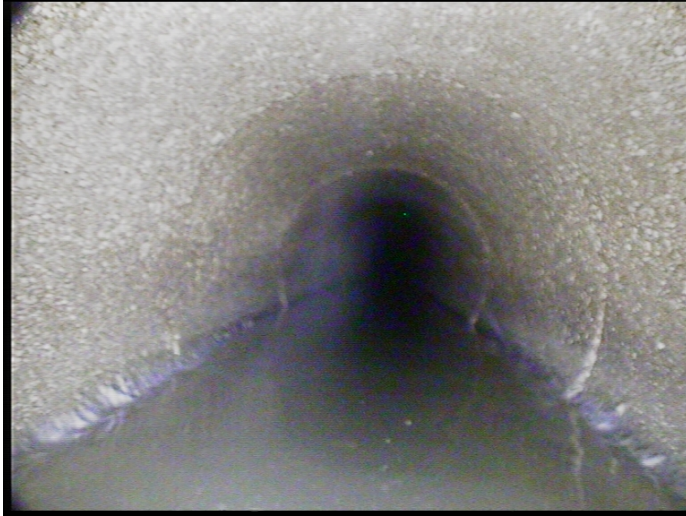
Code: **RFJ**  
Description: **Roots Fine Joint**

Distance (ft): **152.0**  
Structural Grade: **0**  
O&M Grade: **1**  
Clock Start/From: **9**  
Clock To: **3**  
1st Value:  
2nd Value:  
Value Percent:  
Continuous Index: **F03**  
Within 8" of Joint: **YES**  
Remarks:

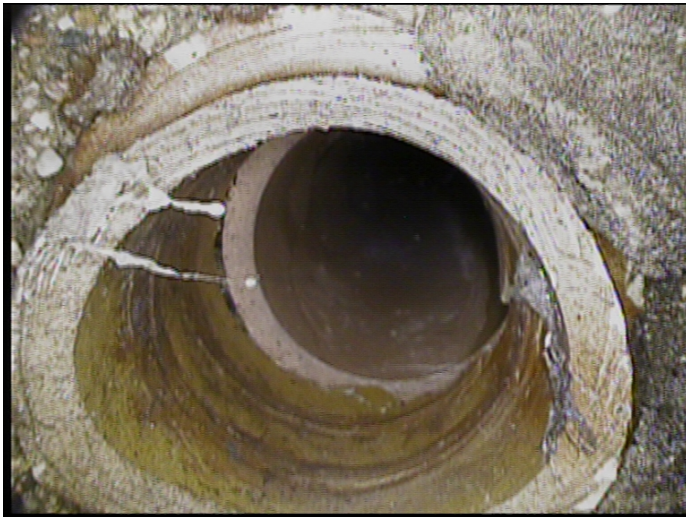
Code: **TB**  
Description: **Tap Break-in**

Distance (ft): **252.6**  
Structural Grade: **0**  
O&M Grade: **0**  
Clock Start/From: **2**  
Clock To:  
1st Value: **4.000**  
2nd Value:  
Value Percent:  
Continuous Index:  
Within 8" of Joint: **NO**  
Remarks:

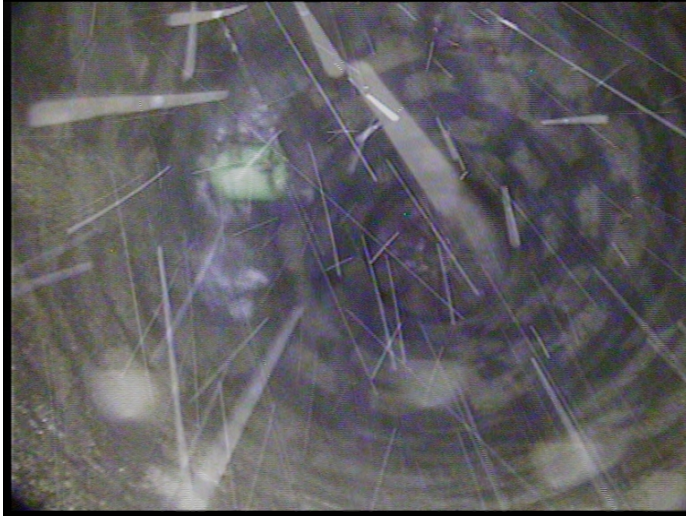
Code: **AMH**  
Description: **Manhole**

Distance (ft): **263.4**  
Structural Grade: **0**  
O&M Grade: **0**  
Clock Start/From:  
Clock To:  
1st Value:  
2nd Value:  
Value Percent:  
Continuous Index:  
Within 8" of Joint: **NO**  
Remarks: **M-505-016**

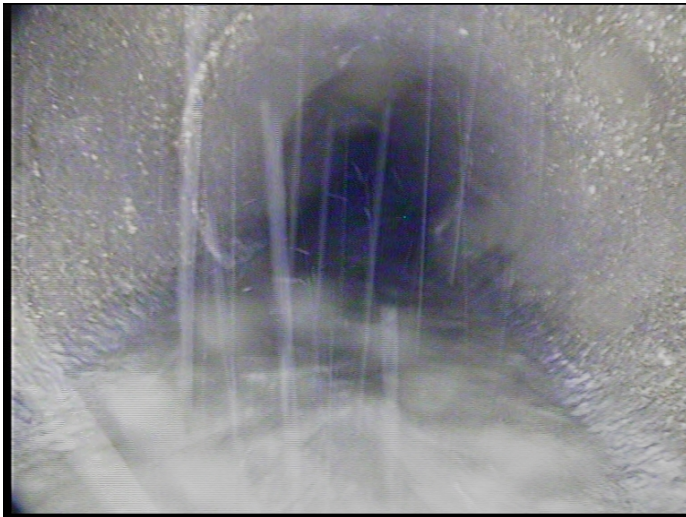
Code: **SAV**  
Description: **Surface Aggregate Visible**

Distance (ft): **263.4**  
Structural Grade: **3**  
O&M Grade: **0**  
Clock Start/From: **8**  
Clock To: **4**  
1st Value:  
2nd Value:  
Value Percent:  
Continuous Index: **F01**  
Within 8" of Joint: **NO**  
Remarks:
