Profile/Photo Observation Report

Date:	04/26/2018	Weather:		Coding:	PACP 6.0
Pipe Length (ft):		Owner:	City of Hobart	Pre Clean:	No Pre-Cleaning
P.O.#:	93	Surveyor:	M. Pielacha	PSR:	P-505-093-092
Customer:	City of Hobart	Clean Date:		Shape:	C

Street:	3rd Street	Flow Control:	Not Controlled
City:	Hobart, IN	Year Renewed:	
Location:	Light Highway	Tape/Media #:	DEP 93
Purpose:	Routine Assessment	Dia/Height:	18"
Use:	Sanitary	Material:	CP
Drain Area:		Lining:	
Category:	NA		
Comment:	YES501824 Submittal 2		
Location Details:		Direction of Survey:	Downstream
US MH:	M-505-093	DS MH:	M-505-092
		Total Length Surveyed (ft):	11.0

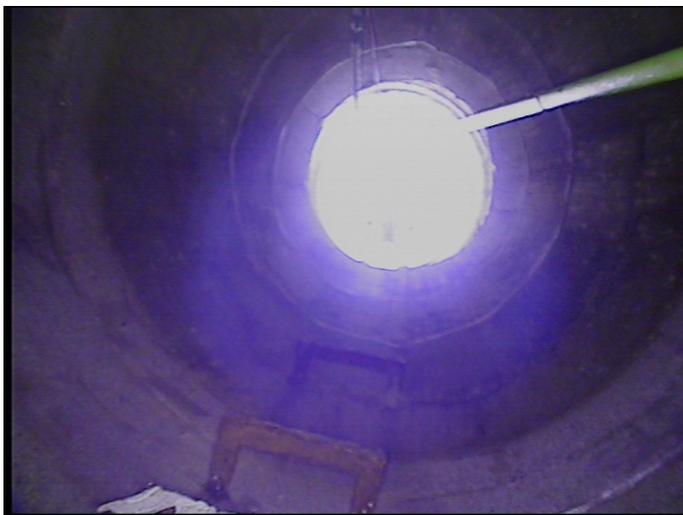
Code: **AMH**
Description: **Manhole**

Distance (ft): **.0**
Structural Grade: **0**
O&M Grade: **0**
Clock Start/From:
Clock To:
1st Value:
2nd Value:
Value Percent:
Continuous Index:
Within 8" of Joint: **NO**
Remarks: **M-505-093**

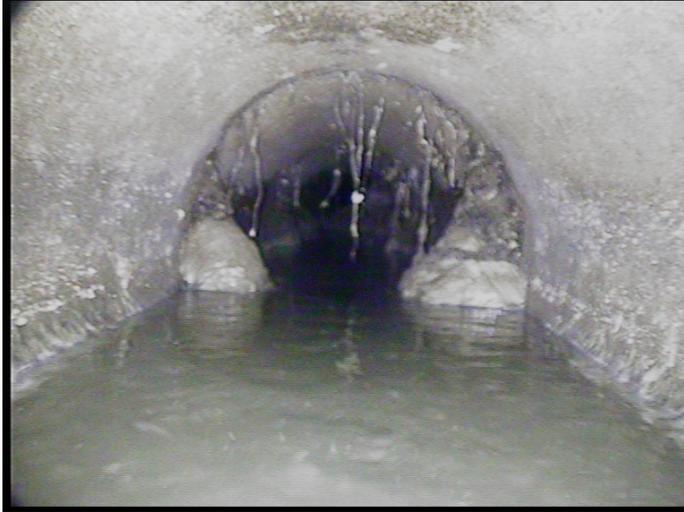
Code: **MWL**
Description: **Water Level**

Distance (ft): **.0**
Structural Grade: **0**
O&M Grade: **0**
Clock Start/From:
Clock To:
1st Value:
2nd Value:
Value Percent: **15.000**
Continuous Index:
Within 8" of Joint: **NO**
Remarks:

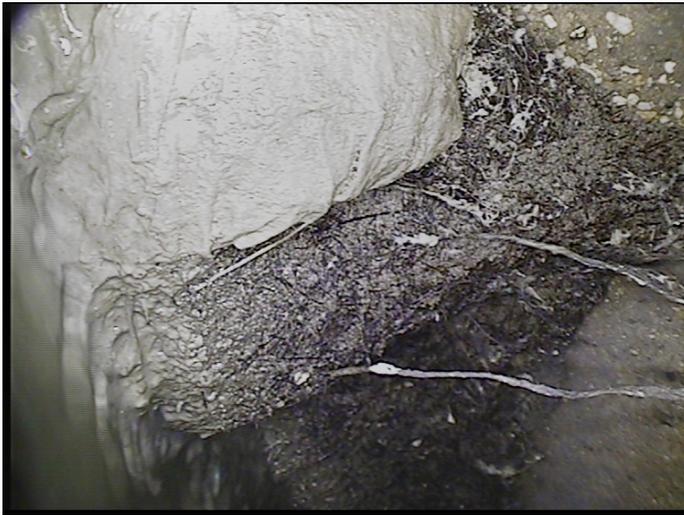
Code: **RMJ**
Description: **Roots Medium Joint**

Distance (ft): **3.0**
Structural Grade: **0**
O&M Grade: **3**
Clock Start/From: **8**
Clock To: **4**
1st Value:
2nd Value:
Value Percent: **20.000**
Continuous Index: **S01**
Within 8" of Joint: **YES**
Remarks:

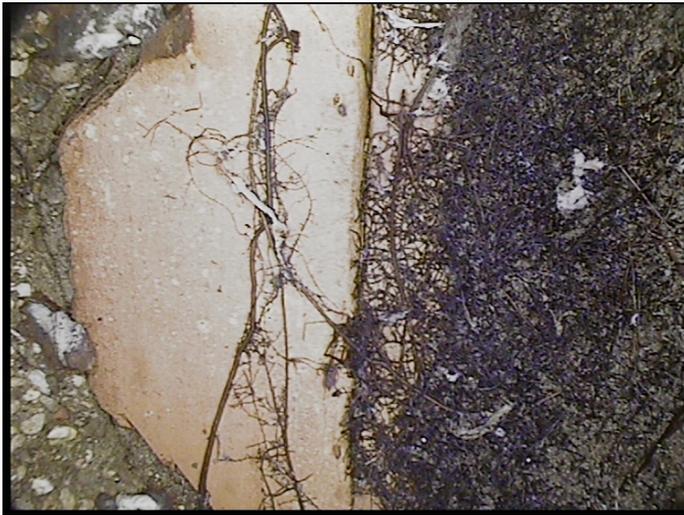
Code: **TBC**
Description: **Tap Break-in Capped**

Distance (ft): **4.2**
Structural Grade: **0**
O&M Grade: **2**
Clock Start/From: **3**
Clock To:
1st Value: **4.000**
2nd Value:
Value Percent:
Continuous Index:
Within 8" of Joint: **NO**
Remarks:

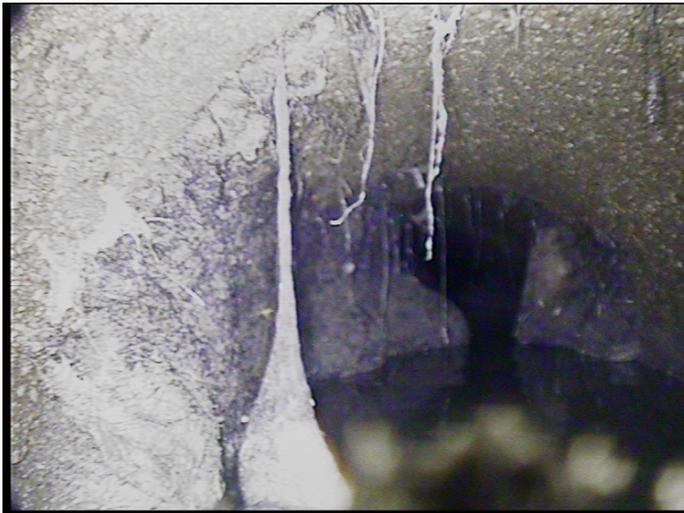
Code: **RMJ**
Description: **Roots Medium Joint**

Distance (ft): **11.0**
Structural Grade: **0**
O&M Grade: **3**
Clock Start/From: **8**
Clock To: **4**
1st Value:
2nd Value:
Value Percent: **25.000**
Continuous Index: **F01**
Within 8" of Joint: **YES**
Remarks:

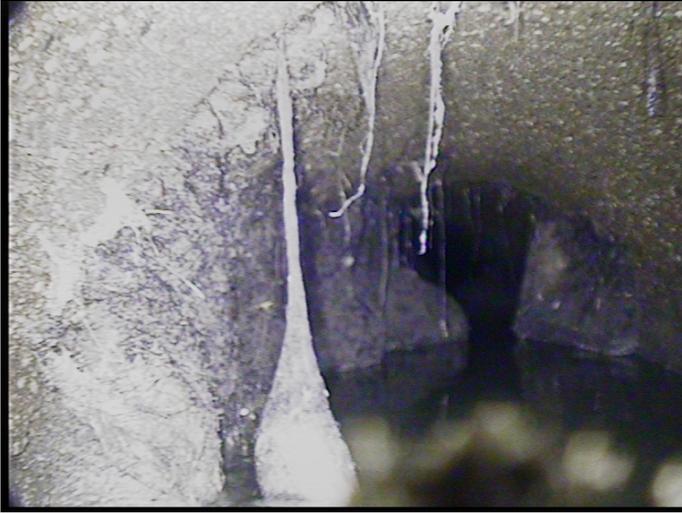
Code: **MSA**
Description: **Abandoned Survey**

Distance (ft): **11.0**
Structural Grade: **0**
O&M Grade: **0**
Clock Start/From:
Clock To:
1st Value:
2nd Value:
Value Percent:
Continuous Index:
Within 8" of Joint: **NO**
Remarks: **roots**
