Profile/Photo Observation Report

| Street: | 3rd Street | Flow Control: | Not Controlled |
| Purpose: | Routine Assessment | Dia/Height: | 18" |
| US MH: | M-505-093 | DS MH: | M-505-092 |

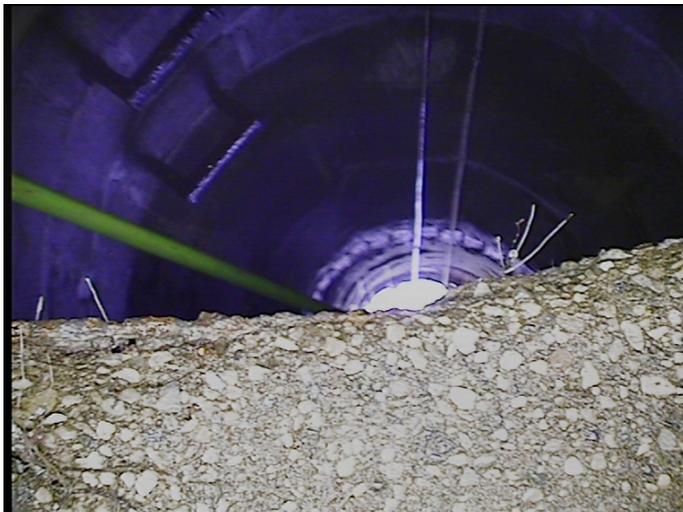
Code: **AMH**
 Description: **Manhole**

Distance (ft): **.0**
 Structural Grade: **0**
 O&M Grade: **0**
 Clock Start/From:
 Clock To:
 1st Value:
 2nd Value:
 Value Percent:
 Continuous Index:
 Within 8" of Joint: **NO**
 Remarks: **M-505-092**

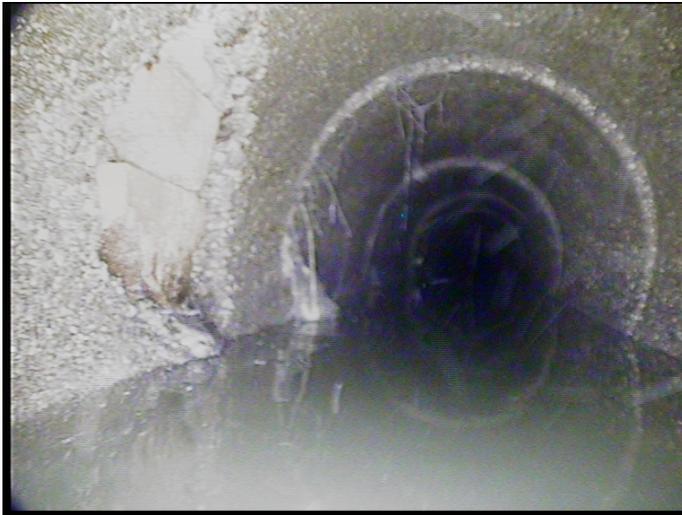
Code: **MWL**
Description: **Water Level**

Distance (ft): **.0**
Structural Grade: **0**
O&M Grade: **0**
Clock Start/From:
Clock To:
1st Value:
2nd Value:
Value Percent: **20.000**
Continuous Index:
Within 8" of Joint: **NO**
Remarks:

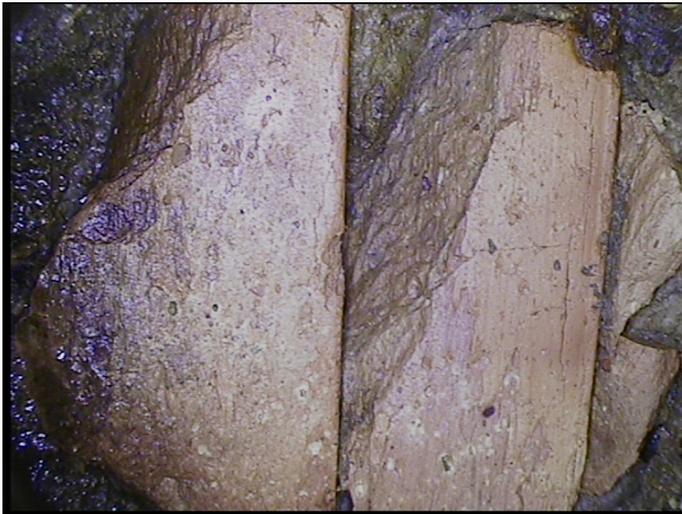
Code: **TBC**
Description: **Tap Break-in Capped**

Distance (ft): **2.4**
Structural Grade: **0**
O&M Grade: **2**
Clock Start/From: **9**
Clock To:
1st Value: **4.000**
2nd Value:
Value Percent:
Continuous Index:
Within 8" of Joint: **NO**
Remarks:

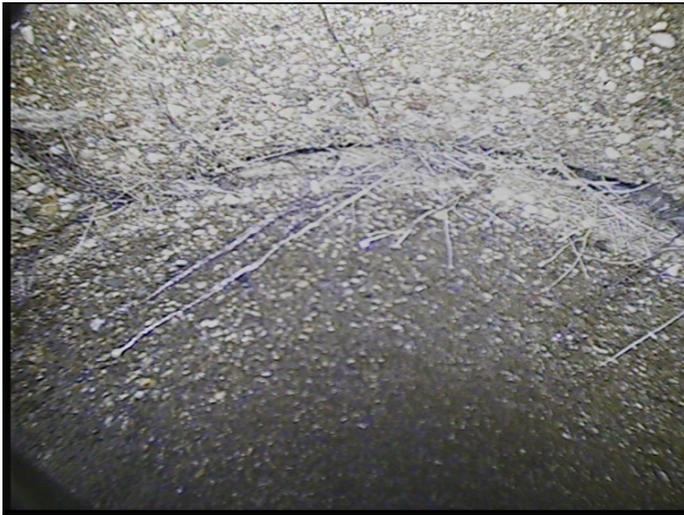
Code: **RFJ**
Description: **Roots Fine Joint**

Distance (ft): **5.7**
Structural Grade: **0**
O&M Grade: **1**
Clock Start/From: **11**
Clock To:
1st Value:
2nd Value:
Value Percent:
Continuous Index: **S01**
Within 8" of Joint: **YES**
Remarks:

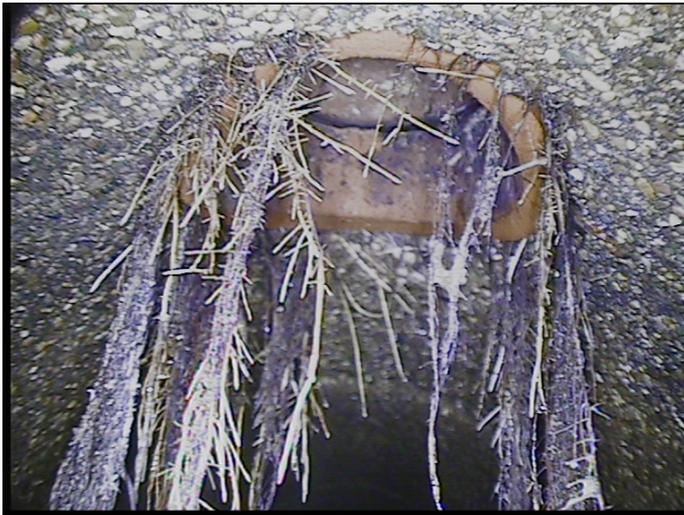
Code: **TBD**
Description: **Tap Break-in Defective**

Distance (ft): **77.5**
Structural Grade: **0**
O&M Grade: **3**
Clock Start/From: **12**
Clock To:
1st Value: **4.000**
2nd Value:
Value Percent:
Continuous Index:
Within 8" of Joint: **NO**
Remarks: **Defective**

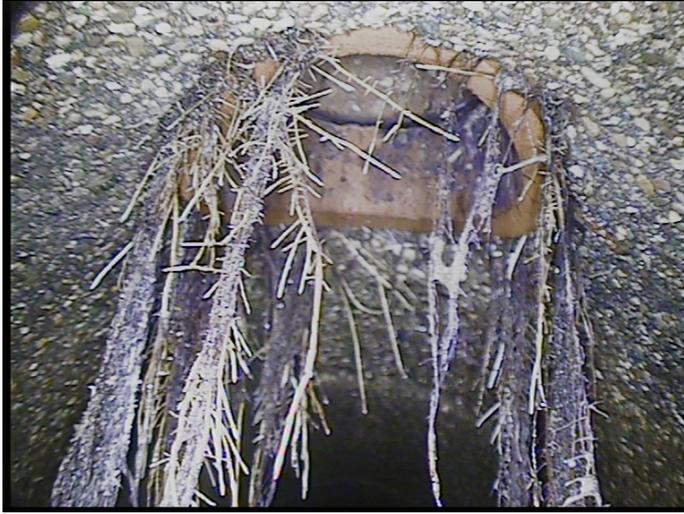
Code: **RFL**
Description: **Roots Fine Lateral**

Distance (ft): **77.5**
Structural Grade: **0**
O&M Grade: **1**
Clock Start/From: **12**
Clock To:
1st Value:
2nd Value:
Value Percent:
Continuous Index:
Within 8" of Joint: **NO**
Remarks:

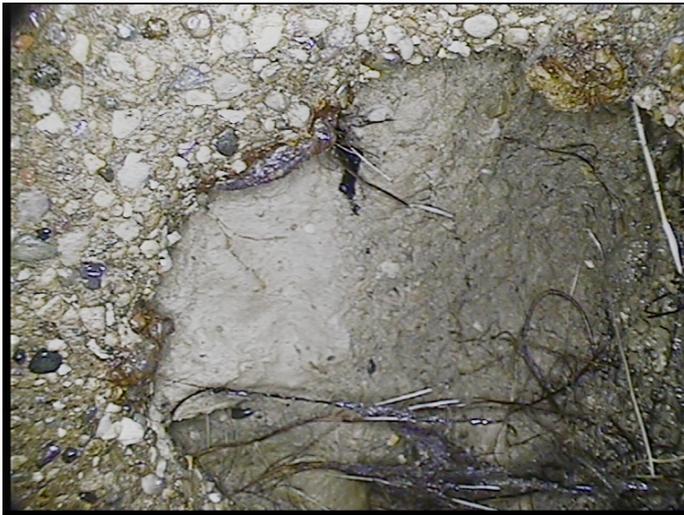
Code: **TBC**
Description: **Tap Break-in Capped**

Distance (ft): **81.1**
Structural Grade: **0**
O&M Grade: **2**
Clock Start/From: **3**
Clock To:
1st Value: **4.000**
2nd Value:
Value Percent:
Continuous Index:
Within 8" of Joint: **NO**
Remarks:

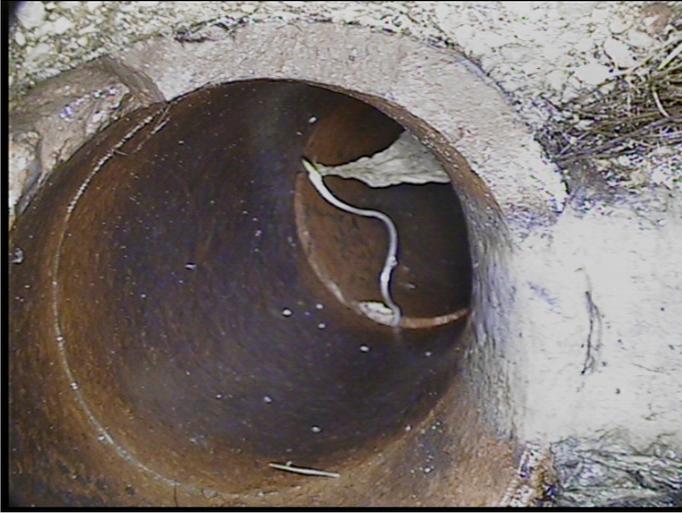
Code: **TBD**
Description: **Tap Break-in Defective**

Distance (ft): **89.6**
Structural Grade: **0**
O&M Grade: **3**
Clock Start/From: **2**
Clock To:
1st Value: **4.000**
2nd Value:
Value Percent:
Continuous Index:
Within 8" of Joint: **YES**
Remarks: **Defective**

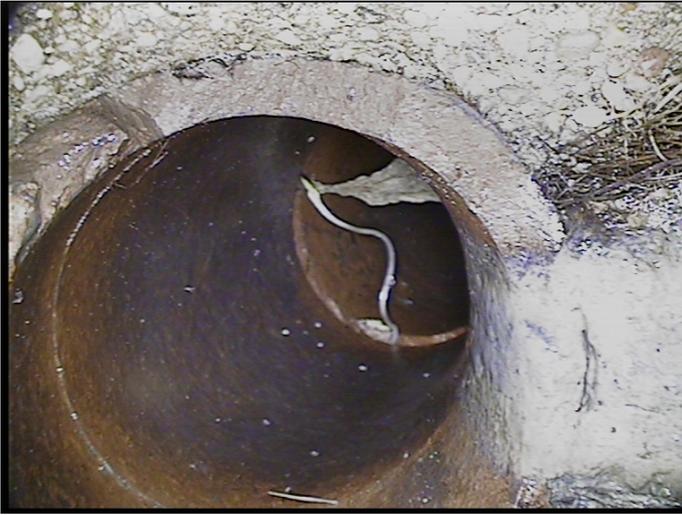
Code: **RFL**
Description: **Roots Fine Lateral**

Distance (ft): **89.6**
Structural Grade: **0**
O&M Grade: **1**
Clock Start/From: **2**
Clock To:
1st Value:
2nd Value:
Value Percent:
Continuous Index:
Within 8" of Joint: **NO**
Remarks:

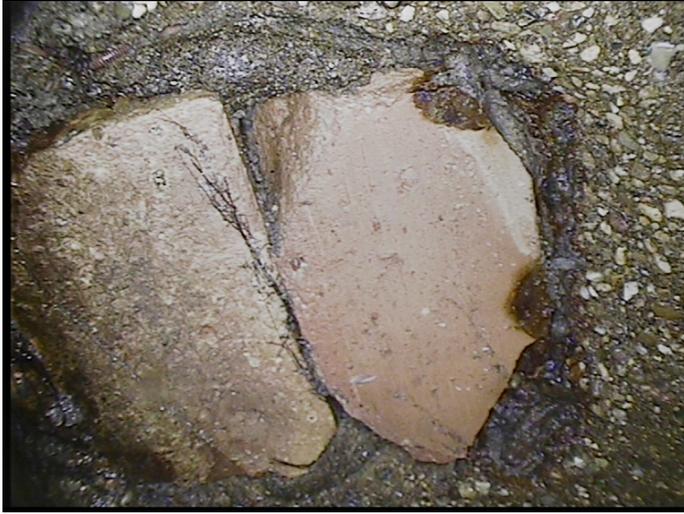
Code: **TBC**
Description: **Tap Break-in Capped**

Distance (ft): **117.2**
Structural Grade: **0**
O&M Grade: **2**
Clock Start/From: **9**
Clock To:
1st Value: **4.000**
2nd Value:
Value Percent:
Continuous Index:
Within 8" of Joint: **NO**
Remarks:

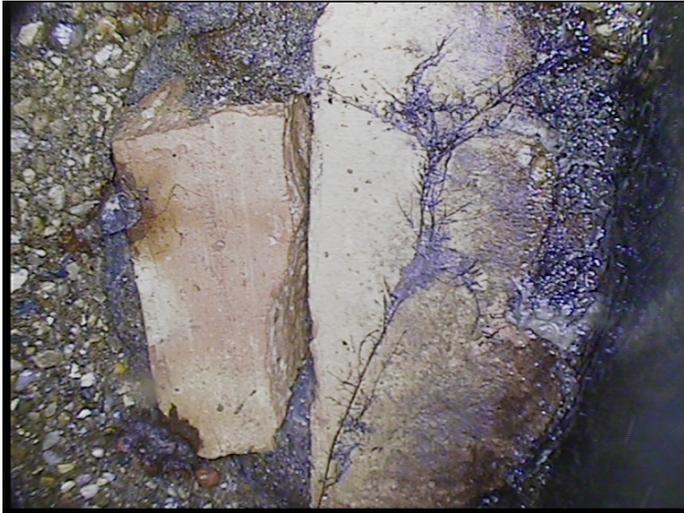
Code: **TFC**
Description: **Tap Factory Capped**

Distance (ft): **120.4**
Structural Grade: **0**
O&M Grade: **0**
Clock Start/From: **3**
Clock To:
1st Value: **4.000**
2nd Value:
Value Percent:
Continuous Index:
Within 8" of Joint: **NO**
Remarks:

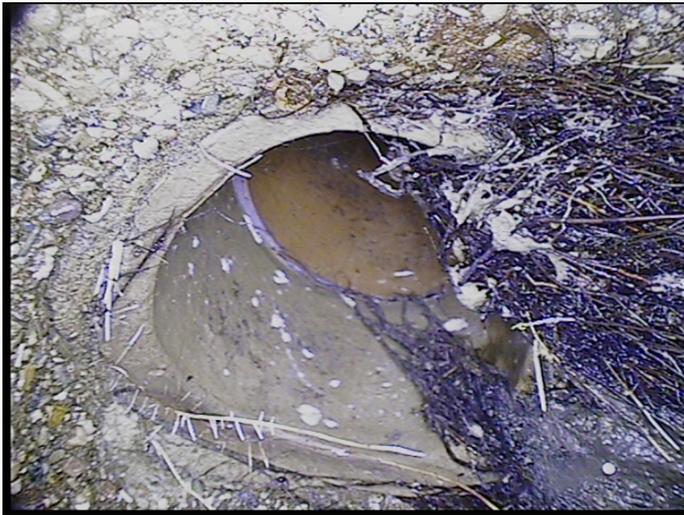
Code: **TBD**
Description: **Tap Break-in Defective**

Distance (ft): **148.1**
Structural Grade: **0**
O&M Grade: **3**
Clock Start/From: **3**
Clock To:
1st Value: **4.000**
2nd Value:
Value Percent:
Continuous Index:
Within 8" of Joint: **NO**
Remarks: **Defective**

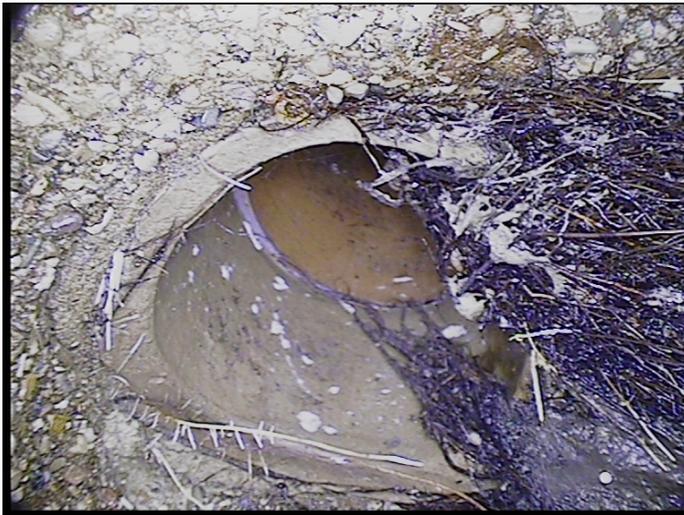
Code: **RFL**
Description: **Roots Fine Lateral**

Distance (ft): **148.1**
Structural Grade: **0**
O&M Grade: **1**
Clock Start/From: **3**
Clock To:
1st Value:
2nd Value:
Value Percent:
Continuous Index:
Within 8" of Joint: **NO**
Remarks:

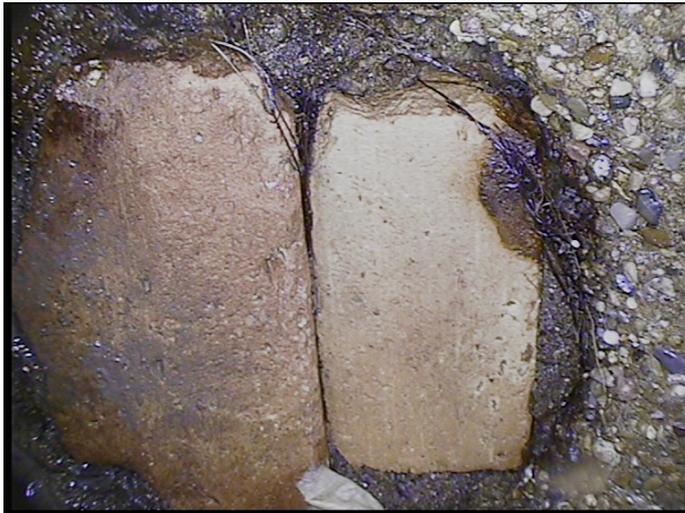
Code: **TBC**
Description: **Tap Break-in Capped**

Distance (ft): **153.9**
Structural Grade: **0**
O&M Grade: **2**
Clock Start/From: **9**
Clock To:
1st Value: **4.000**
2nd Value:
Value Percent:
Continuous Index:
Within 8" of Joint: **NO**
Remarks:

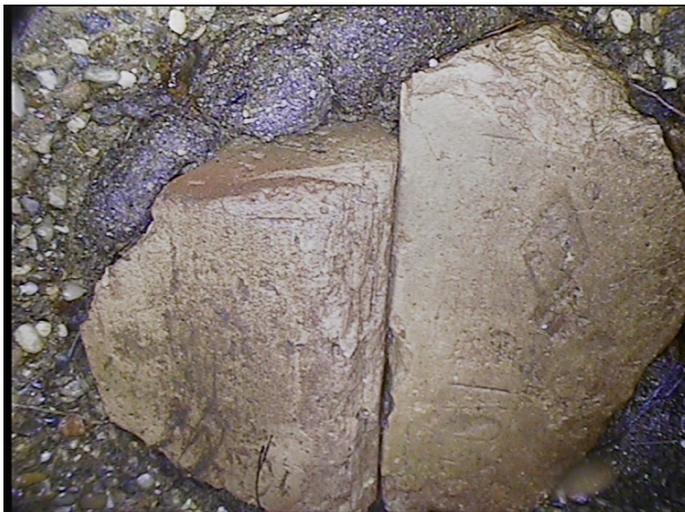
Code: **TBC**
Description: **Tap Break-in Capped**

Distance (ft): **156.8**
Structural Grade: **0**
O&M Grade: **2**
Clock Start/From: **3**
Clock To:
1st Value: **4.000**
2nd Value:
Value Percent:
Continuous Index:
Within 8" of Joint: **NO**
Remarks:

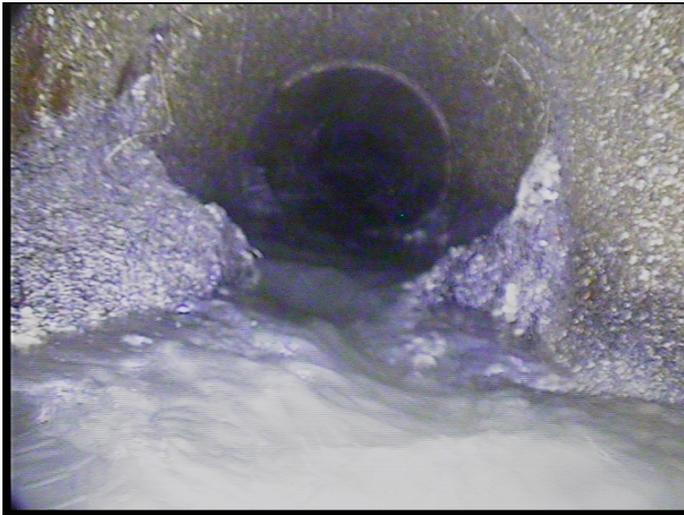
Code: **RFJ**
Description: **Roots Fine Joint**

Distance (ft): **177.4**
Structural Grade: **0**
O&M Grade: **1**
Clock Start/From: **11**
Clock To:
1st Value:
2nd Value:
Value Percent:
Continuous Index: **F01**
Within 8" of Joint: **YES**
Remarks:

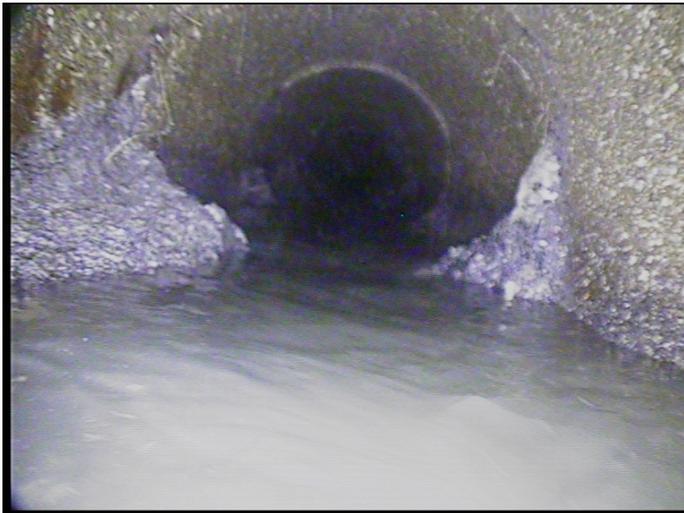
Code: **RMJ**
Description: **Roots Medium Joint**

Distance (ft): **177.4**
Structural Grade: **0**
O&M Grade: **3**
Clock Start/From: **8**
Clock To: **4**
1st Value:
2nd Value:
Value Percent: **20.000**
Continuous Index:
Within 8" of Joint: **YES**
Remarks:

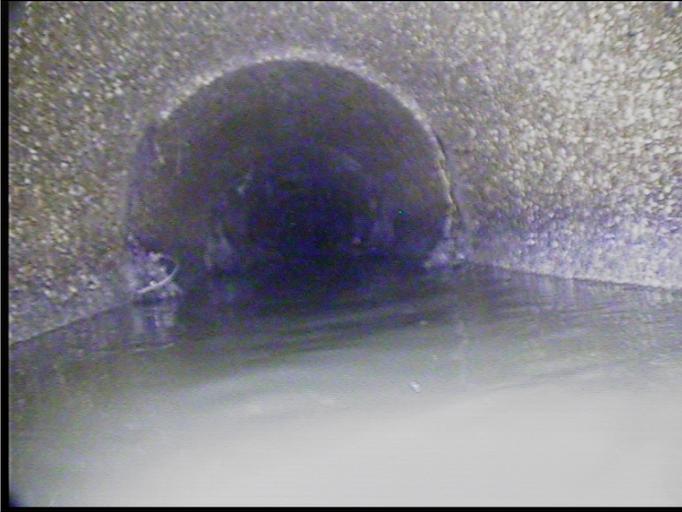
Code: **MSA**
Description: **Abandoned Survey**

Distance (ft): **179.4**
Structural Grade: **0**
O&M Grade: **0**
Clock Start/From:
Clock To:
1st Value:
2nd Value:
Value Percent:
Continuous Index:
Within 8" of Joint: **NO**
Remarks: **roots**
