## Profile/Photo Observation Report

Date:	<b>04/25/2018</b>	Weather:		Coding:	<b>PACP 6.0</b>
Pipe Length (ft):		Owner:	<b>City of Hobart</b>	Pre Clean:	<b>No Pre-Cleaning</b>
P.O.#:	<b>86</b>	Surveyor:	<b>M. Pielacha</b>	PSR:	<b>P-505-095-094</b>
Customer:	<b>City of Hobart</b>	Clean Date:		Shape:	<b>C</b>

Street:	<b>3rd Street</b>	Flow Control:	<b>Not Controlled</b>
City:	<b>Hobart, IN</b>	Year Renewed:	
Location:	<b>Light Highway</b>	Tape/Media #:	<b>DEP 86</b>
Purpose:	<b>Routine Assessment</b>	Dia/Height:	<b>18"</b>
Use:	<b>Sanitary</b>	Material:	<b>CP</b>
Drain Area:		Lining:	
Category:	<b>NA</b>		
Comment:	<b>YES501824 Submittal 2</b>		
Location Details:		Direction of Survey:	<b>Downstream</b>
US MH:	<b>M-505-095</b>	DS MH:	<b>M-505-094</b>
		Total Length Surveyed (ft):	<b>318.7</b>

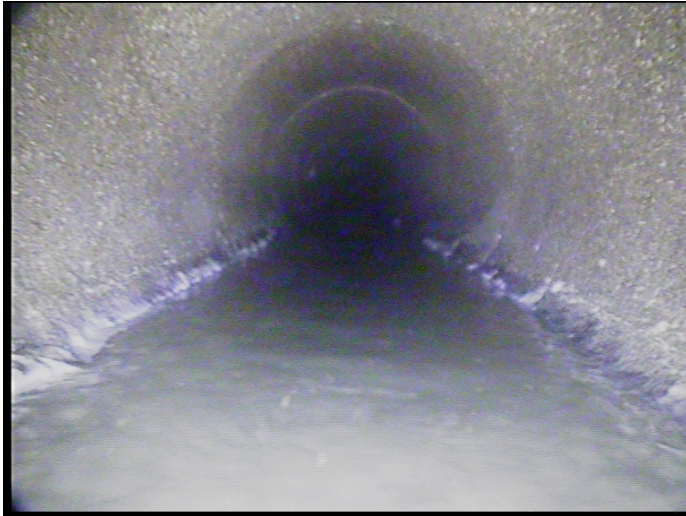
Code: **MWL**  
Description: **Water Level**

Distance (ft): **.0**  
Structural Grade: **0**  
O&M Grade: **0**  
Clock Start/From:  
Clock To:  
1st Value:  
2nd Value:  
Value Percent: **10.000**  
Continuous Index:  
Within 8" of Joint: **NO**  
Remarks:

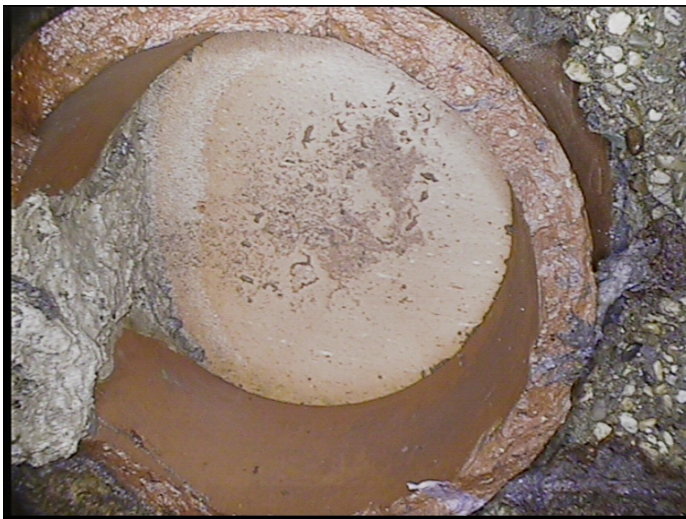
Code: **TBC**  
Description: **Tap Break-in Capped**

Distance (ft): **14.3**  
Structural Grade: **0**  
O&M Grade: **2**  
Clock Start/From: **9**  
Clock To:  
1st Value: **4.000**  
2nd Value:  
Value Percent:  
Continuous Index:  
Within 8" of Joint: **NO**  
Remarks:

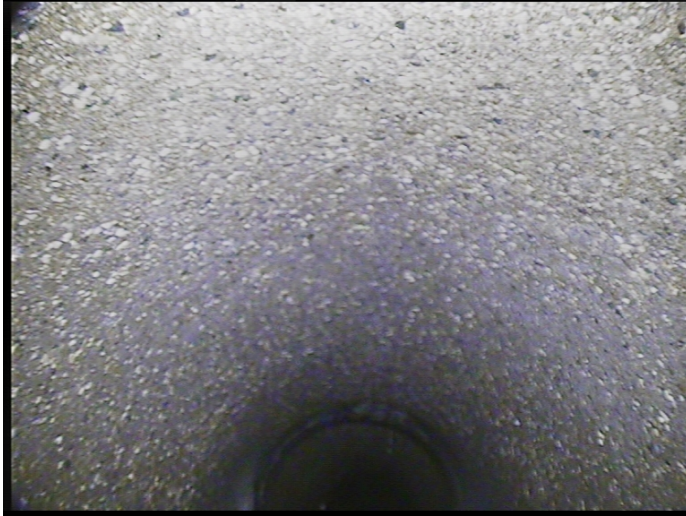
Code:	<b>SAV</b>
Description:	<b>Surface Aggregate Visible</b>
Distance (ft):	<b>15.8</b>
Structural Grade:	<b>3</b>
O&M Grade:	<b>0</b>
Clock Start/From:	<b>8</b>
Clock To:	<b>4</b>
1st Value:	
2nd Value:	
Value Percent:	
Continuous Index:	<b>S01</b>
Within 8" of Joint:	<b>YES</b>
Remarks:

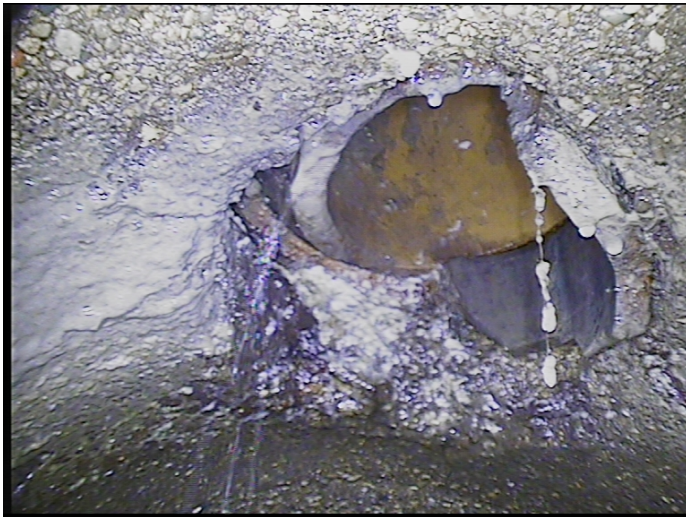
Code:	<b>TBA</b>
Description:	<b>Tap Break-in Active</b>
Distance (ft):	<b>20.6</b>
Structural Grade:	<b>0</b>
O&M Grade:	<b>0</b>
Clock Start/From:	<b>12</b>
Clock To:	
1st Value:	<b>4.000</b>
2nd Value:	
Value Percent:	
Continuous Index:	
Within 8" of Joint:	<b>NO</b>
Remarks:

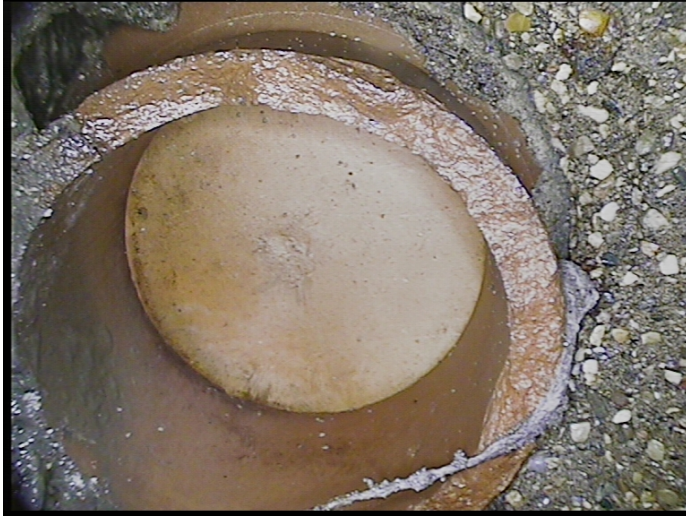
Code:	<b>TBC</b>
Description:	<b>Tap Break-in Capped</b>
Distance (ft):	<b>29.4</b>
Structural Grade:	<b>0</b>
O&M Grade:	<b>2</b>
Clock Start/From:	<b>9</b>
Clock To:	
1st Value:	<b>4.000</b>
2nd Value:	
Value Percent:	
Continuous Index:	
Within 8" of Joint:	<b>NO</b>
Remarks:

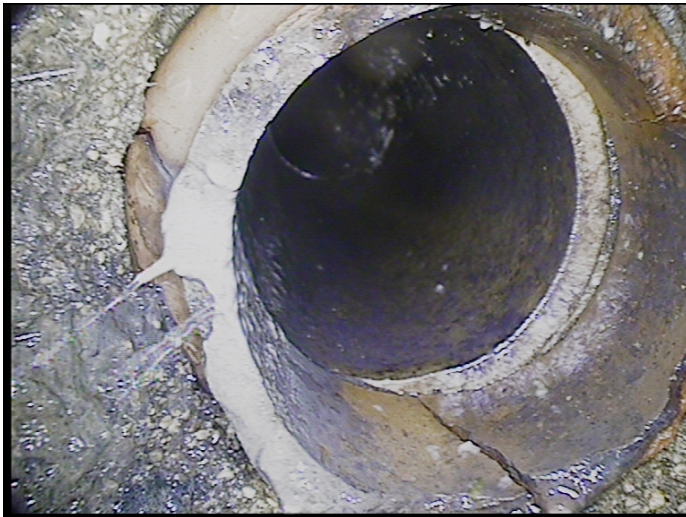
Code:	<b>TBA</b>
Description:	<b>Tap Break-in Active</b>
Distance (ft):	<b>32.1</b>
Structural Grade:	<b>0</b>
O&M Grade:	<b>0</b>
Clock Start/From:	<b>10</b>
Clock To:	
1st Value:	<b>4.000</b>
2nd Value:	
Value Percent:	
Continuous Index:	
Within 8" of Joint:	<b>NO</b>
Remarks:

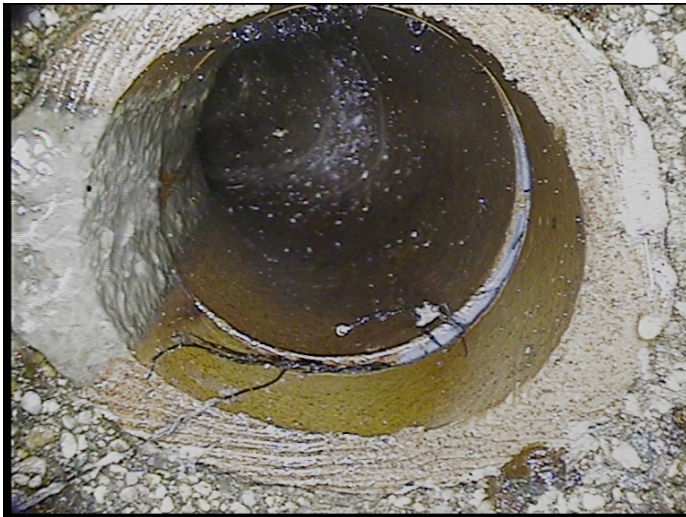
Code: **TBA**  
Description: **Tap Break-in Active**

Distance (ft): **126.8**  
Structural Grade: **0**  
O&M Grade: **0**  
Clock Start/From: **10**  
Clock To:  
1st Value: **4.000**  
2nd Value:  
Value Percent:  
Continuous Index:  
Within 8" of Joint: **NO**  
Remarks:

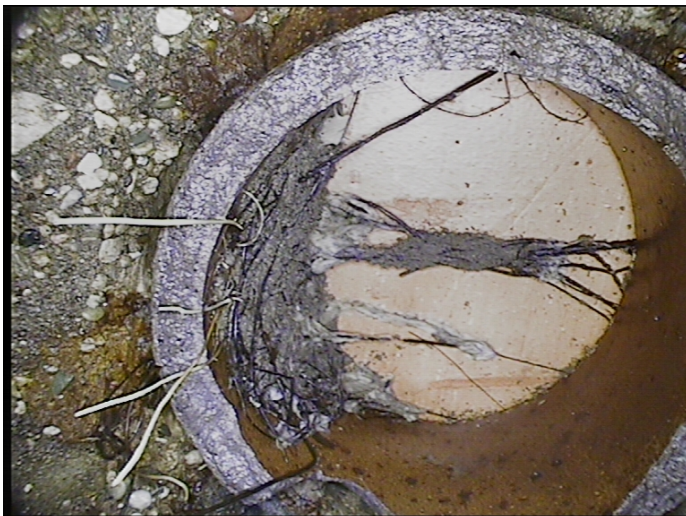
Code: **TBA**  
Description: **Tap Break-in Active**

Distance (ft): **130.1**  
Structural Grade: **0**  
O&M Grade: **0**  
Clock Start/From: **9**  
Clock To:  
1st Value: **4.000**  
2nd Value:  
Value Percent:  
Continuous Index:  
Within 8" of Joint: **NO**  
Remarks:

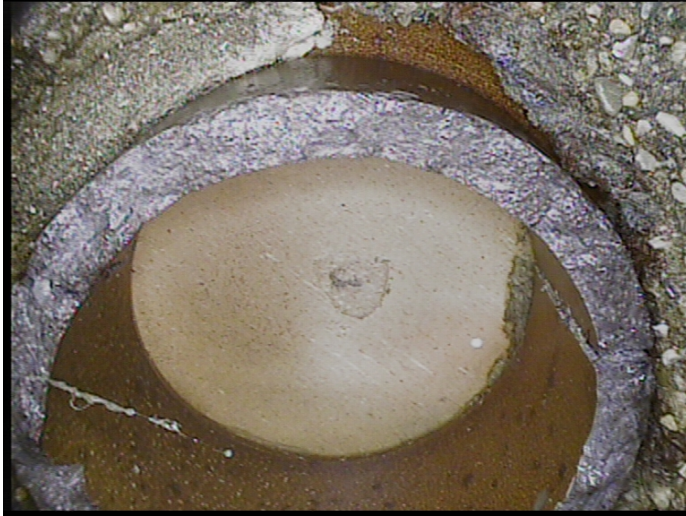
Code: **TBC**  
Description: **Tap Break-in Capped**

Distance (ft): **133.2**  
Structural Grade: **0**  
O&M Grade: **2**  
Clock Start/From: **3**  
Clock To:  
1st Value: **4.000**  
2nd Value:  
Value Percent:  
Continuous Index:  
Within 8" of Joint: **NO**  
Remarks:

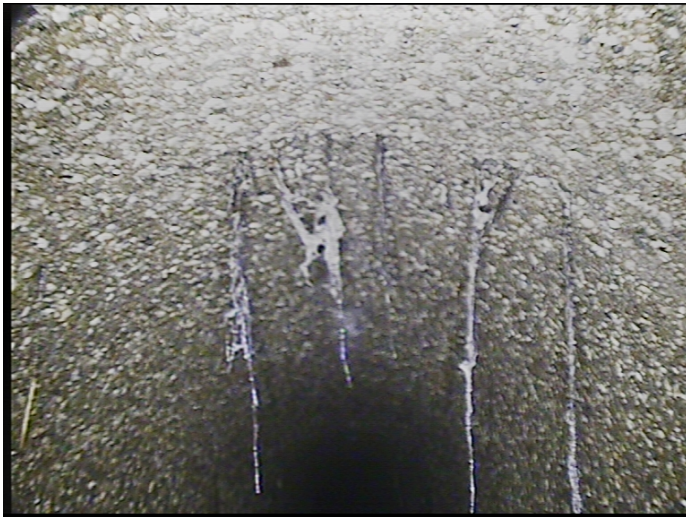
Code: **RFJ**  
Description: **Roots Fine Joint**

Distance (ft): **134.2**  
Structural Grade: **0**  
O&M Grade: **1**  
Clock Start/From: **9**  
Clock To: **3**  
1st Value:  
2nd Value:  
Value Percent:  
Continuous Index: **S02**  
Within 8" of Joint: **YES**  
Remarks:

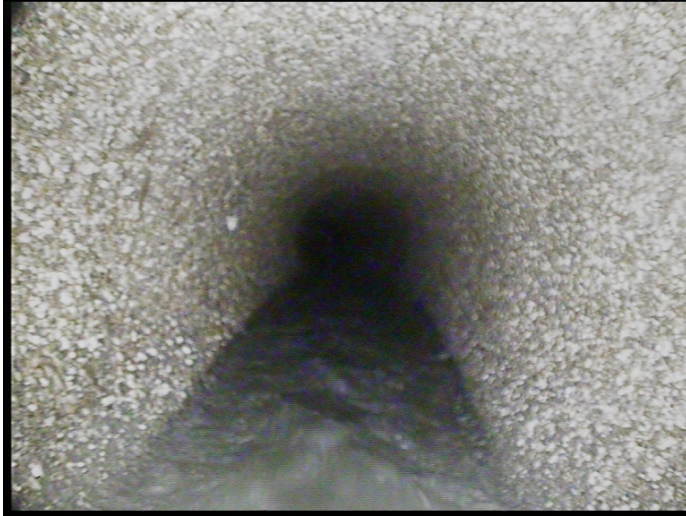
Code:	<b>RFJ</b>
Description:	<b>Roots Fine Joint</b>
Distance (ft):	<b>145.9</b>
Structural Grade:	<b>0</b>
O&M Grade:	<b>1</b>
Clock Start/From:	<b>9</b>
Clock To:	<b>3</b>
1st Value:	
2nd Value:	
Value Percent:	
Continuous Index:	<b>F02</b>
Within 8" of Joint:	<b>YES</b>
Remarks:

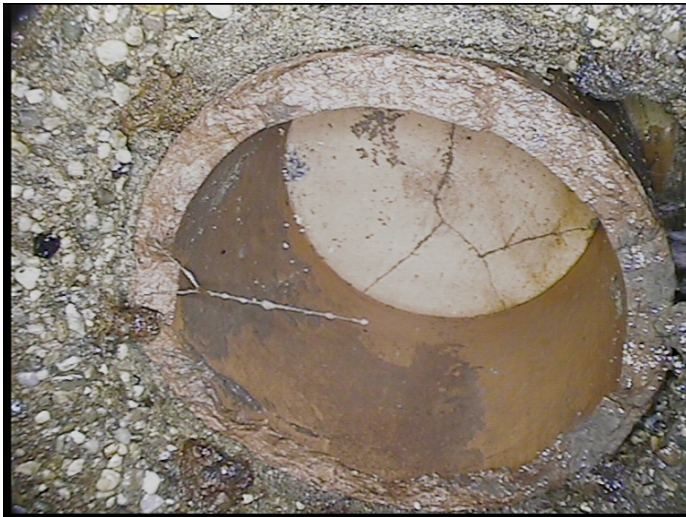
Code:	<b>TBC</b>
Description:	<b>Tap Break-in Capped</b>
Distance (ft):	<b>230.5</b>
Structural Grade:	<b>0</b>
O&M Grade:	<b>2</b>
Clock Start/From:	<b>3</b>
Clock To:	
1st Value:	<b>4.000</b>
2nd Value:	
Value Percent:	
Continuous Index:	
Within 8" of Joint:	<b>NO</b>
Remarks:

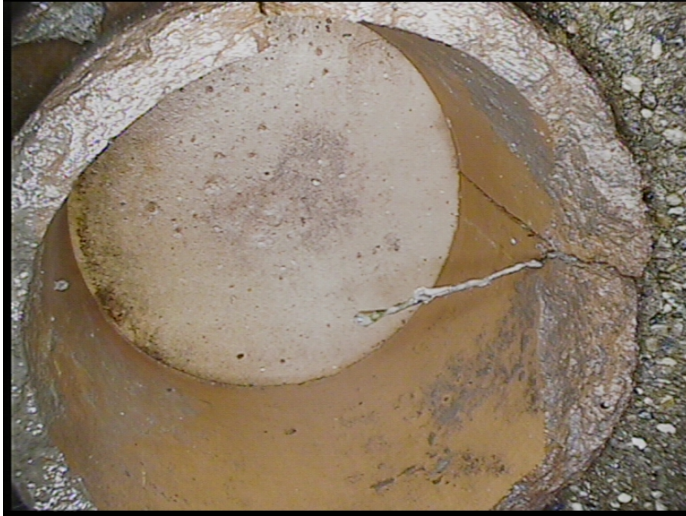
Code: **TBC**  
Description: **Tap Break-in Capped**

Distance (ft): **233.7**  
Structural Grade: **0**  
O&M Grade: **2**  
Clock Start/From: **9**  
Clock To:  
1st Value: **4.000**  
2nd Value:  
Value Percent:  
Continuous Index:  
Within 8" of Joint: **NO**  
Remarks:

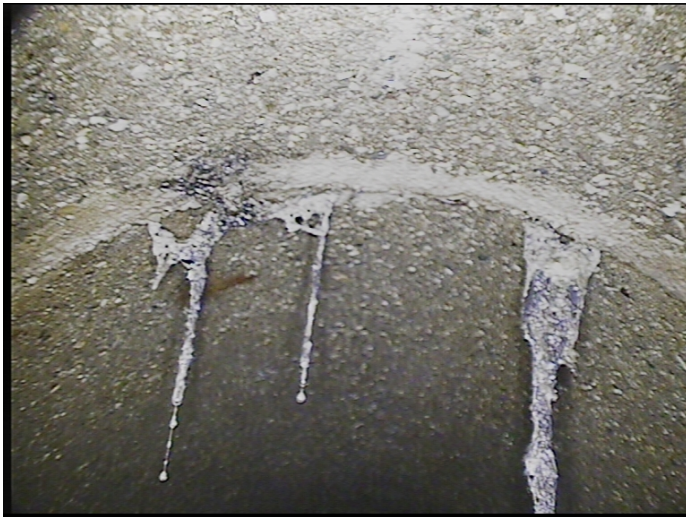
Code: **RFJ**  
Description: **Roots Fine Joint**

Distance (ft): **271.1**  
Structural Grade: **0**  
O&M Grade: **1**  
Clock Start/From: **11**  
Clock To: **1**  
1st Value:  
2nd Value:  
Value Percent:  
Continuous Index: **S03**  
Within 8" of Joint: **YES**  
Remarks:

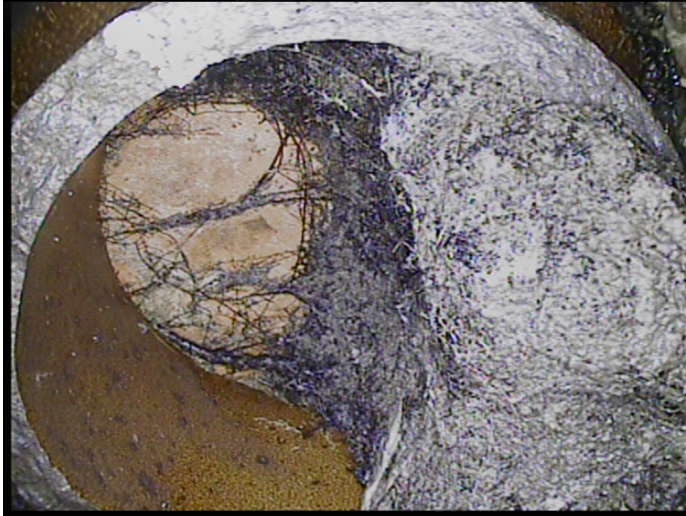
Code: **TFC**  
Description: **Tap Factory Capped**

Distance (ft): **285.6**  
Structural Grade: **0**  
O&M Grade: **0**  
Clock Start/From: **3**  
Clock To:  
1st Value: **4.000**  
2nd Value:  
Value Percent:  
Continuous Index:  
Within 8" of Joint: **NO**  
Remarks:

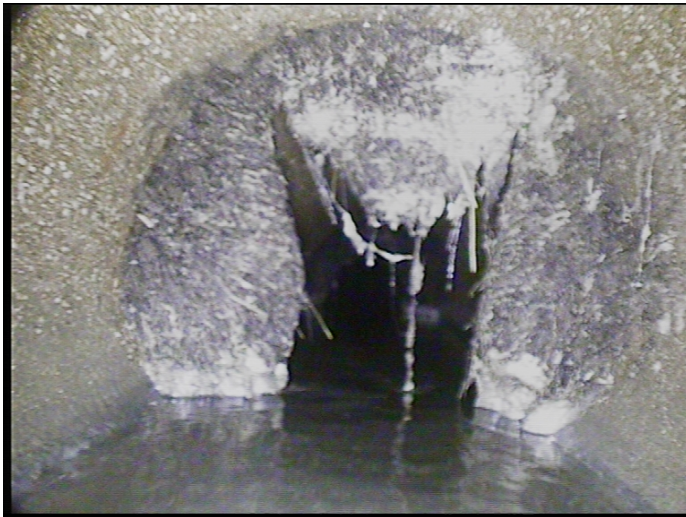
Code: **RFJ**  
Description: **Roots Fine Joint**

Distance (ft): **309.4**  
Structural Grade: **0**  
O&M Grade: **1**  
Clock Start/From: **11**  
Clock To: **1**  
1st Value:  
2nd Value:  
Value Percent:  
Continuous Index: **F03**  
Within 8" of Joint: **YES**  
Remarks:

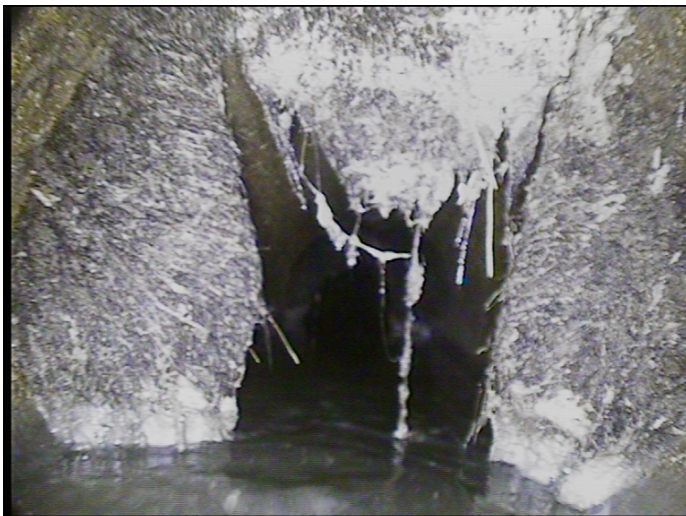
Code: **RMJ**  
Description: **Roots Medium Joint**

Distance (ft): **310.1**  
Structural Grade: **0**  
O&M Grade: **3**  
Clock Start/From: **7**  
Clock To: **5**  
1st Value:  
2nd Value:  
Value Percent: **20.000**  
Continuous Index: **S04**  
Within 8" of Joint: **YES**  
Remarks:

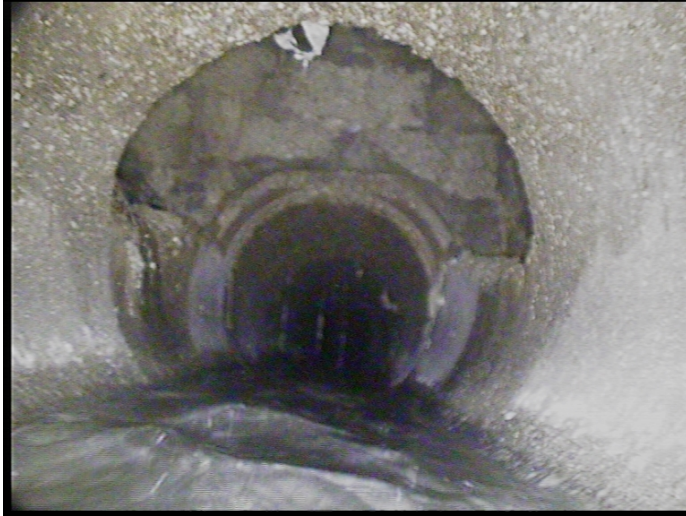
Code: **RMJ**  
Description: **Roots Medium Joint**

Distance (ft): **318.7**  
Structural Grade: **0**  
O&M Grade: **3**  
Clock Start/From: **7**  
Clock To: **5**  
1st Value:  
2nd Value:  
Value Percent: **20.000**  
Continuous Index: **F04**  
Within 8" of Joint: **YES**  
Remarks:

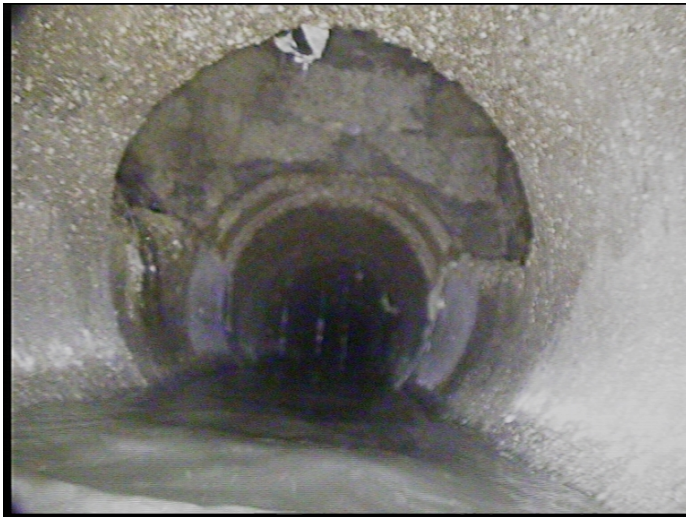
Code: **SAV**  
Description: **Surface Aggregate Visible**

Distance (ft): **318.7**  
Structural Grade: **3**  
O&M Grade: **0**  
Clock Start/From: **8**  
Clock To: **4**  
1st Value:  
2nd Value:  
Value Percent:  
Continuous Index: **F01**  
Within 8" of Joint: **NO**  
Remarks:

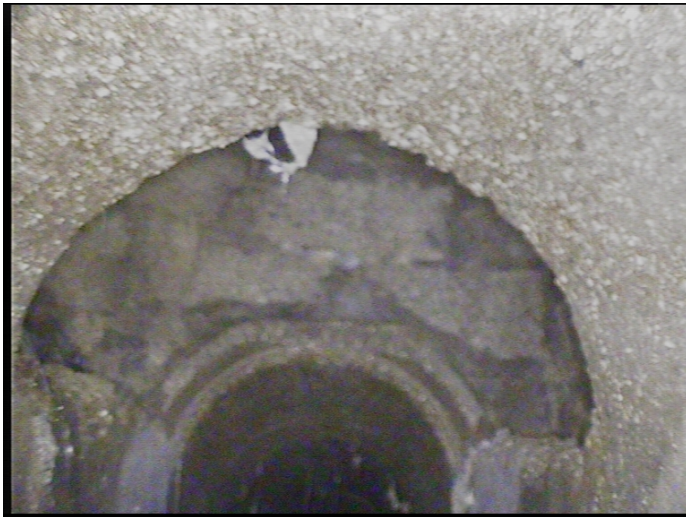
Code:	<b>AMH</b>
Description:	<b>Manhole</b>
Distance (ft):	<b>318.7</b>
Structural Grade:	<b>0</b>
O&M Grade:	<b>0</b>
Clock Start/From:	
Clock To:	
1st Value:	
2nd Value:	
Value Percent:	
Continuous Index:	
Within 8" of Joint:	<b>NO</b>
Remarks:	<b>M-505-094</b>
