Profile/Photo Observation Report

Street:	Off 3rd Street	Flow Control:	
City:	Hobart, IN	Year Renewed:	
Location:	Sidewalk	Tape/Media #:	896
Purpose:	Routine Assessment	Dia/Height:	18"
Use:	Sanitary	Material:	RCP
Drain Area:		Lining:	
Category:	NA		
Comment:

Location Details:		Direction of Survey:	Downstream
US MH:	M-505-96	DS MH:	M-505-95
		Total Length Surveyed (ft):	305.2

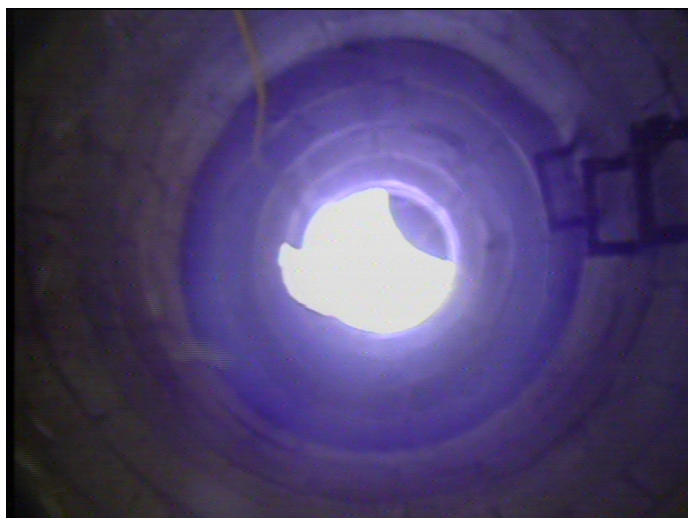
Code: **AMH**
 Description: **Manhole**

Distance (ft): **.0**
 Structural Grade: **0**
 O&M Grade: **0**
 Clock Start/From:
 Clock To:
 1st Value:
 2nd Value:
 Value Percent:
 Continuous Index:
 Within 8" of Joint: **NO**
 Remarks: **M-505-96**

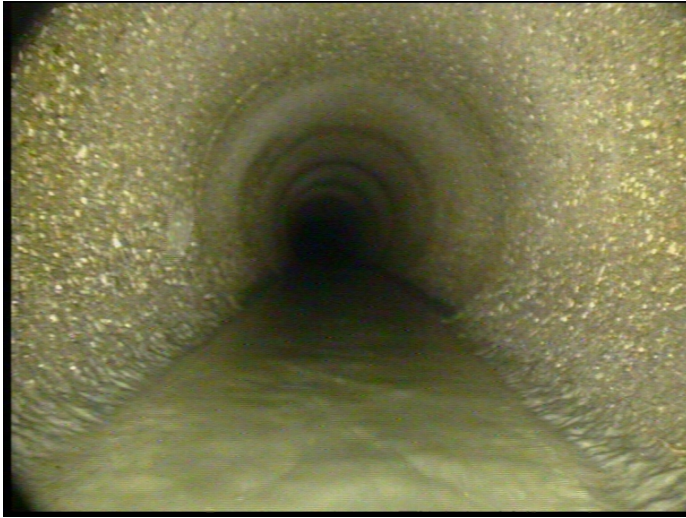
Code: **MWL**
Description: **Water Level**

Distance (ft): **.0**
Structural Grade: **0**
O&M Grade: **0**
Clock Start/From:
Clock To:
1st Value:
2nd Value:
Value Percent: **10.000**
Continuous Index:
Within 8" of Joint: **NO**
Remarks:

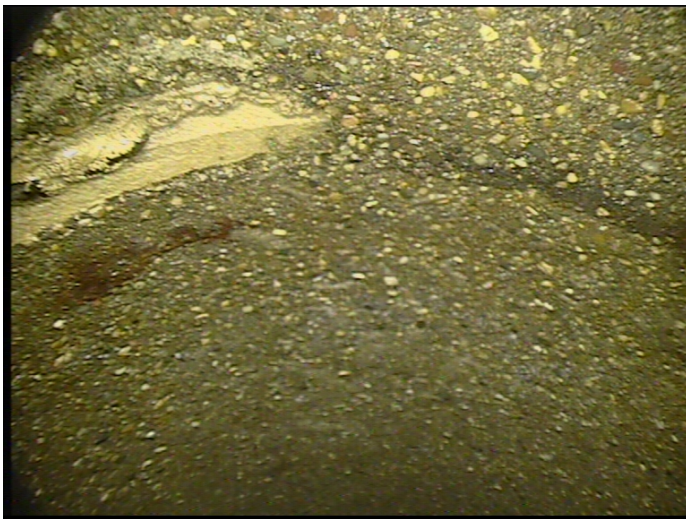
Code: **SAV**
Description: **Surface Aggregate Visible**

Distance (ft): **.0**
Structural Grade: **3**
O&M Grade: **0**
Clock Start/From: **8**
Clock To: **4**
1st Value:
2nd Value:
Value Percent:
Continuous Index: **S01**
Within 8" of Joint: **YES**
Remarks:

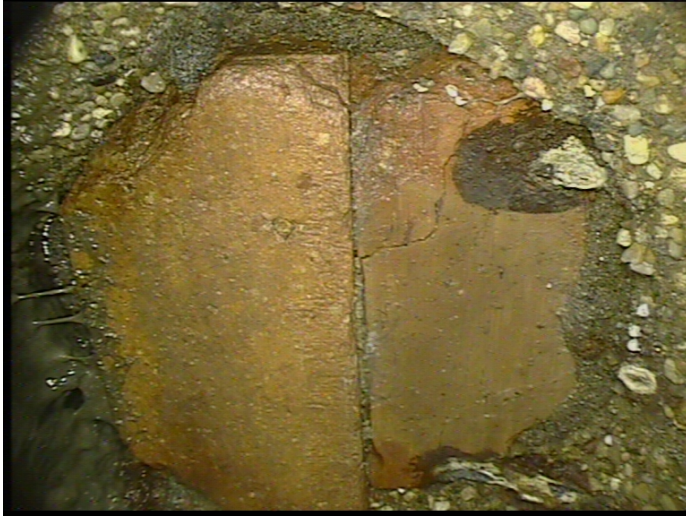
Code: **TFC**
Description: **Tap Factory Capped**

Distance (ft): **30.1**
Structural Grade: **0**
O&M Grade: **0**
Clock Start/From: **9**
Clock To:
1st Value: **4.000**
2nd Value:
Value Percent:
Continuous Index:
Within 8" of Joint: **NO**
Remarks:

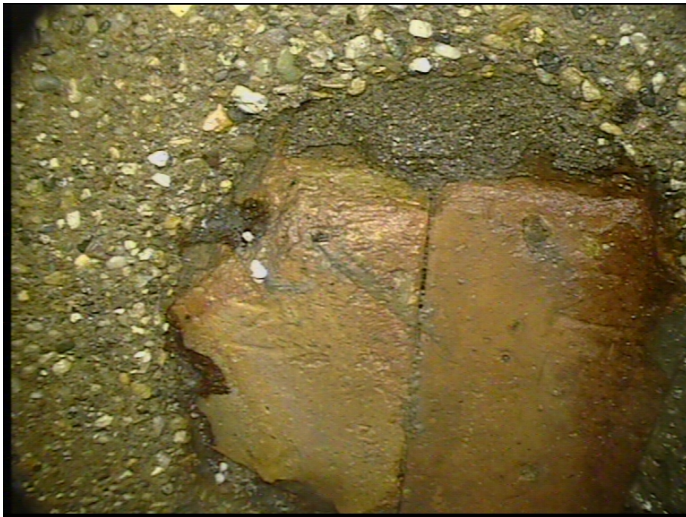
Code: **TFC**
Description: **Tap Factory Capped**

Distance (ft): **42.3**
Structural Grade: **0**
O&M Grade: **0**
Clock Start/From: **3**
Clock To:
1st Value: **4.000**
2nd Value:
Value Percent:
Continuous Index:
Within 8" of Joint: **NO**
Remarks:

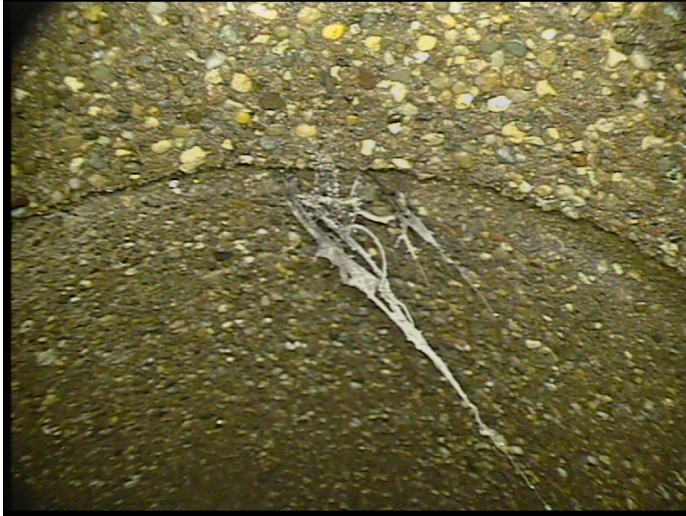
Code: **RFJ**
Description: **Roots Fine Joint**

Distance (ft): **98.7**
Structural Grade: **0**
O&M Grade: **1**
Clock Start/From: **1**
Clock To:
1st Value:
2nd Value:
Value Percent:
Continuous Index:
Within 8" of Joint: **YES**
Remarks:

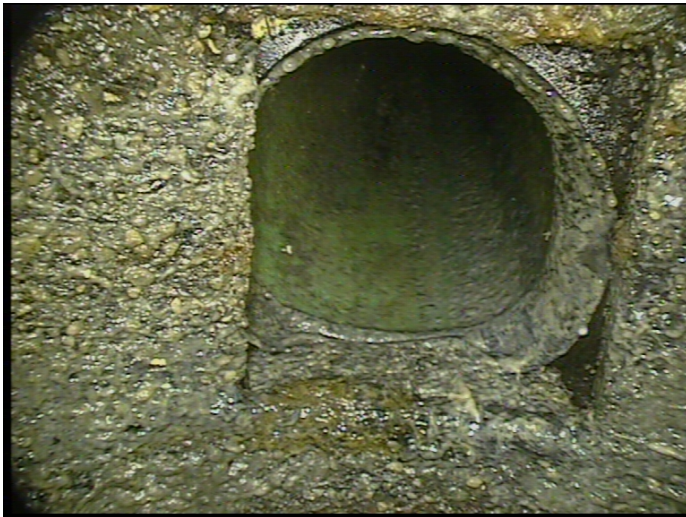
Code: **TBA**
Description: **Tap Break-in Active**

Distance (ft): **134.4**
Structural Grade: **0**
O&M Grade: **0**
Clock Start/From: **12**
Clock To:
1st Value: **4.000**
2nd Value:
Value Percent:
Continuous Index:
Within 8" of Joint: **NO**
Remarks:

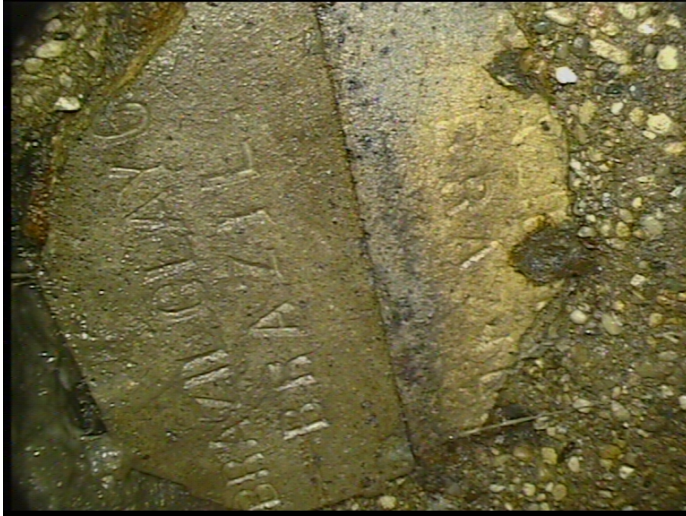
Code:	TFC
Description:	Tap Factory Capped
Distance (ft):	167.9
Structural Grade:	0
O&M Grade:	0
Clock Start/From:	9
Clock To:	
1st Value:	4.000
2nd Value:	
Value Percent:	
Continuous Index:	
Within 8" of Joint:	NO
Remarks:

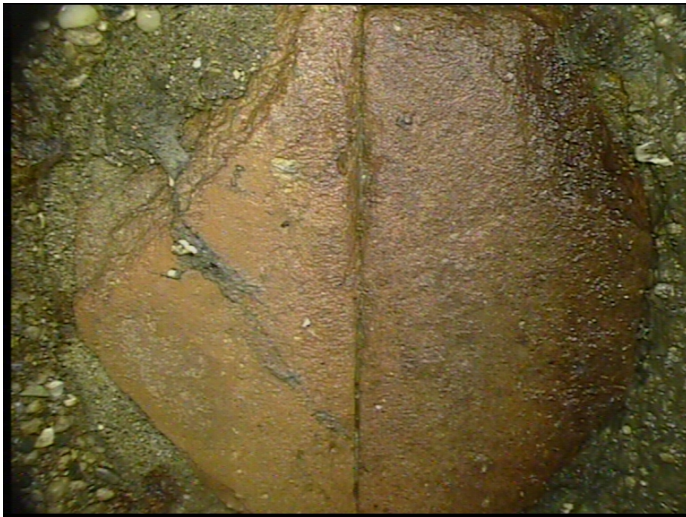
Code:	TFC
Description:	Tap Factory Capped
Distance (ft):	170.4
Structural Grade:	0
O&M Grade:	0
Clock Start/From:	3
Clock To:	
1st Value:	4.000
2nd Value:	
Value Percent:	
Continuous Index:	
Within 8" of Joint:	NO
Remarks:

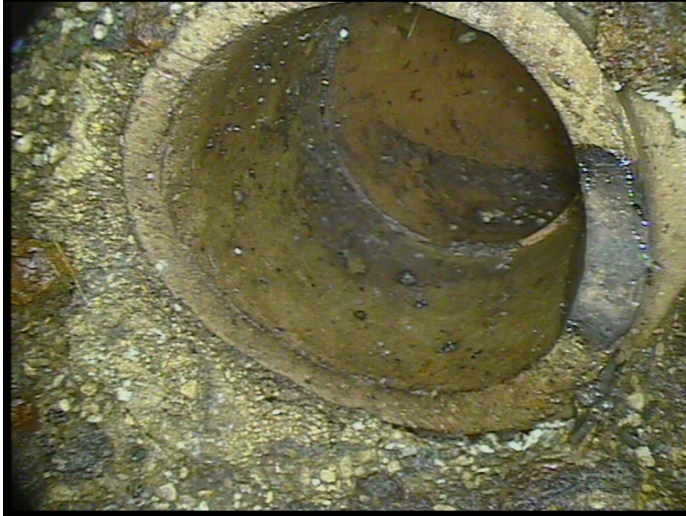
Code: **TBA**
Description: **Tap Break-in Active**

Distance (ft): **195.7**
Structural Grade: **0**
O&M Grade: **0**
Clock Start/From: **2**
Clock To:
1st Value: **4.000**
2nd Value:
Value Percent:
Continuous Index:
Within 8" of Joint: **NO**
Remarks:

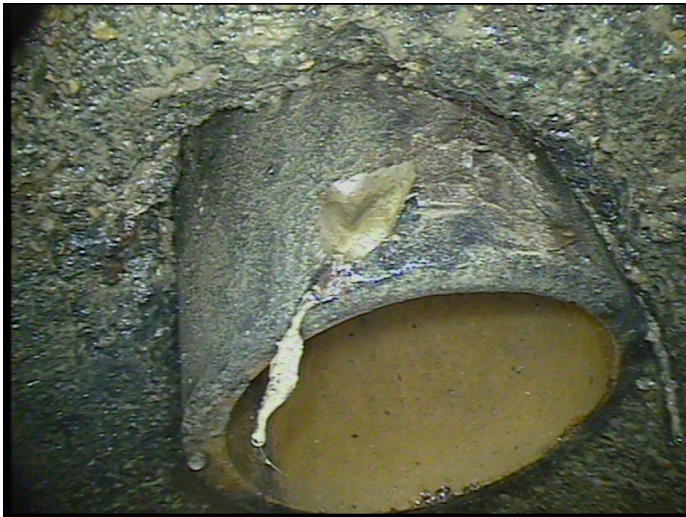
Code: **TBI**
Description: **Tap Break-in Intruding**

Distance (ft): **220.8**
Structural Grade: **0**
O&M Grade: **2**
Clock Start/From: **11**
Clock To:
1st Value: **4.000**
2nd Value: **2.000**
Value Percent:
Continuous Index:
Within 8" of Joint: **NO**
Remarks:

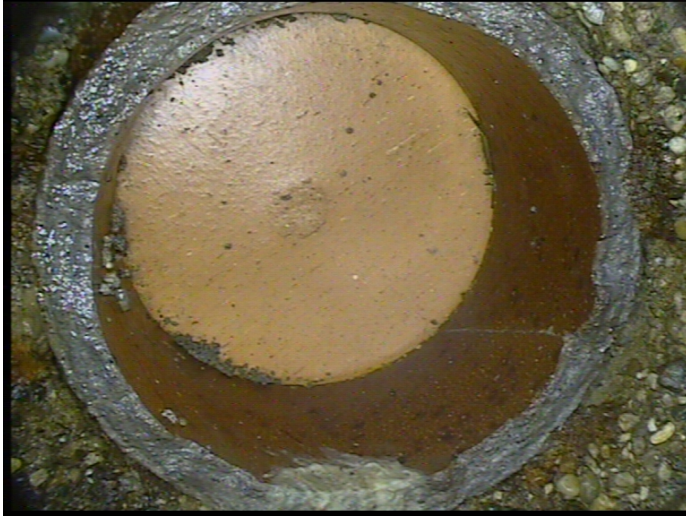
Code: **TBC**
Description: **Tap Break-in Capped**

Distance (ft): **234.3**
Structural Grade: **0**
O&M Grade: **2**
Clock Start/From: **9**
Clock To:
1st Value: **4.000**
2nd Value:
Value Percent:
Continuous Index:
Within 8" of Joint: **NO**
Remarks:

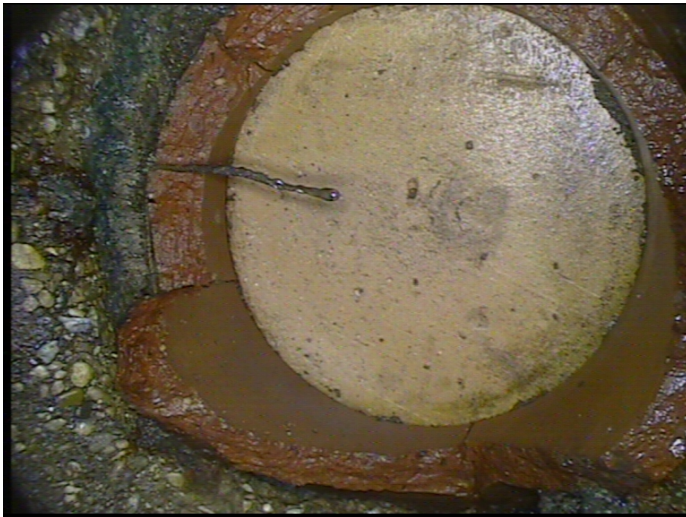
Code: **TBC**
Description: **Tap Break-in Capped**

Distance (ft): **268.5**
Structural Grade: **0**
O&M Grade: **2**
Clock Start/From: **3**
Clock To:
1st Value: **4.000**
2nd Value:
Value Percent:
Continuous Index:
Within 8" of Joint: **NO**
Remarks:

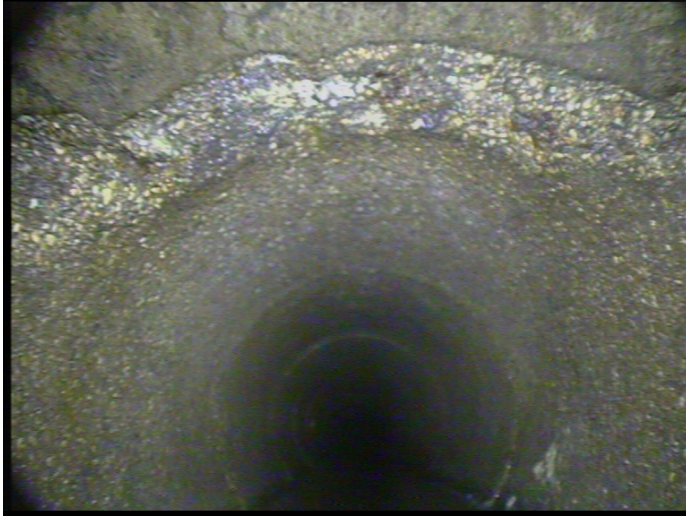
Code:	SAV
Description:	Surface Aggregate Visible
Distance (ft):	305.2
Structural Grade:	3
O&M Grade:	0
Clock Start/From:	8
Clock To:	4
1st Value:	
2nd Value:	
Value Percent:	
Continuous Index:	F01
Within 8" of Joint:	NO
Remarks:

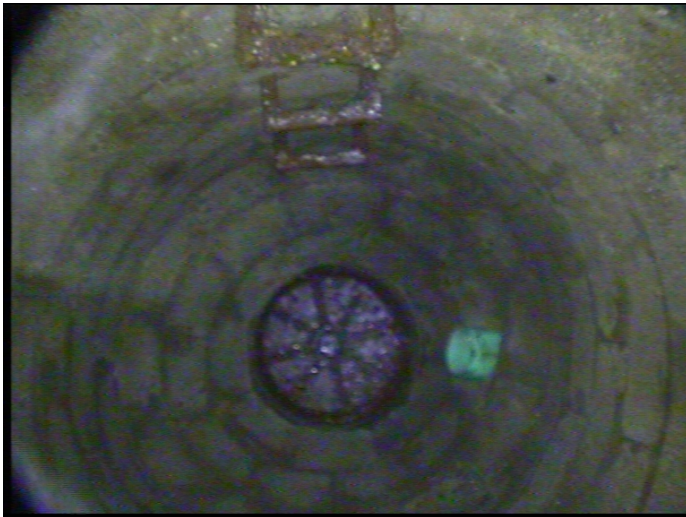
Code:	AMH
Description:	Manhole
Distance (ft):	305.2
Structural Grade:	0
O&M Grade:	0
Clock Start/From:	
Clock To:	
1st Value:	
2nd Value:	
Value Percent:	
Continuous Index:	
Within 8" of Joint:	NO
Remarks:	M-505-95
