## Profile/Photo Observation Report

Street:	<b>FOXCROFT STREET</b>	Flow Control:	<b>Not Controlled</b>
City:	<b>Hobart, IN</b>	Year Renewed:	
Location:	<b>Yard</b>	Tape/Media #:	
Purpose:	<b>Routine Assessment</b>	Dia/Height:	<b>10"</b>
Use:	<b>Sanitary</b>	Material:	<b>VCP</b>
Drain Area:	<b>NA</b>	Lining:	
Category:	<b>NA</b>		
Comment:

Location Details:		Direction of Survey:	<b>Downstream</b>
US MH:	<b>M-505-097</b>	DS MH:	<b>M-505-079</b>
		Total Length Surveyed (ft):	<b>141.7</b>

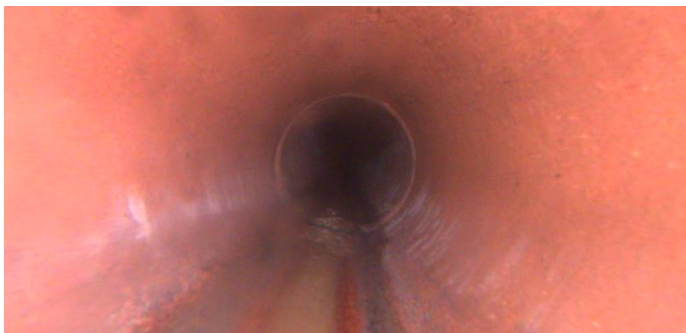
Code: **AMH**  
Description: **Manhole**

Distance (ft): **.0**  
Structural Grade: **0**  
O&M Grade: **0**  
Clock Start/From:  
Clock To:  
1st Value:  
2nd Value:  
Value Percent:  
Continuous Index:  
Within 8" of Joint: **NO**  
Remarks: **M-505-097**

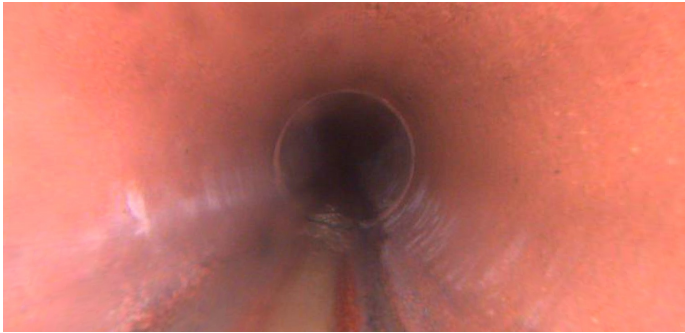
Code:	<b>MWL</b>
Description:	<b>Water Level</b>

Distance (ft):	<b>.0</b>
Structural Grade:	<b>0</b>
O&M Grade:	<b>0</b>
Clock Start/From:	
Clock To:	
1st Value:	
2nd Value:	
Value Percent:	<b>5.000</b>
Continuous Index:	
Within 8" of Joint:	<b>NO</b>
Remarks:

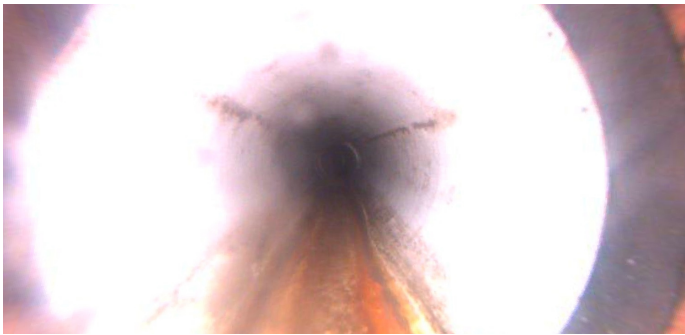
Code:	<b>MMC</b>
Description:	<b>Material Change</b>

Distance (ft):	<b>16.9</b>
Structural Grade:	<b>0</b>
O&M Grade:	<b>0</b>
Clock Start/From:	
Clock To:	
1st Value:	
2nd Value:	
Value Percent:	
Continuous Index:	
Within 8" of Joint:	<b>NO</b>
Remarks:	<b>pvc</b>

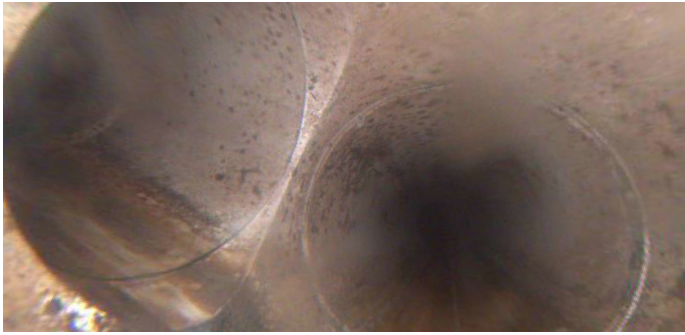
Code: **TFA**  
Description: **Tap Factory Active**

Distance (ft): **21.4**  
Structural Grade: **0**  
O&M Grade: **0**  
Clock Start/From: **3**  
Clock To:  
1st Value: **4.000**  
2nd Value:  
Value Percent:  
Continuous Index:  
Within 8" of Joint:  
Remarks:

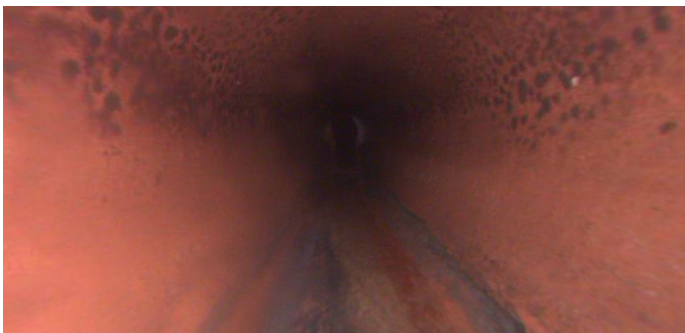
Code: **MMC**  
Description: **Material Change**

Distance (ft): **22.4**  
Structural Grade: **0**  
O&M Grade: **0**  
Clock Start/From:  
Clock To:  
1st Value:  
2nd Value:  
Value Percent:  
Continuous Index:  
Within 8" of Joint: **NO**  
Remarks: **VCP**

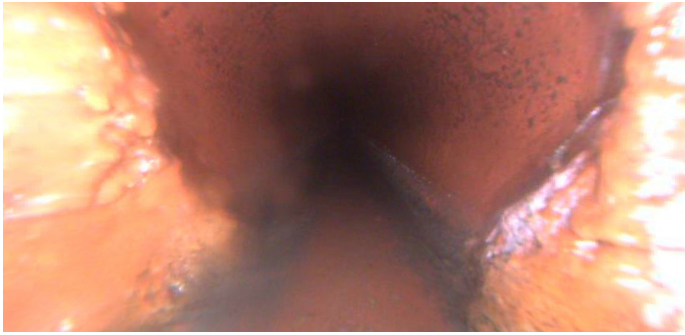
Code: **DAE**  
Description: **Deposits Attached Encrustation**

Distance (ft): **27.1**  
Structural Grade: **0**  
O&M Grade: **2**  
Clock Start/From: **8**  
Clock To: **4**  
1st Value:  
2nd Value:  
Value Percent: **10.000**  
Continuous Index:  
Within 8" of Joint: **YES**  
Remarks:

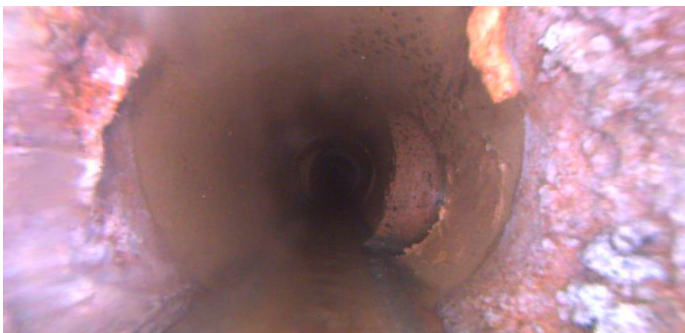
Code: **DAE**  
Description: **Deposits Attached Encrustation**

Distance (ft): **37.0**  
Structural Grade: **0**  
O&M Grade: **2**  
Clock Start/From: **8**  
Clock To: **4**  
1st Value:  
2nd Value:  
Value Percent: **10.000**  
Continuous Index:  
Within 8" of Joint: **YES**  
Remarks:

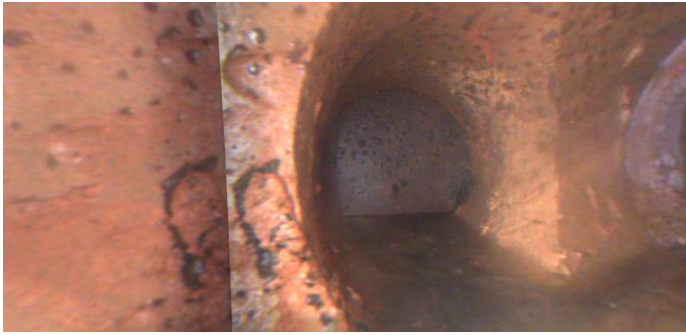
Code: **TFA**  
Description: **Tap Factory Active**

Distance (ft): **38.2**  
Structural Grade: **0**  
O&M Grade: **0**  
Clock Start/From: **3**  
Clock To:  
1st Value: **4.000**  
2nd Value:  
Value Percent:  
Continuous Index:  
Within 8" of Joint:  
Remarks:

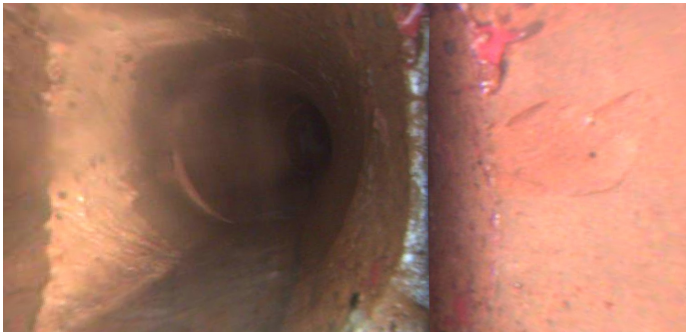
Code: **TFA**  
Description: **Tap Factory Active**

Distance (ft): **40.2**  
Structural Grade: **0**  
O&M Grade: **0**  
Clock Start/From: **9**  
Clock To:  
1st Value: **4.000**  
2nd Value:  
Value Percent:  
Continuous Index:  
Within 8" of Joint:  
Remarks:

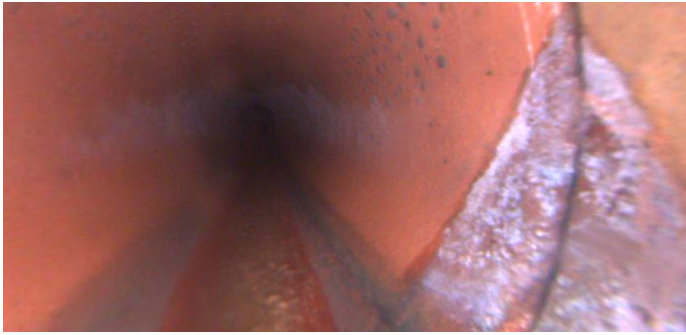
Code: **IS**  
Description: **Infil Stain**

Distance (ft): **40.9**  
Structural Grade: **0**  
O&M Grade: **0**  
Clock Start/From: **3**  
Clock To: **5**  
1st Value:  
2nd Value:  
Value Percent:  
Continuous Index:  
Within 8" of Joint: **YES**  
Remarks:

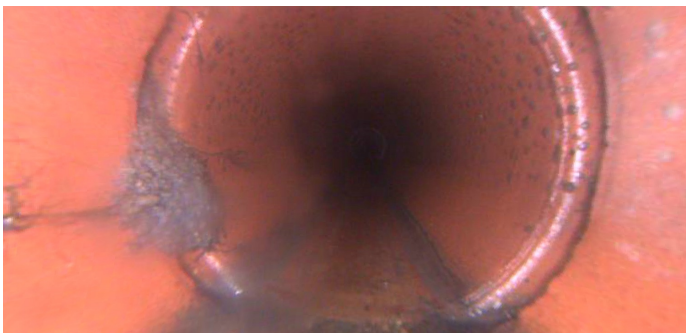
Code: **RMJ**  
Description: **Roots Medium Joint**

Distance (ft): **45.8**  
Structural Grade: **0**  
O&M Grade: **3**  
Clock Start/From: **8**  
Clock To: **9**  
1st Value:  
2nd Value:  
Value Percent: **5.000**  
Continuous Index:  
Within 8" of Joint: **YES**  
Remarks:

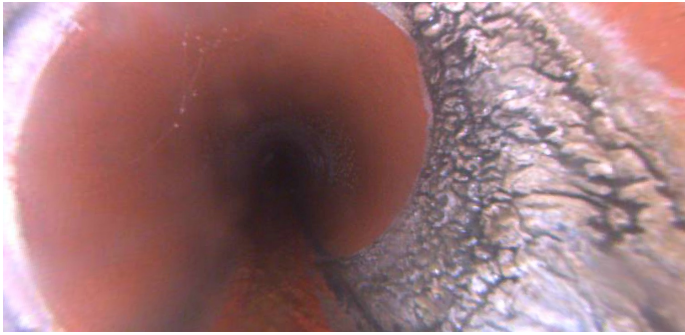
Code: **DAE**  
Description: **Deposits Attached Encrustation**

Distance (ft): **50.8**  
Structural Grade: **0**  
O&M Grade: **2**  
Clock Start/From: **8**  
Clock To: **4**  
1st Value:  
2nd Value:  
Value Percent: **5.000**  
Continuous Index:  
Within 8" of Joint: **YES**  
Remarks:

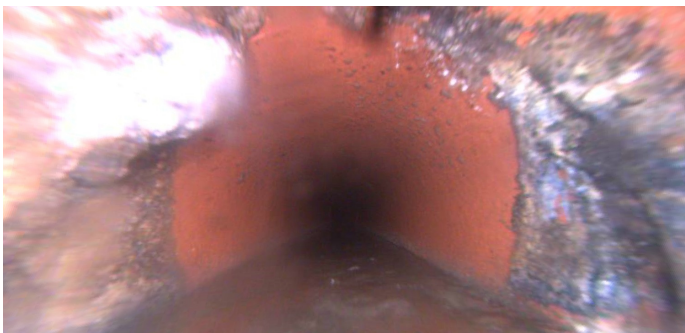
Code: **DAE**  
Description: **Deposits Attached Encrustation**

Distance (ft): **55.8**  
Structural Grade: **0**  
O&M Grade: **2**  
Clock Start/From: **8**  
Clock To: **4**  
1st Value:  
2nd Value:  
Value Percent: **10.000**  
Continuous Index:  
Within 8" of Joint: **YES**  
Remarks:

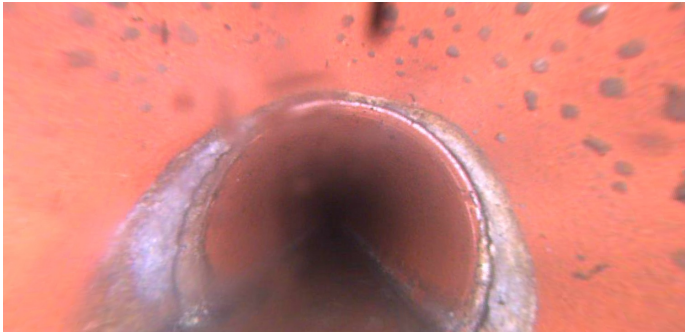
Code: **DAE**  
Description: **Deposits Attached Encrustation**

Distance (ft): **70.5**  
Structural Grade: **0**  
O&M Grade: **2**  
Clock Start/From: **8**  
Clock To: **4**  
1st Value:  
2nd Value:  
Value Percent: **5.000**  
Continuous Index:  
Within 8" of Joint: **YES**  
Remarks:

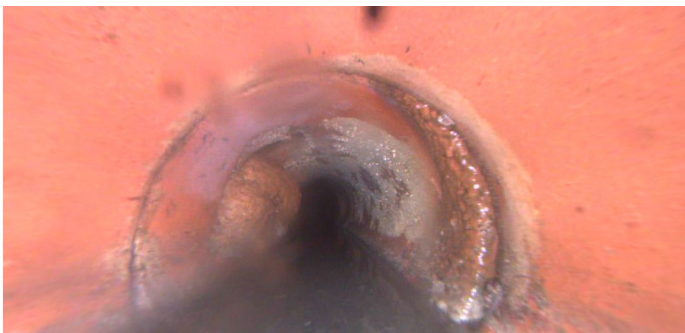
Code: **IW**  
Description: **Infil Weeper**

Distance (ft): **140.2**  
Structural Grade: **0**  
O&M Grade: **2**  
Clock Start/From: **1**  
Clock To: **4**  
1st Value:  
2nd Value:  
Value Percent:  
Continuous Index:  
Within 8" of Joint: **YES**  
Remarks:

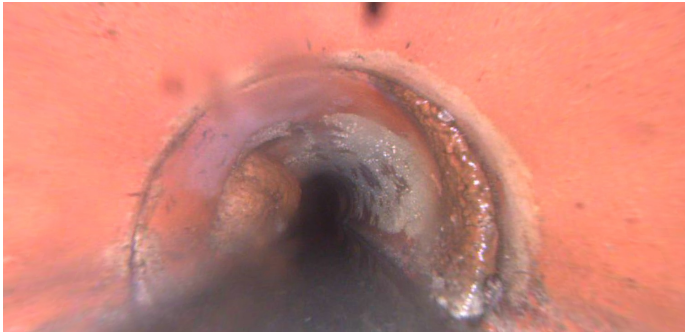
Code: **DAE**  
Description: **Deposits Attached Encrustation**

Distance (ft): **140.2**  
Structural Grade: **0**  
O&M Grade: **2**  
Clock Start/From: **1**  
Clock To: **4**  
1st Value:  
2nd Value:  
Value Percent: **5.000**  
Continuous Index:  
Within 8" of Joint: **YES**  
Remarks:

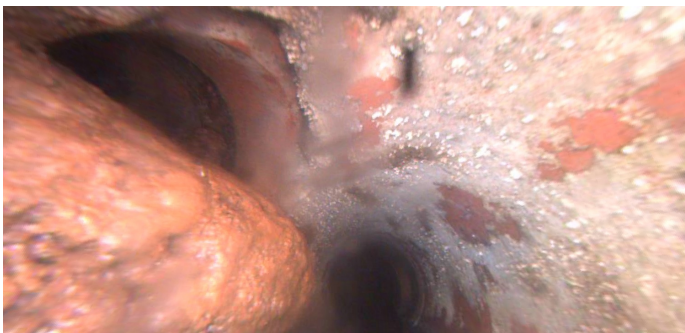
Code: **TBD**  
Description: **Tap Break-in Defective**

Distance (ft): **140.9**  
Structural Grade: **0**  
O&M Grade: **3**  
Clock Start/From: **10**  
Clock To:  
1st Value: **4.000**  
2nd Value:  
Value Percent:  
Continuous Index:  
Within 8" of Joint:  
Remarks: **DAE**

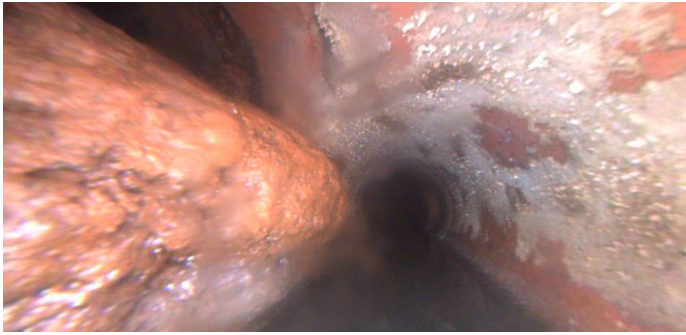
Code: **DAE**  
Description: **Deposits Attached Encrustation**

Distance (ft): **140.9**  
Structural Grade: **0**  
O&M Grade: **2**  
Clock Start/From: **8**  
Clock To: **9**  
1st Value:  
2nd Value:  
Value Percent: **10.000**  
Continuous Index:  
Within 8" of Joint: **NO**  
Remarks:

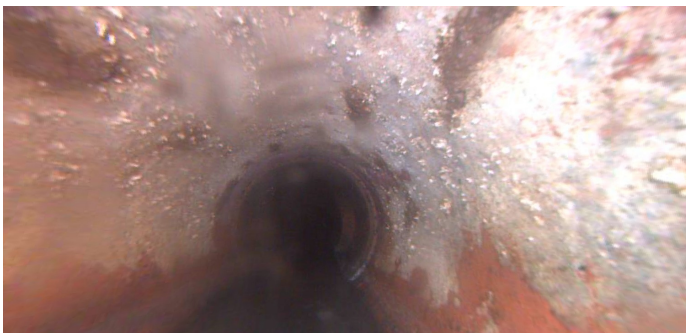
Code: **MSA**  
Description: **Abandoned Survey**

Distance (ft): **141.7**  
Structural Grade: **0**  
O&M Grade: **0**  
Clock Start/From:  
Clock To:  
1st Value:  
2nd Value:  
Value Percent:  
Continuous Index:  
Within 8" of Joint: **NO**  
Remarks: **DAE**
