Profile/Photo Observation Report

Street:	West 8th Street	Flow Control:	Not Controlled
City:	Hobart, IN	Year Renewed:	
Location:	Light Highway	Tape/Media #:	DEP 621
Purpose:	Routine Assessment	Dia/Height:	12"
Use:	Sanitary	Material:	VCP
Drain Area:		Lining:	
Category:	NA		
Comment:	5-21-2018

Location Details:		Direction of Survey:	Downstream
US MH:	M-506-002	DS MH:	M-506-001
		Total Length Surveyed (ft):	299.5

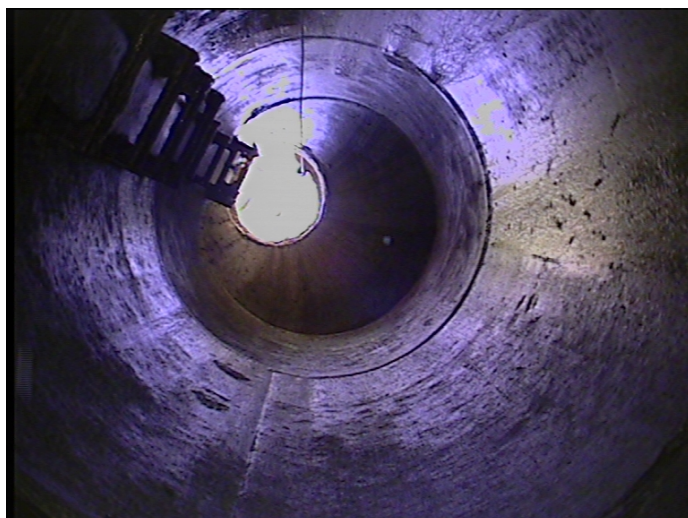
Code: **AMH**
Description: **Manhole**

Distance (ft): **.0**
Structural Grade: **0**
O&M Grade: **0**
Clock Start/From:
Clock To:
1st Value:
2nd Value:
Value Percent:
Continuous Index:
Within 8" of Joint: **NO**
Remarks: **M-506-002**

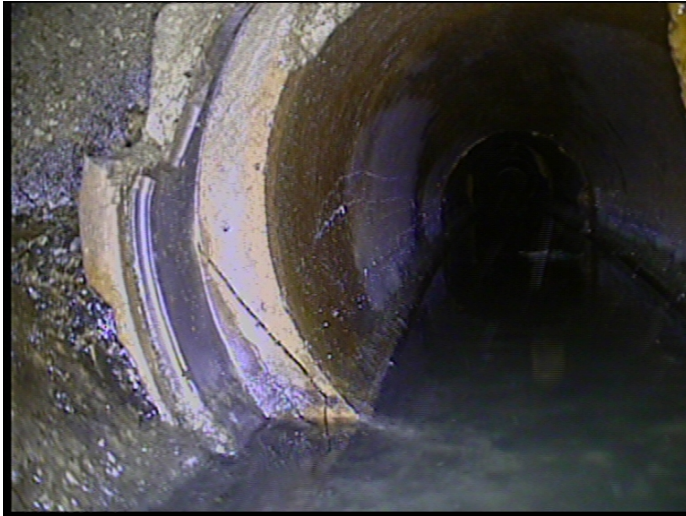
Code: **MWL**
Description: **Water Level**

Distance (ft): **.0**
Structural Grade: **0**
O&M Grade: **0**
Clock Start/From:
Clock To:
1st Value:
2nd Value:
Value Percent: **10.000**
Continuous Index:
Within 8" of Joint: **NO**
Remarks:

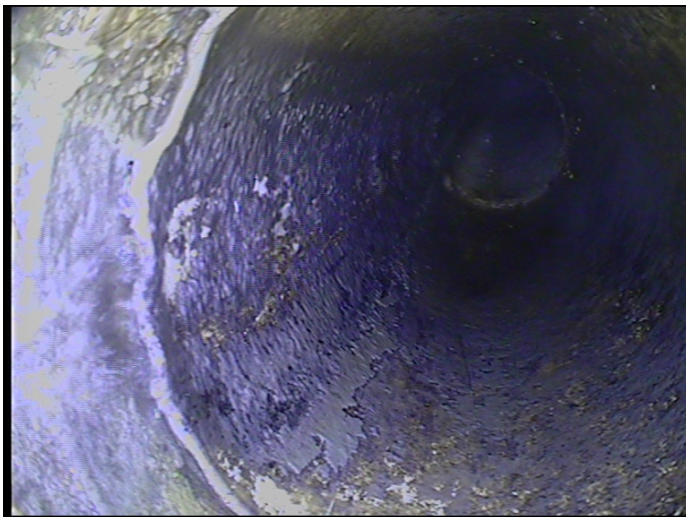
Code: **TFA**
Description: **Tap Factory Active**

Distance (ft): **25.5**
Structural Grade: **0**
O&M Grade: **0**
Clock Start/From: **10**
Clock To:
1st Value: **4.000**
2nd Value:
Value Percent:
Continuous Index:
Within 8" of Joint: **NO**
Remarks:

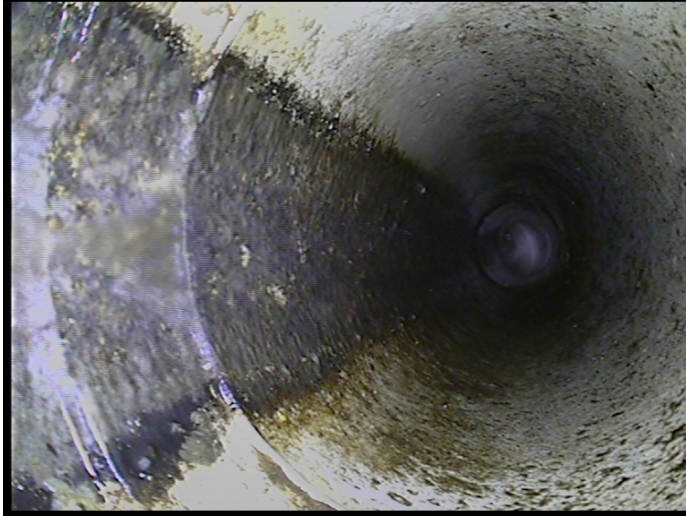
Code: **TFA**
Description: **Tap Factory Active**

Distance (ft): **40.4**
Structural Grade: **0**
O&M Grade: **0**
Clock Start/From: **10**
Clock To:
1st Value: **4.000**
2nd Value:
Value Percent:
Continuous Index:
Within 8" of Joint: **NO**
Remarks:

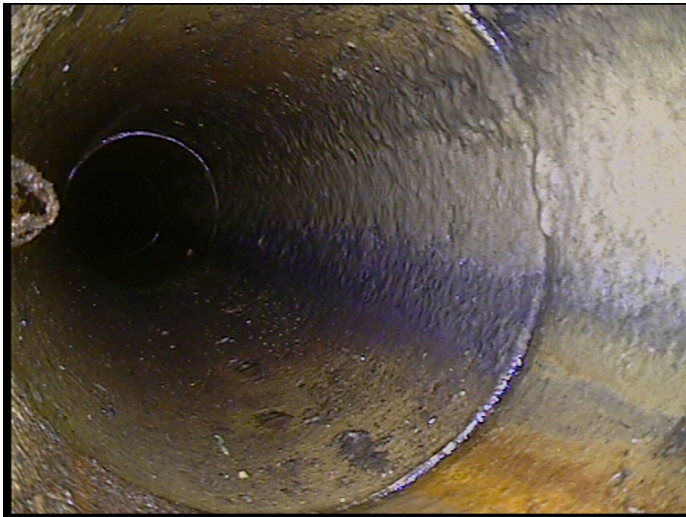
Code: **TF**
Description: **Tap Factory**

Distance (ft): **78.8**
Structural Grade: **0**
O&M Grade: **0**
Clock Start/From: **2**
Clock To:
1st Value: **4.000**
2nd Value:
Value Percent:
Continuous Index:
Within 8" of Joint: **NO**
Remarks:

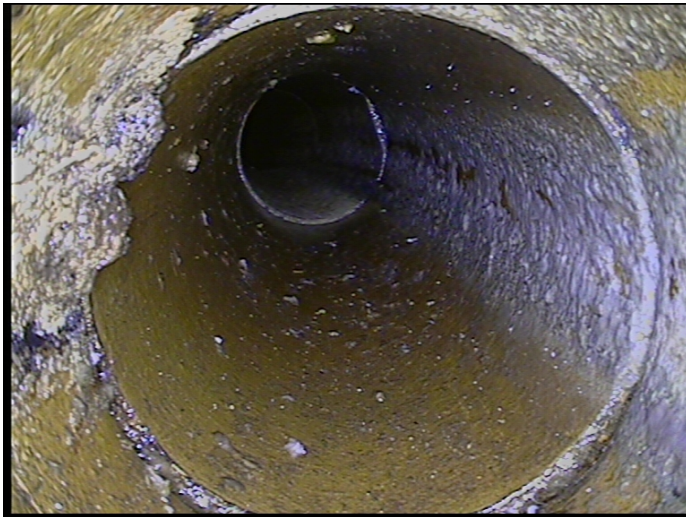
Code:	TF
Description:	Tap Factory
Distance (ft):	106.8
Structural Grade:	0
O&M Grade:	0
Clock Start/From:	2
Clock To:	
1st Value:	4.000
2nd Value:	
Value Percent:	
Continuous Index:	
Within 8" of Joint:	NO
Remarks:

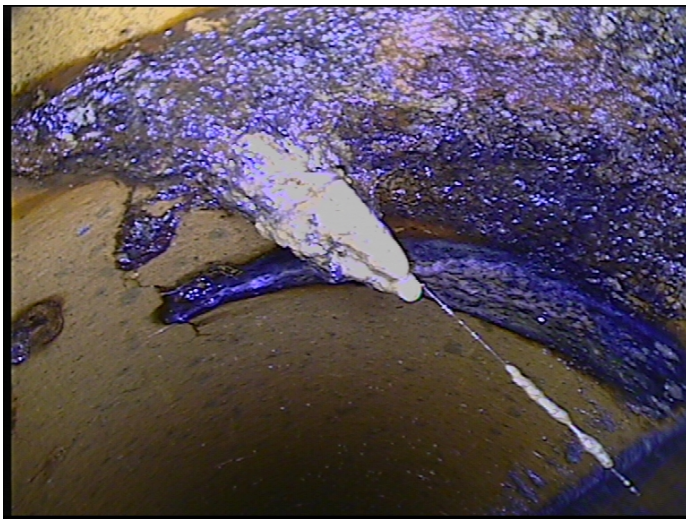
Code:	ID
Description:	Infil Dripper
Distance (ft):	116.5
Structural Grade:	0
O&M Grade:	3
Clock Start/From:	1
Clock To:	
1st Value:	
2nd Value:	
Value Percent:	
Continuous Index:	
Within 8" of Joint:	YES
Remarks:

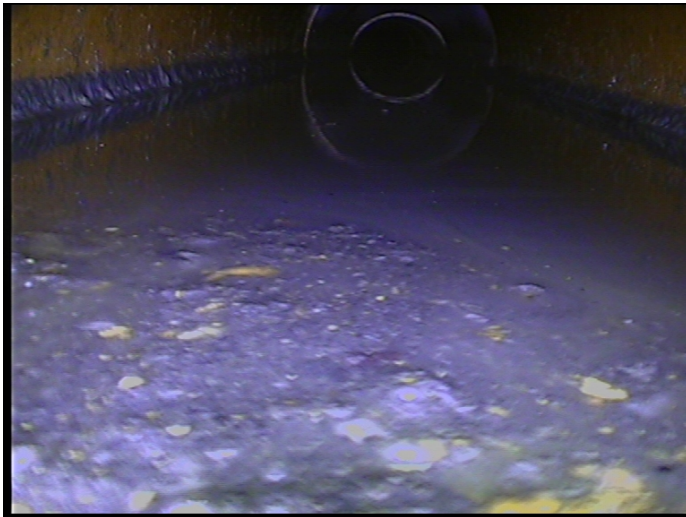
Code: **DSF**
Description: **Deposits Settled Fine**

Distance (ft): **116.5**
Structural Grade: **0**
O&M Grade: **3**
Clock Start/From: **4**
Clock To: **8**
1st Value:
2nd Value:
Value Percent: **20.000**
Continuous Index: **S01**
Within 8" of Joint: **YES**
Remarks:

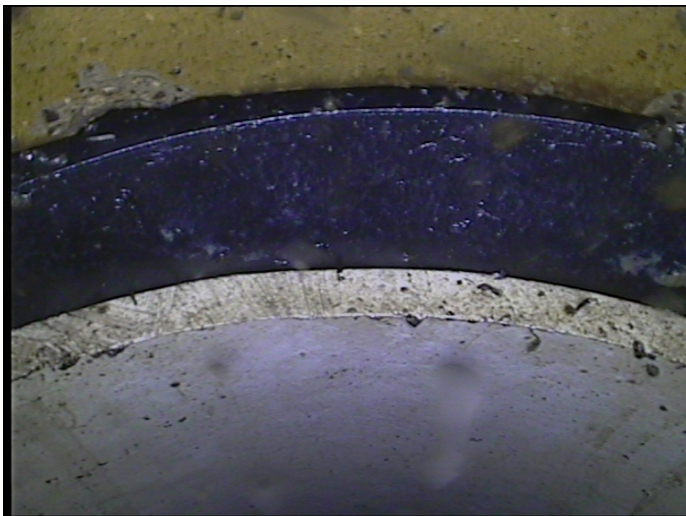
Code: **MMC**
Description: **Material Change**

Distance (ft): **127.0**
Structural Grade: **0**
O&M Grade: **0**
Clock Start/From:
Clock To:
1st Value:
2nd Value:
Value Percent:
Continuous Index:
Within 8" of Joint: **NO**
Remarks: **pvc**

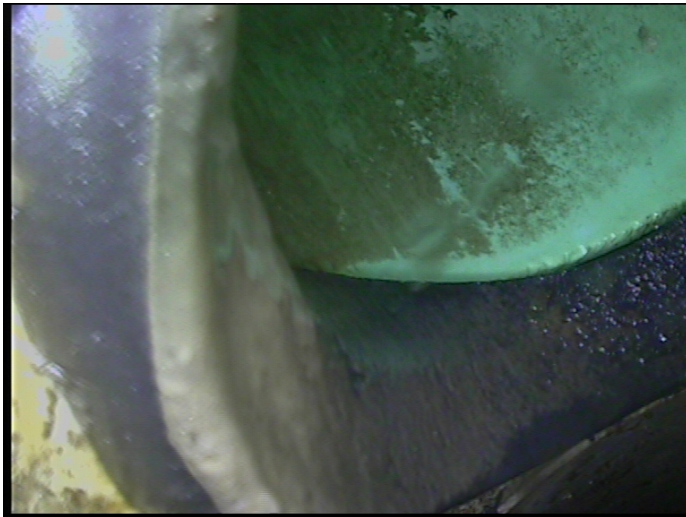
Code: **TBA**
Description: **Tap Break-in Active**

Distance (ft): **132.1**
Structural Grade: **0**
O&M Grade: **0**
Clock Start/From: **10**
Clock To:
1st Value: **4.000**
2nd Value:
Value Percent:
Continuous Index:
Within 8" of Joint: **NO**
Remarks:

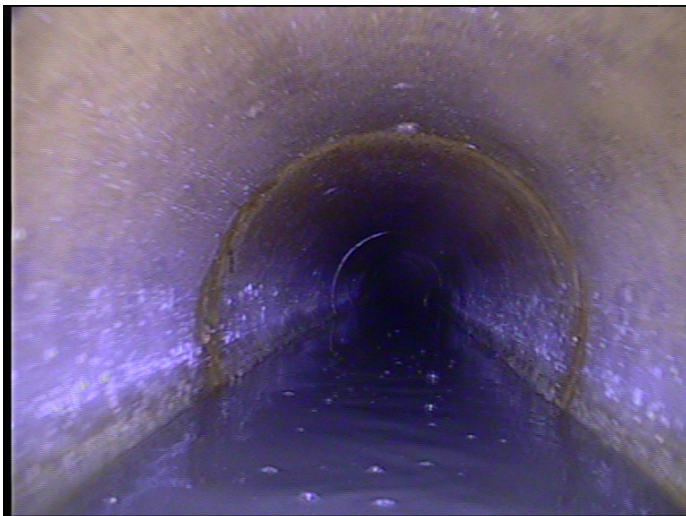
Code: **DSF**
Description: **Deposits Settled Fine**

Distance (ft): **168.3**
Structural Grade: **0**
O&M Grade: **3**
Clock Start/From: **4**
Clock To: **8**
1st Value:
2nd Value:
Value Percent: **20.000**
Continuous Index: **F01**
Within 8" of Joint: **NO**
Remarks:

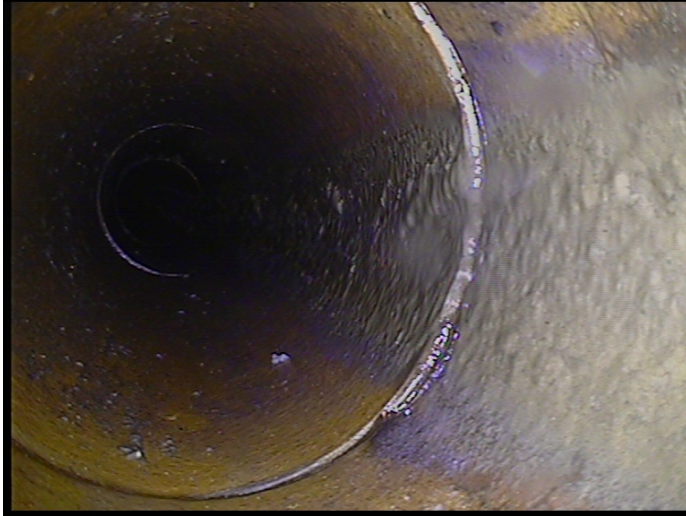
Code: **TFA**
Description: **Tap Factory Active**

Distance (ft): **179.0**
Structural Grade: **0**
O&M Grade: **0**
Clock Start/From: **2**
Clock To:
1st Value: **4.000**
2nd Value:
Value Percent:
Continuous Index:
Within 8" of Joint: **NO**
Remarks:

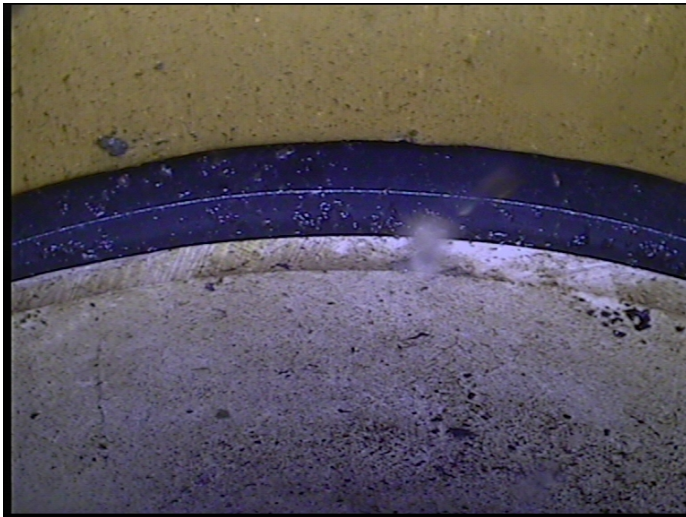
Code: **MMC**
Description: **Material Change**

Distance (ft): **208.1**
Structural Grade: **0**
O&M Grade: **0**
Clock Start/From:
Clock To:
1st Value:
2nd Value:
Value Percent:
Continuous Index:
Within 8" of Joint: **NO**
Remarks: **pvc**

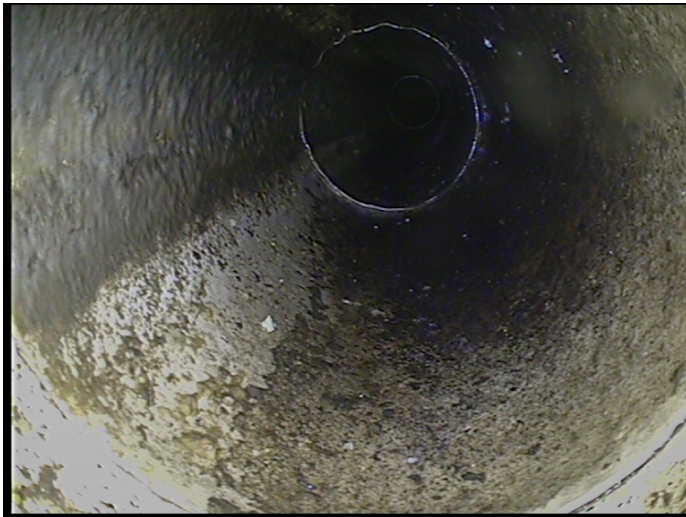
Code: **TF**
Description: **Tap Factory**

Distance (ft): **216.7**
Structural Grade: **0**
O&M Grade: **0**
Clock Start/From: **10**
Clock To:
1st Value: **4.000**
2nd Value:
Value Percent:
Continuous Index:
Within 8" of Joint: **NO**
Remarks:

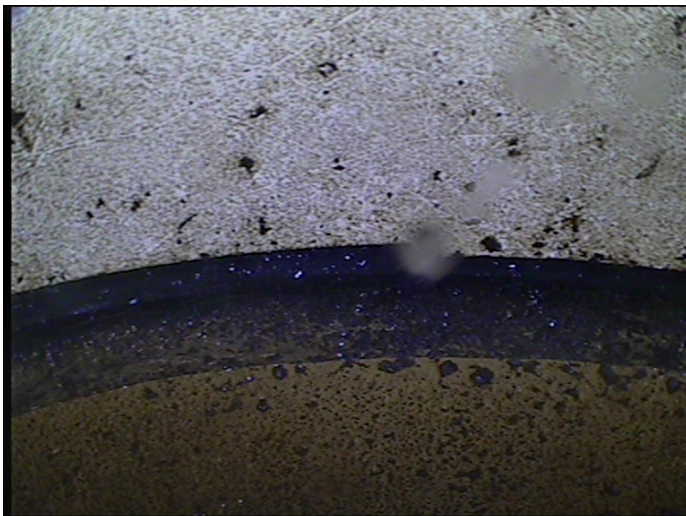
Code: **MMC**
Description: **Material Change**

Distance (ft): **222.3**
Structural Grade: **0**
O&M Grade: **0**
Clock Start/From:
Clock To:
1st Value:
2nd Value:
Value Percent:
Continuous Index:
Within 8" of Joint: **NO**
Remarks: **vcp**

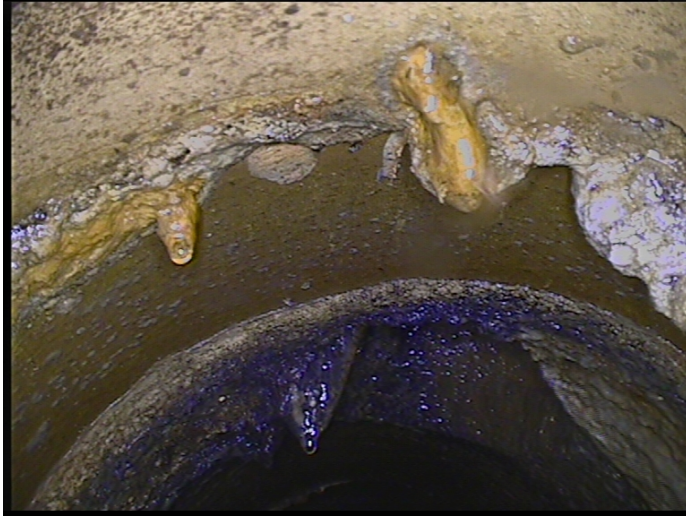
Code:	ID
Description:	Infil Dripper
Distance (ft):	233.7
Structural Grade:	0
O&M Grade:	3
Clock Start/From:	1
Clock To:	
1st Value:	
2nd Value:	
Value Percent:	
Continuous Index:	
Within 8" of Joint:	YES
Remarks:

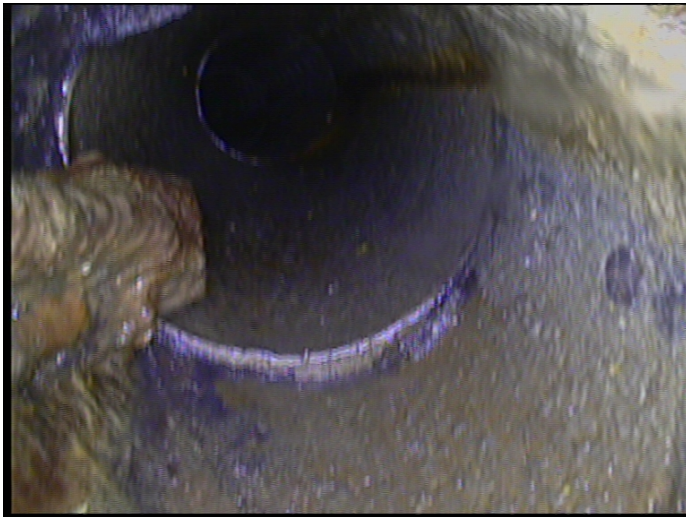
Code:	TFA
Description:	Tap Factory Active
Distance (ft):	235.0
Structural Grade:	0
O&M Grade:	0
Clock Start/From:	2
Clock To:	
1st Value:	4.000
2nd Value:	
Value Percent:	
Continuous Index:	
Within 8" of Joint:	NO
Remarks:

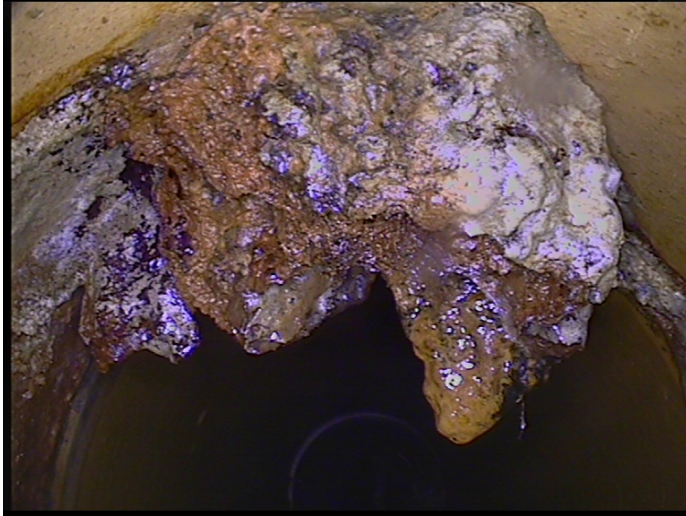
Code: **ID**
Description: **Infil Dripper**

Distance (ft): **258.9**
Structural Grade: **0**
O&M Grade: **3**
Clock Start/From: **12**
Clock To:
1st Value:
2nd Value:
Value Percent:
Continuous Index:
Within 8" of Joint: **YES**
Remarks:

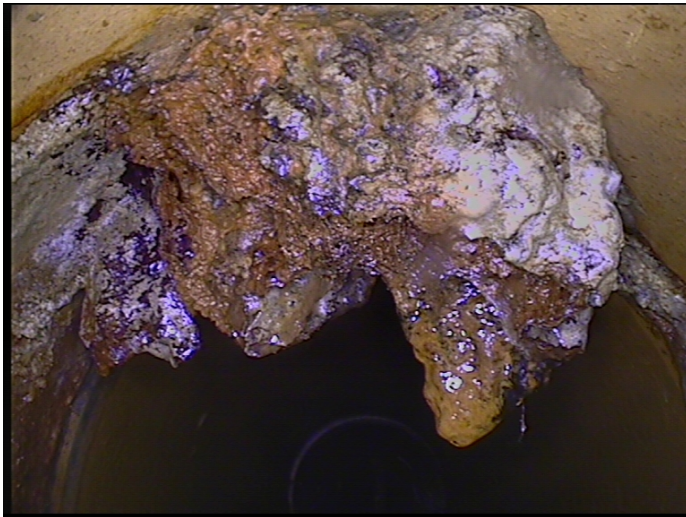
Code: **DAE**
Description: **Deposits Attached Encrustation**

Distance (ft): **258.9**
Structural Grade: **0**
O&M Grade: **3**
Clock Start/From: **10**
Clock To: **2**
1st Value:
2nd Value:
Value Percent: **15.000**
Continuous Index:
Within 8" of Joint: **NO**
Remarks:

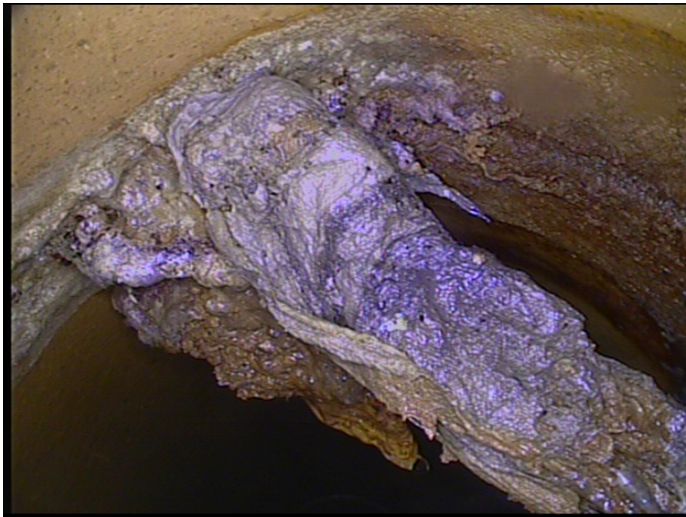
Code: **DAE**
Description: **Deposits Attached Encrustation**

Distance (ft): **271.2**
Structural Grade: **0**
O&M Grade: **3**
Clock Start/From: **11**
Clock To: **2**
1st Value:
2nd Value:
Value Percent: **15.000**
Continuous Index:
Within 8" of Joint: **YES**
Remarks:

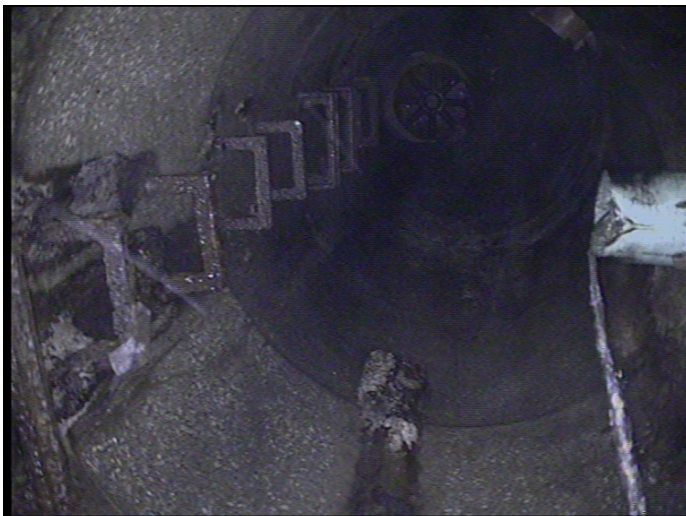
Code: **AMH**
Description: **Manhole**

Distance (ft): **299.5**
Structural Grade: **0**
O&M Grade: **0**
Clock Start/From:
Clock To:
1st Value:
2nd Value:
Value Percent:
Continuous Index:
Within 8" of Joint: **NO**
Remarks: **M-506-001**
