Profile/Photo Observation Report

Street:	FOXCROFT STREET	Flow Control:	Not Controlled
City:	Hobart, IN	Year Renewed:	
Location:	Yard	Tape/Media #:	
Purpose:	Routine Assessment	Dia/Height:	12"
Use:	Sanitary	Material:	VCP
Drain Area:	NA	Lining:	
Category:	NA		
Comment:

Location Details:		Direction of Survey:	Upstream
US MH:	M-506-003	DS MH:	M-506-002
		Total Length Surveyed (ft):	2.1

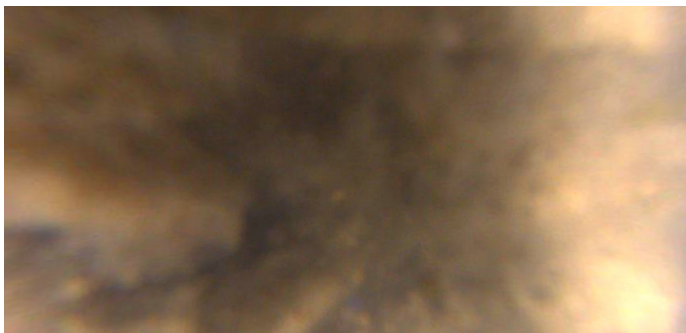
Code: **AMH**
Description: **Manhole**

Distance (ft): **.0**
Structural Grade: **0**
O&M Grade: **0**
Clock Start/From:
Clock To:
1st Value:
2nd Value:
Value Percent:
Continuous Index:
Within 8" of Joint: **NO**
Remarks: **M-506-002**

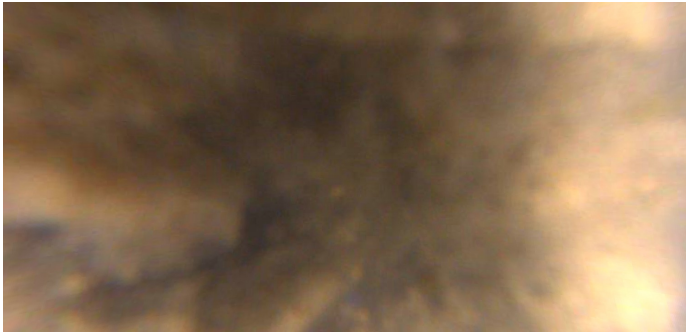
Code:	MWL
Description:	Water Level

Distance (ft):	.0
Structural Grade:	0
O&M Grade:	0
Clock Start/From:	
Clock To:	
1st Value:	
2nd Value:	
Value Percent:	100.000
Continuous Index:	
Within 8" of Joint:	NO
Remarks:
