Profile/Photo Observation Report

Street:	South 8th Street	Flow Control:	Not Controlled
City:	Hobart, IN	Year Renewed:	
Location:	Easement/Right of Way	Tape/Media #:	
Purpose:	Routine Assessment	Dia/Height:	12"
Use:	Sanitary Sewage Pipe	Material:	VCP
Drain Area:		Lining:	None
Category:	NA		
Comment:

Location Details:		Direction of Survey:	Downstream
US MH:	M-506-005	DS MH:	M-506-004
		Total Length Surveyed (ft):	209.3

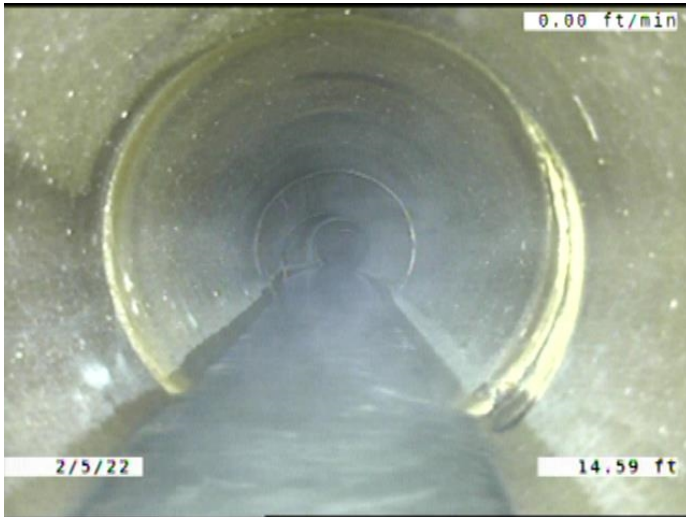
Code: **MWLS**
Description: **Miscellaneous Water Level Sag**

Distance (ft): **14.6**
Structural Grade: **2**
O&M Grade: **0**
Clock Start/From:
Clock To:
1st Value:
2nd Value:
Value Percent: **5.000**
Continuous Index: **S01**
Within 8" of Joint: **NO**
Remarks:

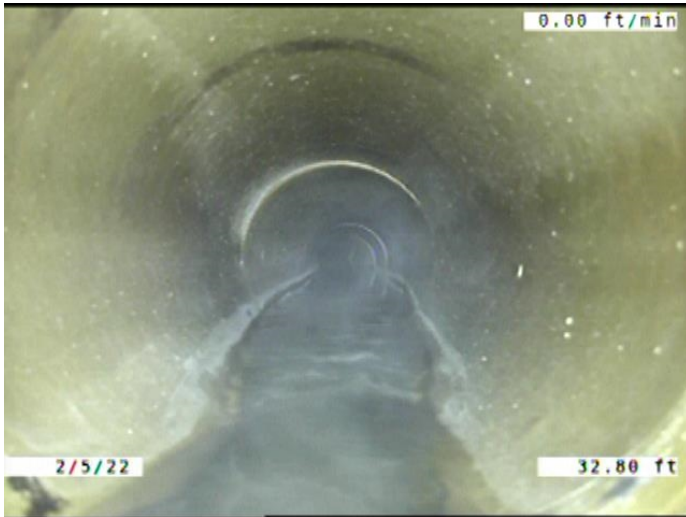
Code: **MWLS**
Description: **Miscellaneous Water Level Sag**

Distance (ft): **32.8**
Structural Grade: **2**
O&M Grade: **0**
Clock Start/From:
Clock To:
1st Value:
2nd Value:
Value Percent: **5.000**
Continuous Index: **F01**
Within 8" of Joint: **NO**
Remarks:

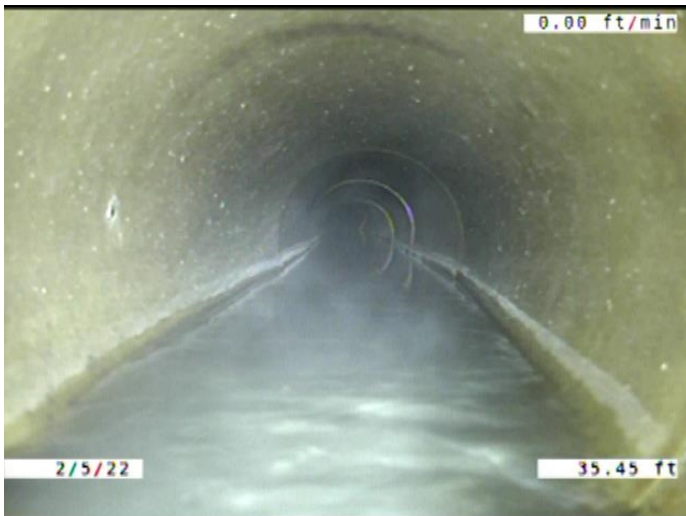
Code: **MWLS**
Description: **Miscellaneous Water Level Sag**

Distance (ft): **35.4**
Structural Grade: **2**
O&M Grade: **0**
Clock Start/From:
Clock To:
1st Value:
2nd Value:
Value Percent: **15.000**
Continuous Index: **S03**
Within 8" of Joint: **NO**
Remarks:

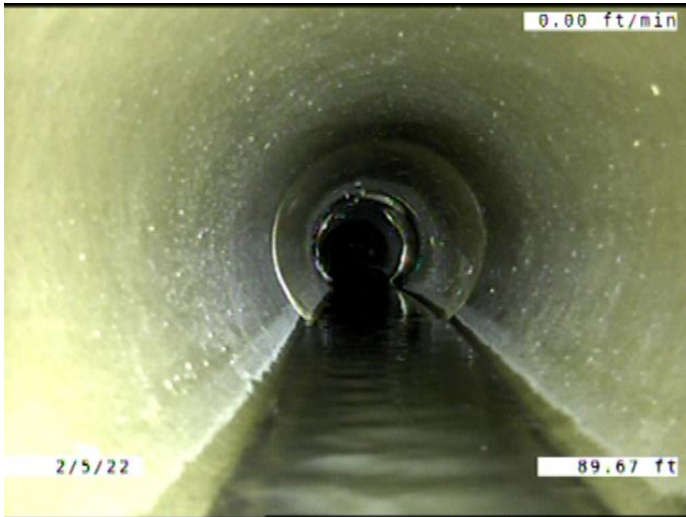
Code: **MWLS**
 Description: **Miscellaneous Water Level Sag**

Distance (ft): **89.7**
 Structural Grade: **2**
 O&M Grade: **0**
 Clock Start/From:
 Clock To:
 1st Value:
 2nd Value:
 Value Percent: **15.000**
 Continuous Index: **F03**
 Within 8" of Joint: **NO**
 Remarks:

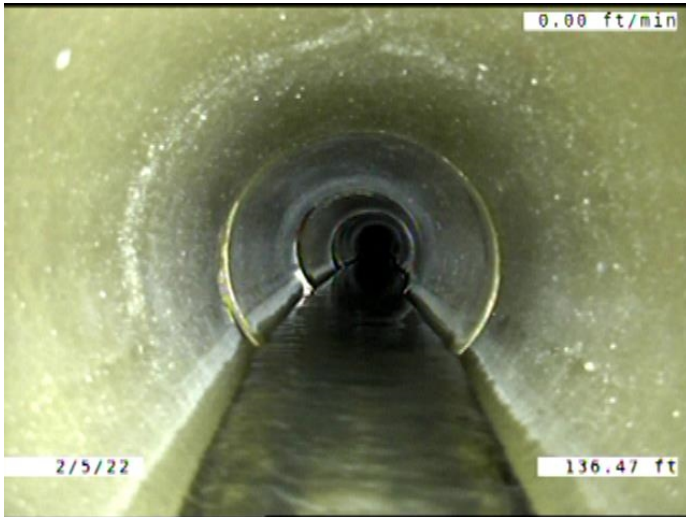
Code: **MWLS**
 Description: **Miscellaneous Water Level Sag**

Distance (ft): **136.5**
 Structural Grade: **2**
 O&M Grade: **0**
 Clock Start/From:
 Clock To:
 1st Value:
 2nd Value:
 Value Percent: **10.000**
 Continuous Index: **S04**
 Within 8" of Joint: **NO**
 Remarks:

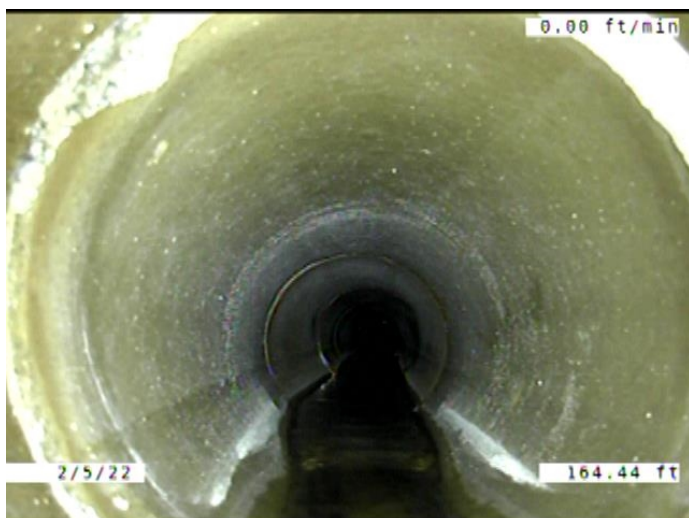
Code: **MWLS**
 Description: **Miscellaneous Water Level Sag**

Distance (ft): **164.4**
 Structural Grade: **2**
 O&M Grade: **0**
 Clock Start/From:
 Clock To:
 1st Value:
 2nd Value:
 Value Percent: **10.000**
 Continuous Index: **F04**
 Within 8" of Joint: **NO**
 Remarks:

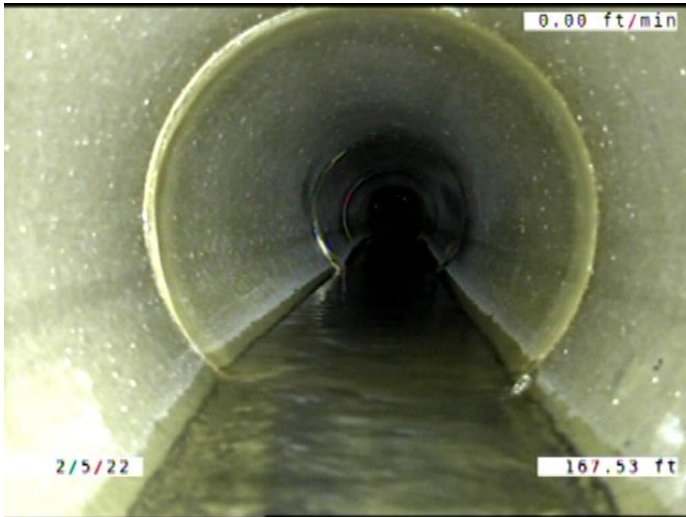
Code: **MWLS**
Description: **Miscellaneous Water Level Sag**

Distance (ft): **167.5**
Structural Grade: **2**
O&M Grade: **0**
Clock Start/From:
Clock To:
1st Value:
2nd Value:
Value Percent: **10.000**
Continuous Index: **S05**
Within 8" of Joint: **NO**
Remarks:

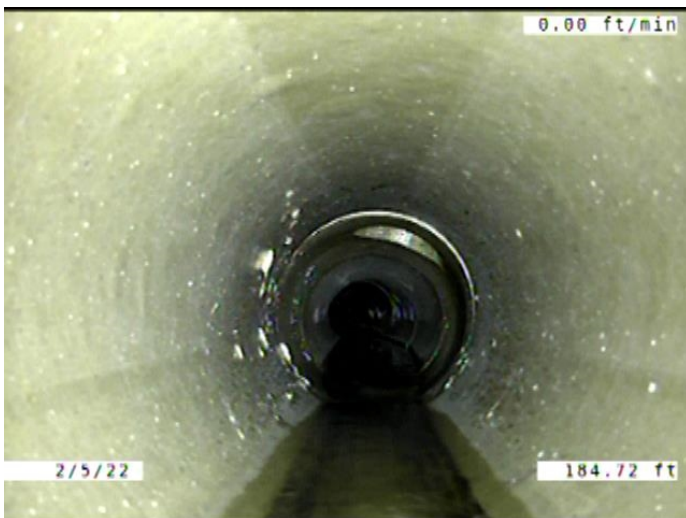
Code: **MWLS**
Description: **Miscellaneous Water Level Sag**

Distance (ft): **184.7**
Structural Grade: **2**
O&M Grade: **0**
Clock Start/From:
Clock To:
1st Value:
2nd Value:
Value Percent: **10.000**
Continuous Index: **F05**
Within 8" of Joint: **NO**
Remarks:

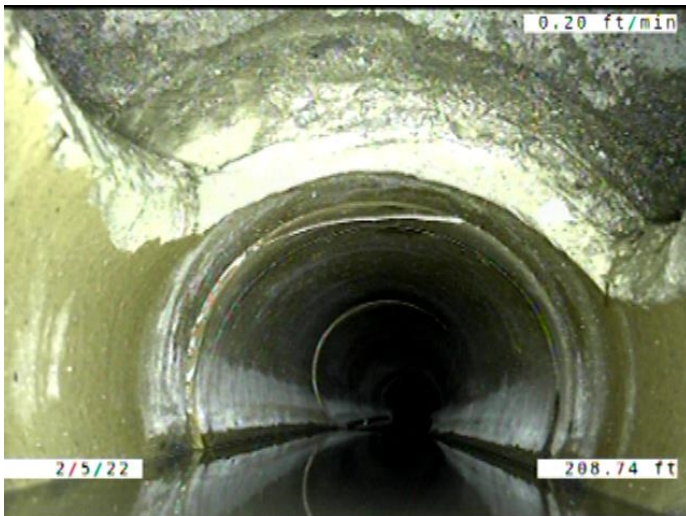
Code: **MWLS**
 Description: **Miscellaneous Water Level Sag**

Distance (ft): **208.7**
 Structural Grade: **2**
 O&M Grade: **0**
 Clock Start/From:
 Clock To:
 1st Value:
 2nd Value:
 Value Percent: **10.000**
 Continuous Index: **F06**
 Within 8" of Joint: **NO**
 Remarks:

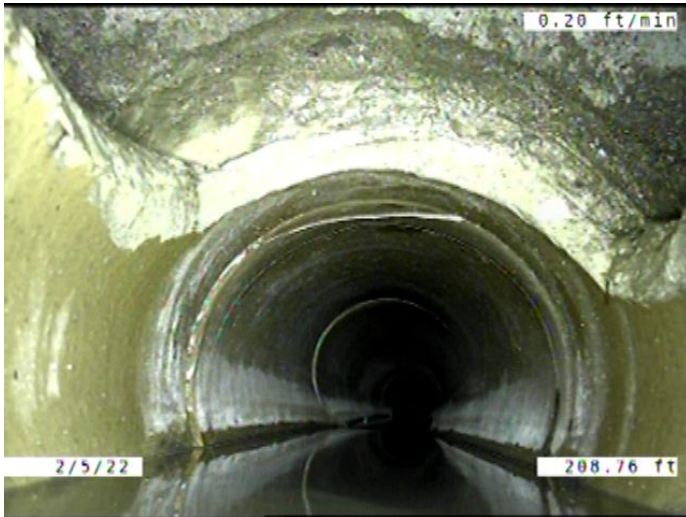
Code: **DAE**
 Description: **Deposits Attached Encrustation**

Distance (ft): **208.7**
 Structural Grade: **0**
 O&M Grade: **2**
 Clock Start/From: **8**
 Clock To: **4**
 1st Value:
 2nd Value:
 Value Percent: **5.000**
 Continuous Index: **F02**
 Within 8" of Joint: **YES**
 Remarks:
