Profile/Photo Observation Report

Date:	02/05/2022	Weather:		Coding:	PACP 7.0
Pipe Length (ft):	278.1	Owner:	City of Hobart	Pre Clean:	Heavy Cleaning
P.O.#:	YES502259	Surveyor:	S. Bucklin	PSR:	P-506-006-005
Customer:	City of Hobart	Clean Date:	02/02/2022	Shape:	C

Street:	South 8th Street	Flow Control:	Not Controlled
City:	Hobart, IN	Year Renewed:	
Location:	Easement/Right of Way	Tape/Media #:	
Purpose:	Routine Assessment	Dia/Height:	12"
Use:	Sanitary Sewage Pipe	Material:	VCP
Drain Area:		Lining:	None
Category:	NA

Comment:		Direction of Survey:	Upstream
Location Details:			
US MH:	M-506-006	DS MH:	M-506-005
		Total Length Surveyed (ft):	278.1

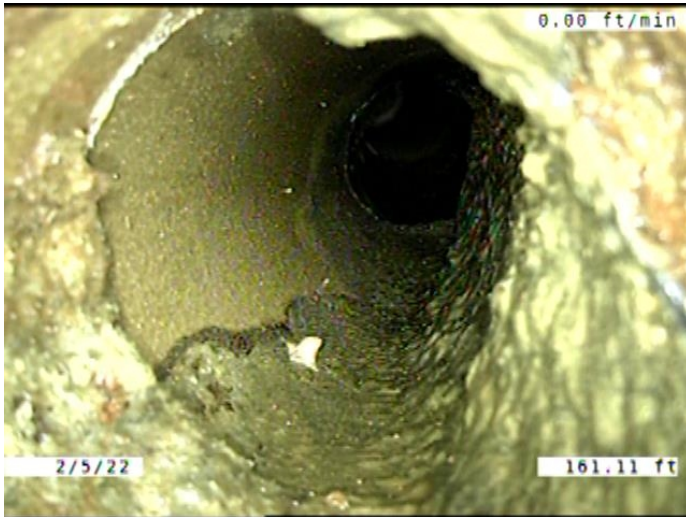
Code: **TF**
 Description: **Tap Factory**

Distance (ft): **161.1**
 Structural Grade: **0**
 O&M Grade: **0**
 Clock Start/From: **1**
 Clock To:
 1st Value: **6.000**
 2nd Value:
 Value Percent:
 Continuous Index:
 Within 8" of Joint: **YES**
 Remarks: **CONSTANTLY DRIPPING WATER.
 ENCRUSTATION COMING FROM THE**

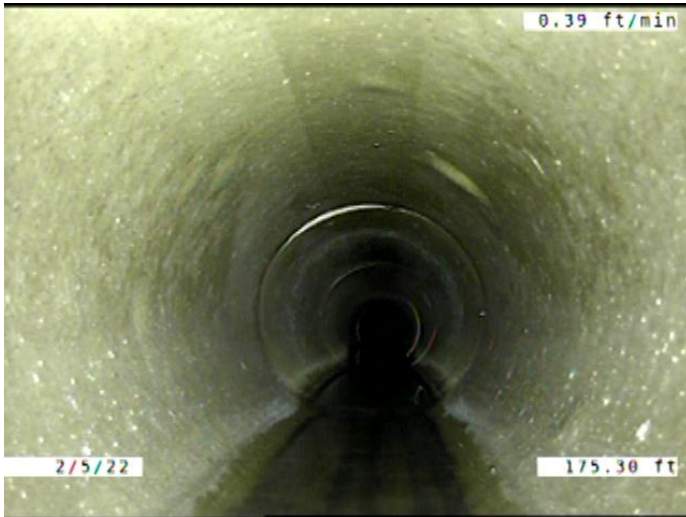
Code: **MWLS**
Description: **Miscellaneous Water Level Sag**

Distance (ft): **175.3**
Structural Grade: **2**
O&M Grade: **0**
Clock Start/From:
Clock To:
1st Value:
2nd Value:
Value Percent: **10.000**
Continuous Index: **F03**
Within 8" of Joint: **NO**
Remarks:

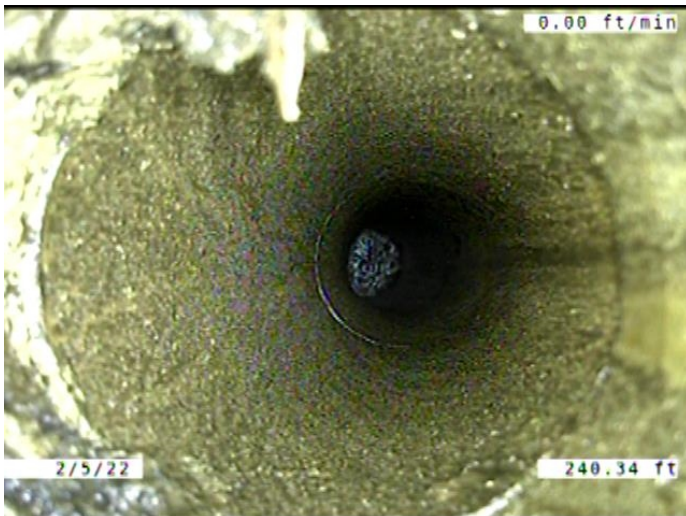
Code: **TF**
Description: **Tap Factory**

Distance (ft): **240.3**
Structural Grade: **0**
O&M Grade: **0**
Clock Start/From: **1**
Clock To:
1st Value: **6.000**
2nd Value:
Value Percent:
Continuous Index:
Within 8" of Joint: **YES**
Remarks: **ENCRUSTATION COMING FROM THE SERVICE TO MAIN CONNECTION.**

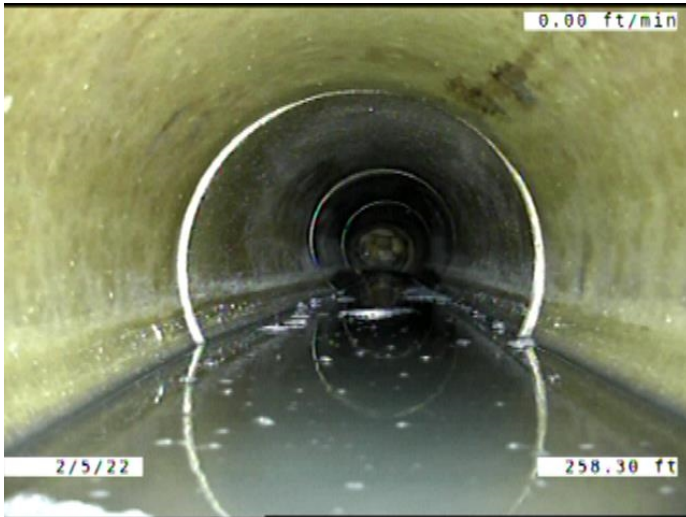
Code: **MWLS**
Description: **Miscellaneous Water Level Sag**

Distance (ft): **258.3**
Structural Grade: **2**
O&M Grade: **0**
Clock Start/From:
Clock To:
1st Value:
2nd Value:
Value Percent: **15.000**
Continuous Index: **S04**
Within 8" of Joint: **NO**
Remarks:
