Profile/Photo Observation Report

Date:	04/06/2018	Weather:		Coding:	PACP 6.0
Pipe Length (ft):	212.4	Owner:	NA	Pre Clean:	No Pre-Cleaning
P.O.#:		Surveyor:	Mark Ruby	PSR:	P-506-009-008
Customer:		Clean Date:	01/01/1900	Shape:	C

Street:	CARDINAL CT	Flow Control:	Not Controlled
City:	Hobart, IN	Year Renewed:	
Location:	Yard	Tape/Media #:	
Purpose:	Routine Assessment	Dia/Height:	10"
Use:	Sanitary	Material:	PVC
Drain Area:	NA	Lining:	
Category:	NA		
Comment:	Flow direction is marked wrong.		
Location Details:		Direction of Survey:	Downstream
US MH:	M-506-008	DS MH:	M-506-009
		Total Length Surveyed (ft):	101.6

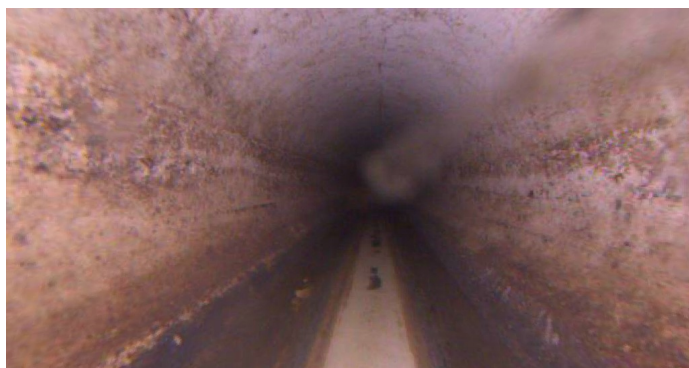
Code: **AMH**
 Description: **Manhole**

Distance (ft): **.0**
 Structural Grade: **0**
 O&M Grade: **0**
 Clock Start/From:
 Clock To:
 1st Value:
 2nd Value:
 Value Percent:
 Continuous Index:
 Within 8" of Joint: **NO**
 Remarks: **M-506-008**

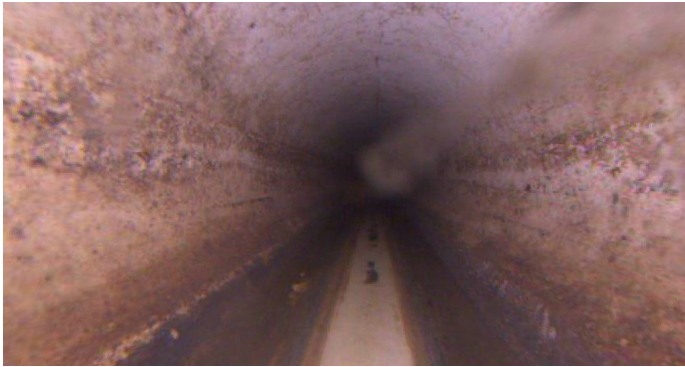
Code:	MWL
Description:	Water Level

Distance (ft):	.0
Structural Grade:	0
O&M Grade:	0
Clock Start/From:	
Clock To:	
1st Value:	
2nd Value:	
Value Percent:	10.000
Continuous Index:	
Within 8" of Joint:	NO
Remarks:

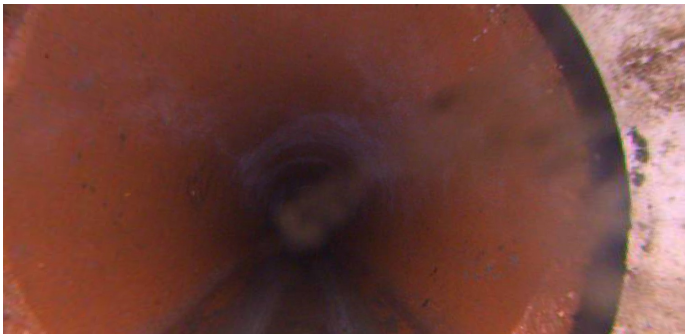
Code:	MMC
Description:	Material Change

Distance (ft):	8.1
Structural Grade:	0
O&M Grade:	0
Clock Start/From:	
Clock To:	
1st Value:	
2nd Value:	
Value Percent:	
Continuous Index:	
Within 8" of Joint:	NO
Remarks:	VCP

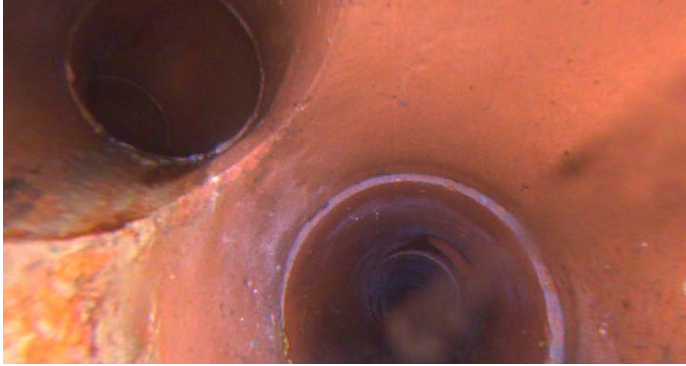
Code: **TF**
Description: **Tap Factory**

Distance (ft): **21.3**
Structural Grade: **0**
O&M Grade: **0**
Clock Start/From: **10**
Clock To:
1st Value: **4.000**
2nd Value:
Value Percent:
Continuous Index:
Within 8" of Joint:
Remarks:

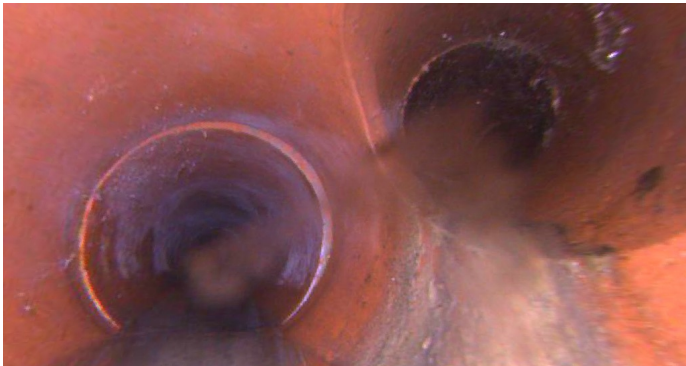
Code: **TF**
Description: **Tap Factory**

Distance (ft): **23.1**
Structural Grade: **0**
O&M Grade: **0**
Clock Start/From: **2**
Clock To:
1st Value: **4.000**
2nd Value:
Value Percent:
Continuous Index:
Within 8" of Joint:
Remarks:

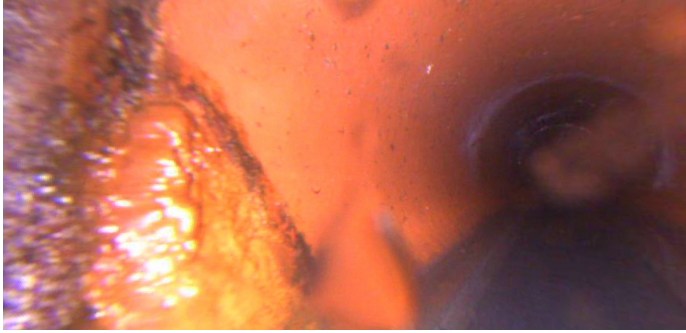
Code:	DAE
Description:	Deposits Attached Encrustation

Distance (ft):	56.6
Structural Grade:	0
O&M Grade:	2
Clock Start/From:	7
Clock To:	9
1st Value:	
2nd Value:	
Value Percent:	5.000
Continuous Index:	
Within 8" of Joint:	YES
Remarks:

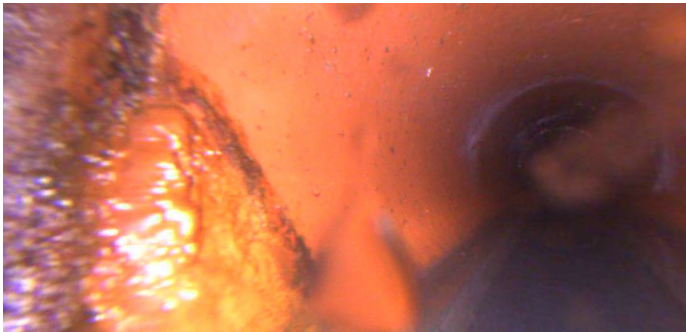
Code:	IW
Description:	Infil Weeper

Distance (ft):	56.6
Structural Grade:	0
O&M Grade:	2
Clock Start/From:	7
Clock To:	9
1st Value:	
2nd Value:	
Value Percent:	
Continuous Index:	
Within 8" of Joint:	YES
Remarks:

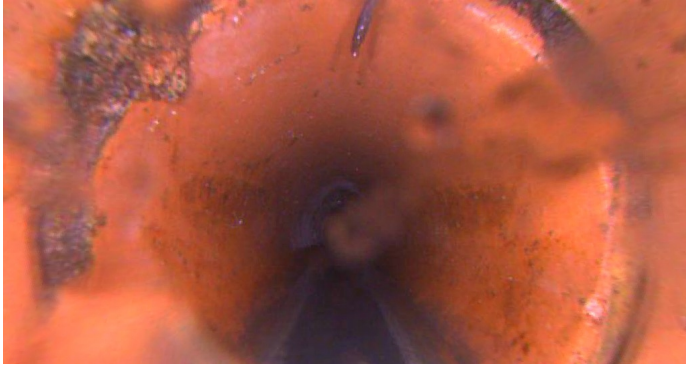
Code: **RFJ**
Description: **Roots Fine Joint**

Distance (ft): **60.3**
Structural Grade: **0**
O&M Grade: **1**
Clock Start/From: **8**
Clock To: **4**
1st Value:
2nd Value:
Value Percent:
Continuous Index:
Within 8" of Joint: **YES**
Remarks:

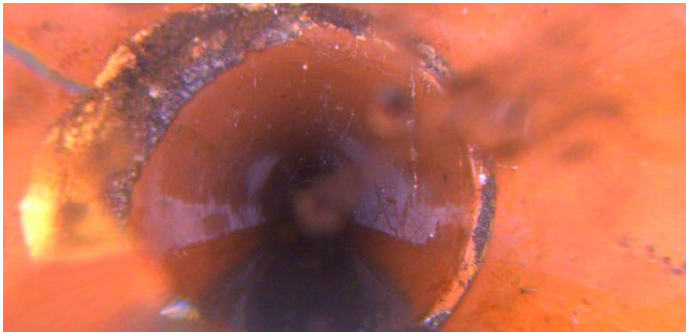
Code: **DAE**
Description: **Deposits Attached Encrustation**

Distance (ft): **64.2**
Structural Grade: **0**
O&M Grade: **2**
Clock Start/From: **8**
Clock To: **4**
1st Value:
2nd Value:
Value Percent: **5.000**
Continuous Index:
Within 8" of Joint: **YES**
Remarks:

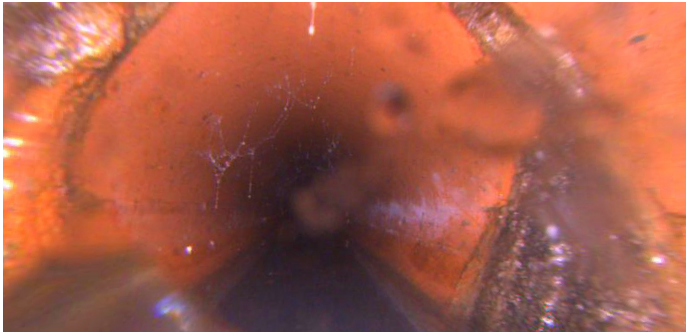
Code: **DAE**
Description: **Deposits Attached Encrustation**

Distance (ft): **68.4**
Structural Grade: **0**
O&M Grade: **2**
Clock Start/From: **8**
Clock To: **4**
1st Value:
2nd Value:
Value Percent: **5.000**
Continuous Index:
Within 8" of Joint: **YES**
Remarks:

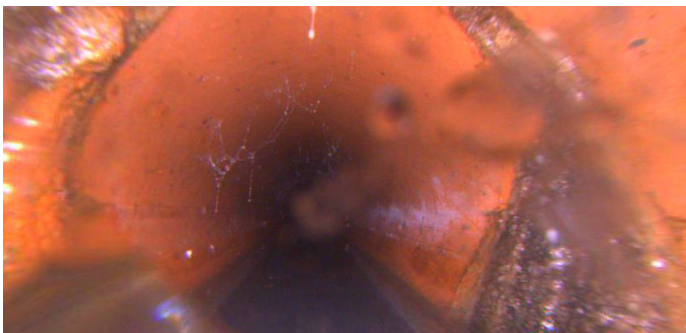
Code: **IW**
Description: **Infil Weeper**

Distance (ft): **68.4**
Structural Grade: **0**
O&M Grade: **2**
Clock Start/From: **8**
Clock To: **4**
1st Value:
2nd Value:
Value Percent:
Continuous Index:
Within 8" of Joint: **YES**
Remarks:

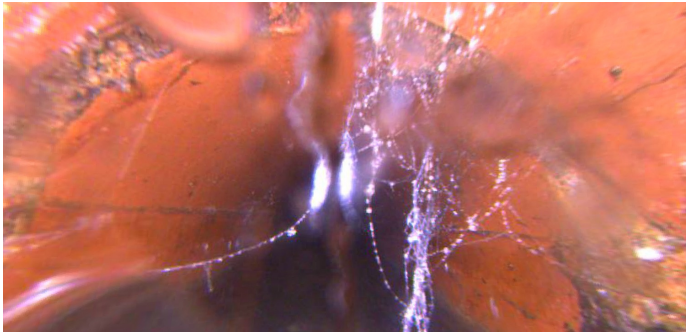
Code: **DAE**
Description: **Deposits Attached Encrustation**

Distance (ft): **80.6**
Structural Grade: **0**
O&M Grade: **2**
Clock Start/From: **8**
Clock To: **4**
1st Value:
2nd Value:
Value Percent: **5.000**
Continuous Index:
Within 8" of Joint: **YES**
Remarks:

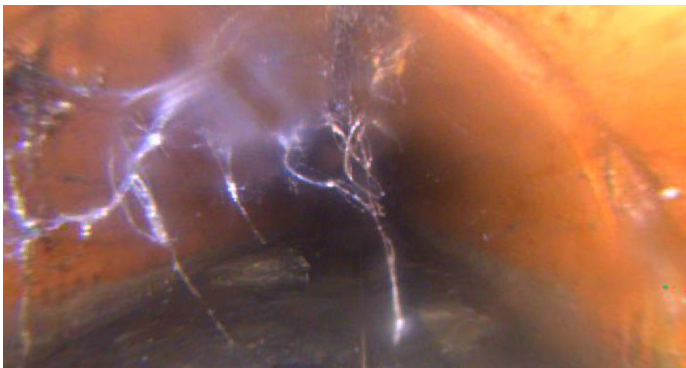
Code: **RFJ**
Description: **Roots Fine Joint**

Distance (ft): **85.3**
Structural Grade: **0**
O&M Grade: **1**
Clock Start/From: **5**
Clock To: **12**
1st Value:
2nd Value:
Value Percent:
Continuous Index:
Within 8" of Joint: **YES**
Remarks:

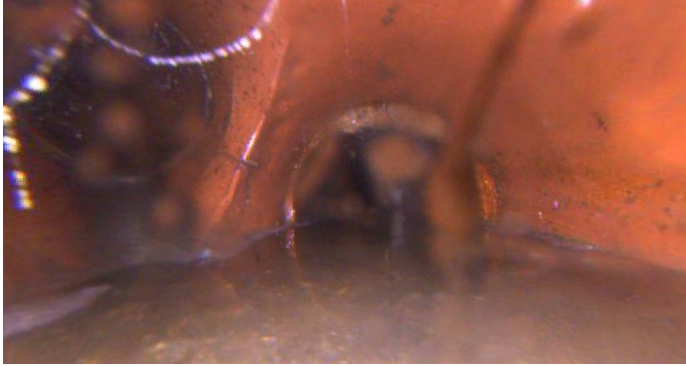
Code: **TF**
Description: **Tap Factory**

Distance (ft): **93.9**
Structural Grade: **0**
O&M Grade: **0**
Clock Start/From: **9**
Clock To:
1st Value: **4.000**
2nd Value:
Value Percent:
Continuous Index:
Within 8" of Joint:
Remarks:

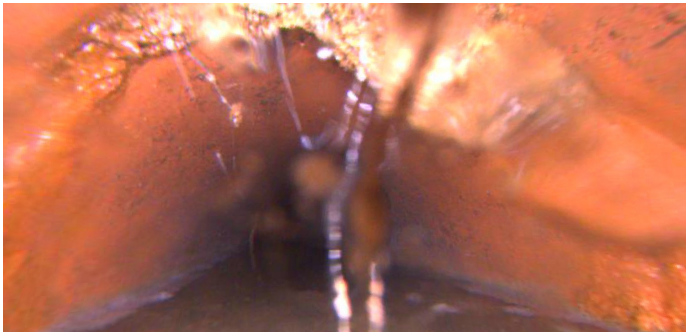
Code: **DAE**
Description: **Deposits Attached Encrustation**

Distance (ft): **94.8**
Structural Grade: **0**
O&M Grade: **2**
Clock Start/From: **8**
Clock To: **4**
1st Value:
2nd Value:
Value Percent: **10.000**
Continuous Index:
Within 8" of Joint: **YES**
Remarks:

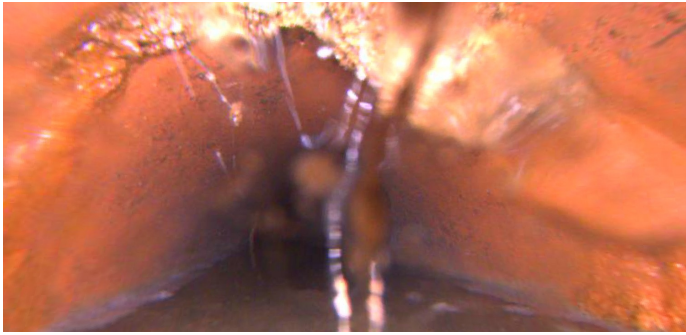
Code: **IW**
Description: **Infil Weeper**

Distance (ft): **94.8**
Structural Grade: **0**
O&M Grade: **2**
Clock Start/From: **8**
Clock To: **4**
1st Value:
2nd Value:
Value Percent:
Continuous Index:
Within 8" of Joint: **YES**
Remarks:

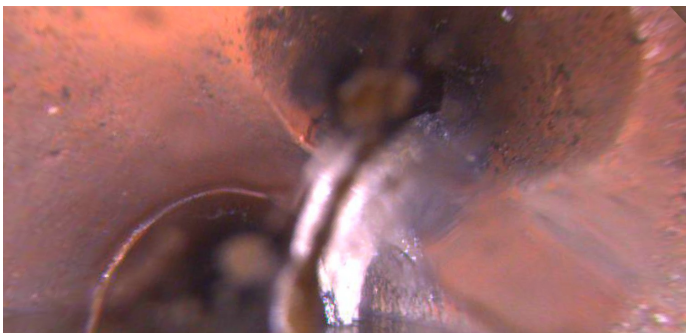
Code: **TFD**
Description: **Tap Factory Defective**

Distance (ft): **96.0**
Structural Grade: **0**
O&M Grade: **2**
Clock Start/From: **2**
Clock To:
1st Value: **4.000**
2nd Value:
Value Percent:
Continuous Index:
Within 8" of Joint:
Remarks: **dags**

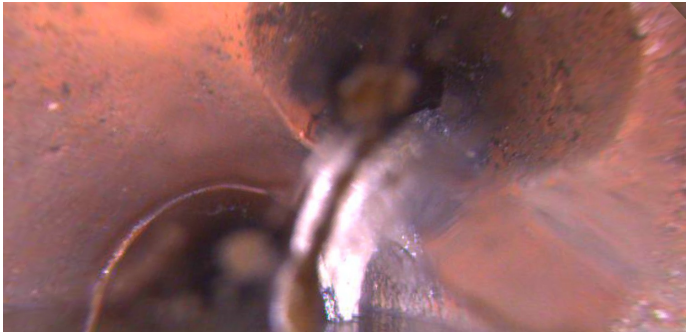
Code: **DAGS**
Description: **Deposits Attached Grease**

Distance (ft): **96.0**
Structural Grade: **0**
O&M Grade: **2**
Clock Start/From: **2**
Clock To: **4**
1st Value:
2nd Value:
Value Percent: **5.000**
Continuous Index:
Within 8" of Joint: **NO**
Remarks:

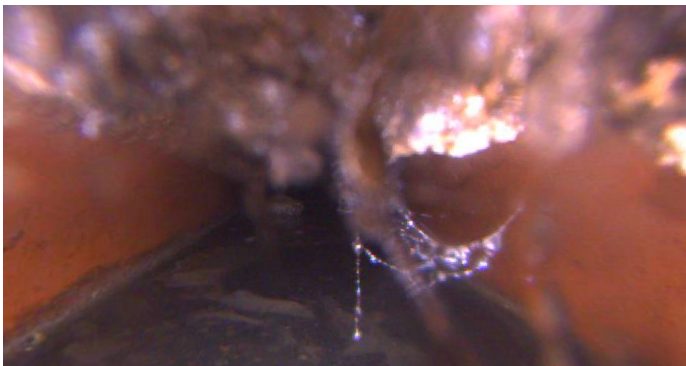
Code: **DAZ**
Description: **Deposits Attached Other**

Distance (ft): **101.6**
Structural Grade: **0**
O&M Grade: **2**
Clock Start/From: **12**
Clock To:
1st Value:
2nd Value:
Value Percent: **5.000**
Continuous Index:
Within 8" of Joint: **YES**
Remarks:

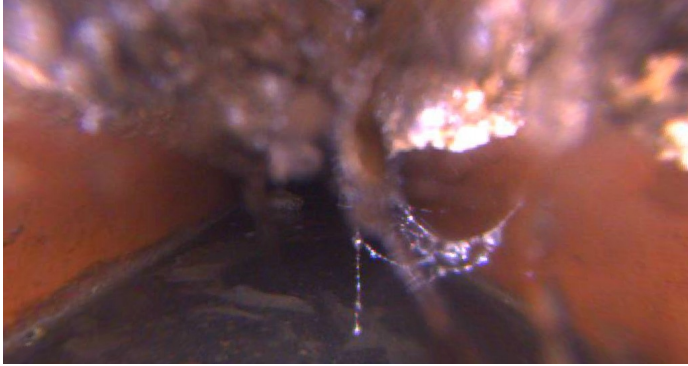
Code:	MSA
Description:	Abandoned Survey
Distance (ft):	101.6
Structural Grade:	0
O&M Grade:	0
Clock Start/From:	
Clock To:	
1st Value:	
2nd Value:	
Value Percent:	
Continuous Index:	
Within 8" of Joint:	NO
Remarks:	daz
