Profile/Photo Observation Report

Street:	S COLORADO ST & W 8TH ST	Flow Control:	Not Controlled
City:	Hobart, IN	Year Renewed:	
Location:	Yard	Tape/Media #:	
Purpose:	Routine Assessment	Dia/Height:	12"
Use:	Sanitary	Material:	VCP
Drain Area:	NA	Lining:	
Category:	NA		
Comment:

Location Details:		Direction of Survey:	Downstream
US MH:	M-506-010	DS MH:	M-506-006
		Total Length Surveyed (ft):	136.4

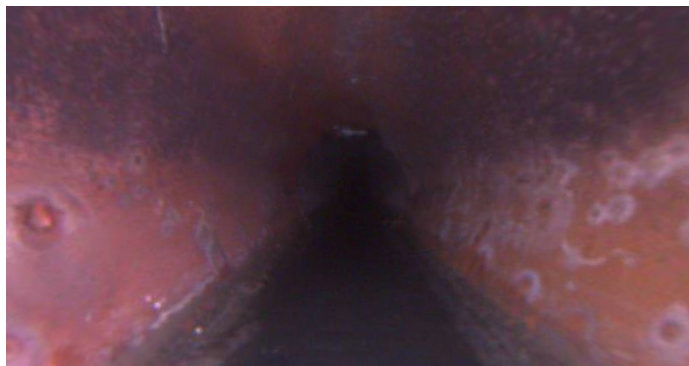
Code: **AMH**
 Description: **Manhole**

Distance (ft): **.0**
 Structural Grade: **0**
 O&M Grade: **0**
 Clock Start/From:
 Clock To:
 1st Value:
 2nd Value:
 Value Percent:
 Continuous Index:
 Within 8" of Joint: **NO**
 Remarks: **M-506-010**

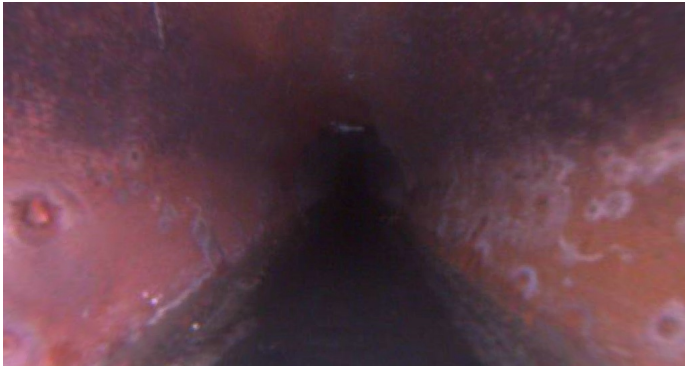
Code:	MWL
Description:	Water Level

Distance (ft):	.0
Structural Grade:	0
O&M Grade:	0
Clock Start/From:	
Clock To:	
1st Value:	
2nd Value:	
Value Percent:	10.000
Continuous Index:	
Within 8" of Joint:	NO
Remarks:

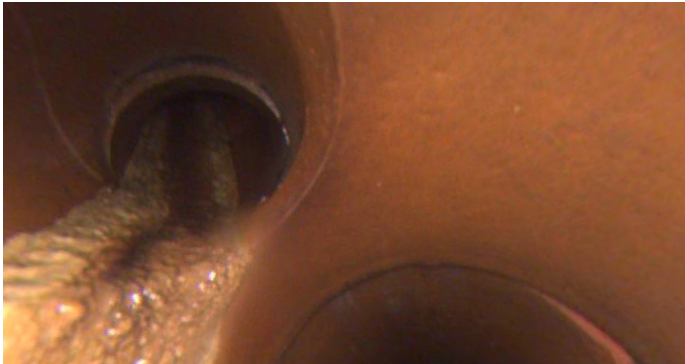
Code:	TF
Description:	Tap Factory

Distance (ft):	20.2
Structural Grade:	0
O&M Grade:	0
Clock Start/From:	2
Clock To:	
1st Value:	4.000
2nd Value:	
Value Percent:	
Continuous Index:	
Within 8" of Joint:	
Remarks:

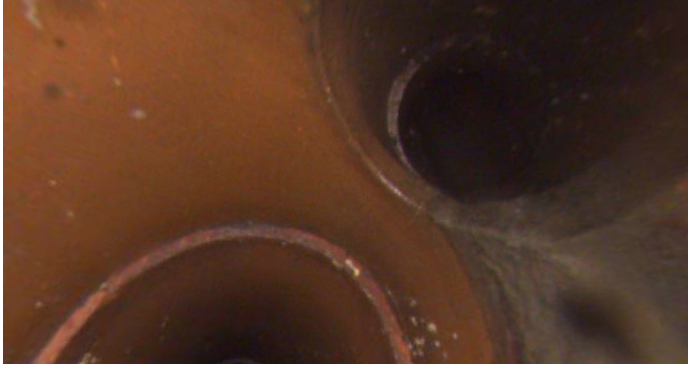
Code: **TF**
Description: **Tap Factory**

Distance (ft): **62.1**
Structural Grade: **0**
O&M Grade: **0**
Clock Start/From: **10**
Clock To:
1st Value: **4.000**
2nd Value:
Value Percent:
Continuous Index:
Within 8" of Joint:
Remarks:

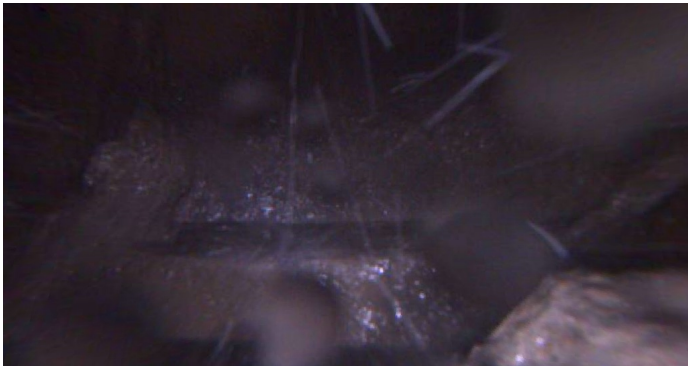
Code: **AMH**
Description: **Manhole**

Distance (ft): **136.4**
Structural Grade: **0**
O&M Grade: **0**
Clock Start/From:
Clock To:
1st Value:
2nd Value:
Value Percent:
Continuous Index:
Within 8" of Joint: **NO**
Remarks: **M-506-006**
