Profile/Photo Observation Report

Street:	FOXCROFT STREET	Flow Control:	Not Controlled
City:	Hobart, IN	Year Renewed:	
Location:	Yard	Tape/Media #:	
Purpose:	Routine Assessment	Dia/Height:	12"
Use:	Sanitary	Material:	VCP
Drain Area:	NA	Lining:	
Category:	NA		
Comment:

Location Details:		Direction of Survey:	Downstream
US MH:	M-506-010	DS MH:	M-506-006
		Total Length Surveyed (ft):	136.4

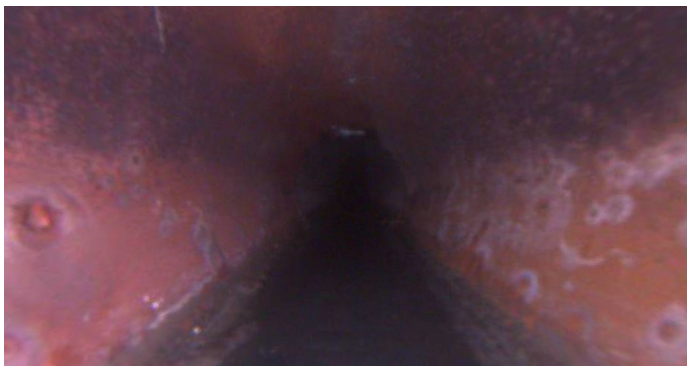
Code: **AMH**
Description: **Manhole**

Distance (ft): **.0**
Structural Grade: **0**
O&M Grade: **0**
Clock Start/From:
Clock To:
1st Value:
2nd Value:
Value Percent:
Continuous Index:
Within 8" of Joint: **NO**
Remarks: **M-506-010**

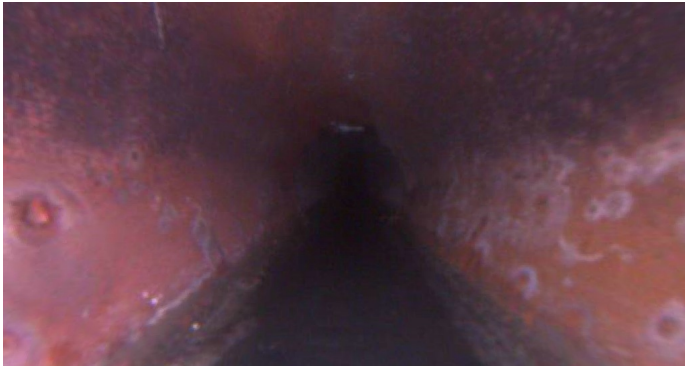
Code:	MWL
Description:	Water Level

Distance (ft):	.0
Structural Grade:	0
O&M Grade:	0
Clock Start/From:	
Clock To:	
1st Value:	
2nd Value:	
Value Percent:	10.000
Continuous Index:	
Within 8" of Joint:	NO
Remarks:

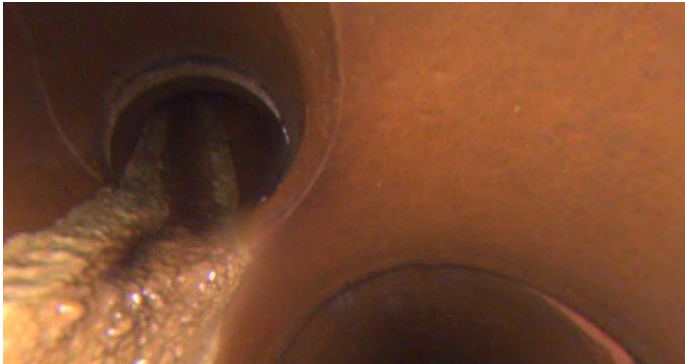
Code:	TF
Description:	Tap Factory

Distance (ft):	20.2
Structural Grade:	0
O&M Grade:	0
Clock Start/From:	2
Clock To:	
1st Value:	4.000
2nd Value:	
Value Percent:	
Continuous Index:	
Within 8" of Joint:	
Remarks:

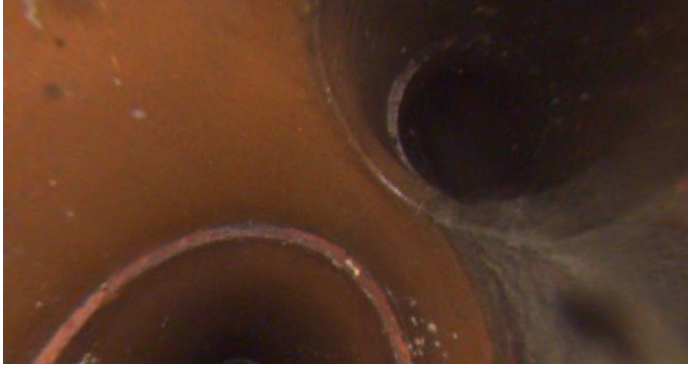
Code: **TF**
Description: **Tap Factory**

Distance (ft): **62.1**
Structural Grade: **0**
O&M Grade: **0**
Clock Start/From: **10**
Clock To:
1st Value: **4.000**
2nd Value:
Value Percent:
Continuous Index:
Within 8" of Joint:
Remarks:

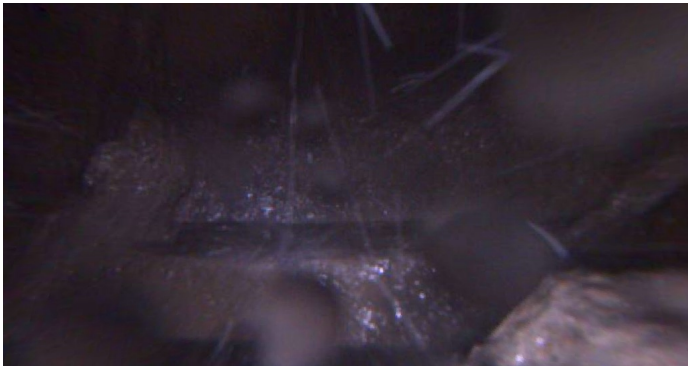
Code: **AMH**
Description: **Manhole**

Distance (ft): **136.4**
Structural Grade: **0**
O&M Grade: **0**
Clock Start/From:
Clock To:
1st Value:
2nd Value:
Value Percent:
Continuous Index:
Within 8" of Joint: **NO**
Remarks: **M-506-006**
