Profile/Photo Observation Report

Street:	FOXCROFT STREET	Flow Control:	Not Controlled
City:	Hobart, IN	Year Renewed:	
Location:	Yard	Tape/Media #:	
Purpose:	Routine Assessment	Dia/Height:	10"
Use:	Sanitary	Material:	VCP
Drain Area:	NA	Lining:	
Category:	NA		
Comment:

Location Details:		Direction of Survey:	Upstream
US MH:	M-506-010	DS MH:	M-506-011
		Total Length Surveyed (ft):	3.1

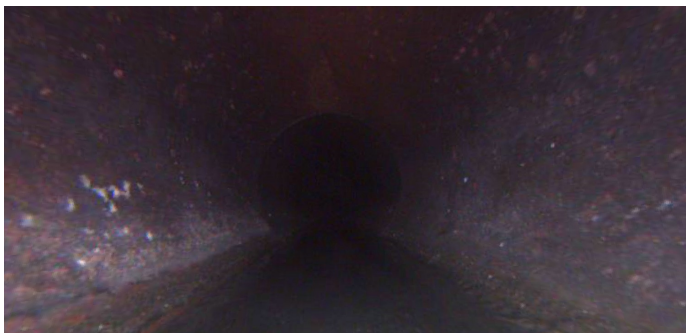
Code: **AMH**
Description: **Manhole**

Distance (ft): **.0**
Structural Grade: **0**
O&M Grade: **0**
Clock Start/From:
Clock To:
1st Value:
2nd Value:
Value Percent:
Continuous Index:
Within 8" of Joint: **NO**
Remarks: **M-506-011**

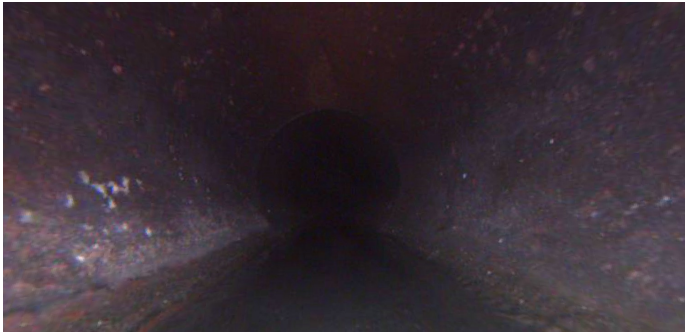
Code:	MWL
Description:	Water Level

Distance (ft):	.0
Structural Grade:	0
O&M Grade:	0
Clock Start/From:	
Clock To:	
1st Value:	
2nd Value:	
Value Percent:	10.000
Continuous Index:	
Within 8" of Joint:	NO
Remarks:

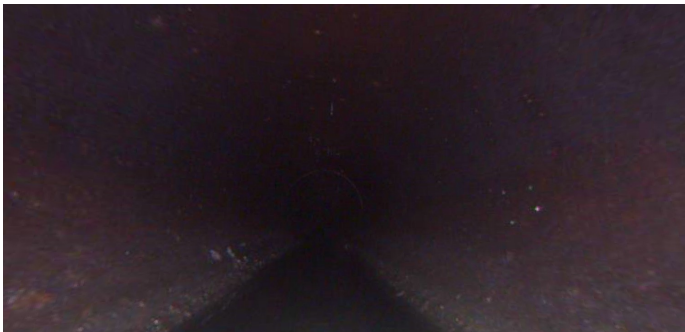
Code:	MSA
Description:	Abandoned Survey

Distance (ft):	3.1
Structural Grade:	0
O&M Grade:	0
Clock Start/From:	
Clock To:	
1st Value:	
2nd Value:	
Value Percent:	
Continuous Index:	
Within 8" of Joint:	NO
Remarks:	unknown
