Profile/Photo Observation Report

Date:	04/06/2018	Weather:		Coding:	PACP 6.0
Pipe Length (ft):	207.0	Owner:	NA	Pre Clean:	No Pre-Cleaning
P.O.#:		Surveyor:	Byrd Fitzgerald	PSR:	P-506-011-010
Customer:		Clean Date:	01/01/1900	Shape:	C

Street:	S COLORADO ST & W 7TH PL	Flow Control:	Not Controlled
City:	Hobart, IN	Year Renewed:	
Location:	Yard	Tape/Media #:	
Purpose:	Routine Assessment	Dia/Height:	12"
Use:	Sanitary	Material:	VCP
Drain Area:	NA	Lining:	
Category:	NA		
Comment:	P_C lip in pipe, flow direction is marked wrong.		
Location Details:		Direction of Survey:	Upstream
US MH:	M-506-010	DS MH:	M-506-011
		Total Length Surveyed (ft):	29.7

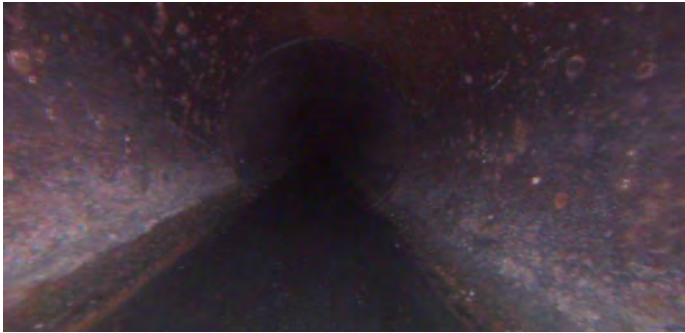
Code:	MWL
Description:	Water Level

Distance (ft):	.0
Structural Grade:	0
O&M Grade:	0
Clock Start/From:	
Clock To:	
1st Value:	
2nd Value:	
Value Percent:	5.000
Continuous Index:	
Within 8" of Joint:	NO
Remarks:

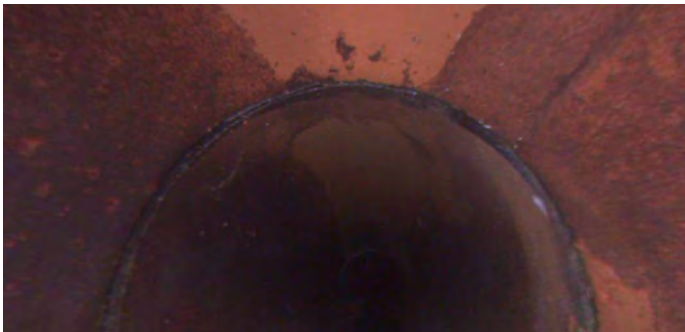
Code:	CM
Description:	Crack Multiple

Distance (ft):	13.8
Structural Grade:	3
O&M Grade:	0
Clock Start/From:	11
Clock To:	1
1st Value:	
2nd Value:	
Value Percent:	
Continuous Index:	S01
Within 8" of Joint:	YES
Remarks:	wandering

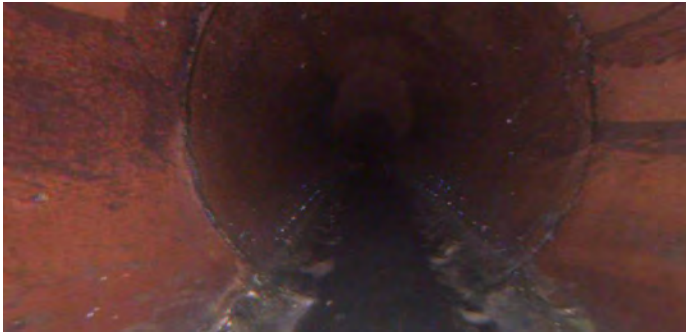
Code: **MSA**
Description: **Abandoned Survey**

Distance (ft): **29.7**
Structural Grade: **0**
O&M Grade: **0**
Clock Start/From:
Clock To:
1st Value:
2nd Value:
Value Percent:
Continuous Index:
Within 8" of Joint: **NO**
Remarks: **no blockage**

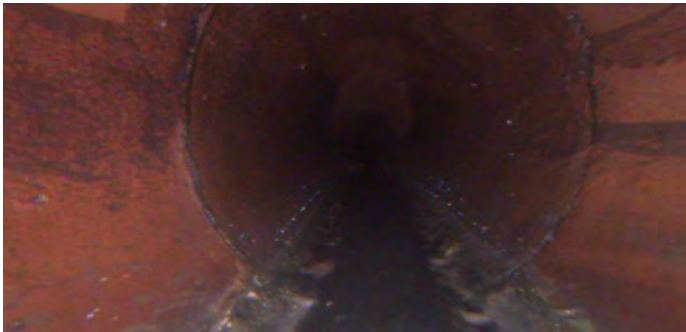
Code: **CM**
Description: **Crack Multiple**

Distance (ft): **29.7**
Structural Grade: **3**
O&M Grade: **0**
Clock Start/From: **11**
Clock To: **1**
1st Value:
2nd Value:
Value Percent:
Continuous Index: **F01**
Within 8" of Joint: **YES**
Remarks: **wandering**
