Profile/Photo Observation Report

Street:	FOXCROFT STREET	Flow Control:	Not Controlled
City:	Hobart, IN	Year Renewed:	
Location:	Yard	Tape/Media #:	
Purpose:	Routine Assessment	Dia/Height:	10"
Use:	Sanitary	Material:	VCP
Drain Area:	NA	Lining:	
Category:	NA		
Comment:	Flow direction is marked wrong.

Location Details:		Direction of Survey:	Upstream
US MH:	M-506-011	DS MH:	M-506-012
		Total Length Surveyed (ft):	129.9

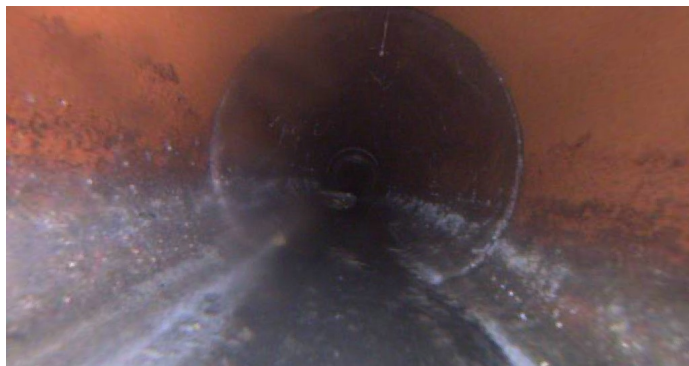
Code: **AMH**
 Description: **Manhole**

Distance (ft): **.0**
 Structural Grade: **0**
 O&M Grade: **0**
 Clock Start/From:
 Clock To:
 1st Value:
 2nd Value:
 Value Percent:
 Continuous Index:
 Within 8" of Joint: **NO**
 Remarks: **M-506-012**

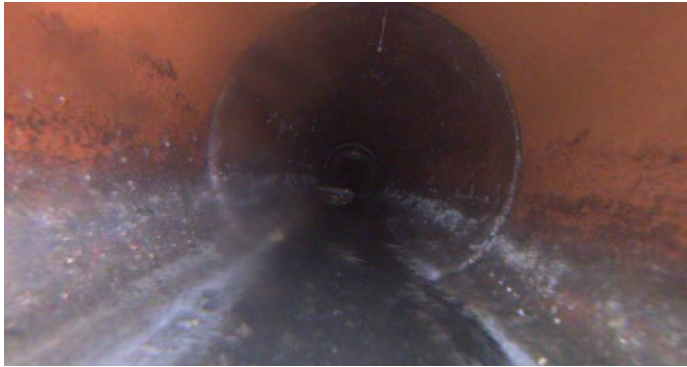
Code: **MWL**
Description: **Water Level**

Distance (ft): **.0**
Structural Grade: **0**
O&M Grade: **0**
Clock Start/From:
Clock To:
1st Value:
2nd Value:
Value Percent: **10.000**
Continuous Index:
Within 8" of Joint: **NO**
Remarks:

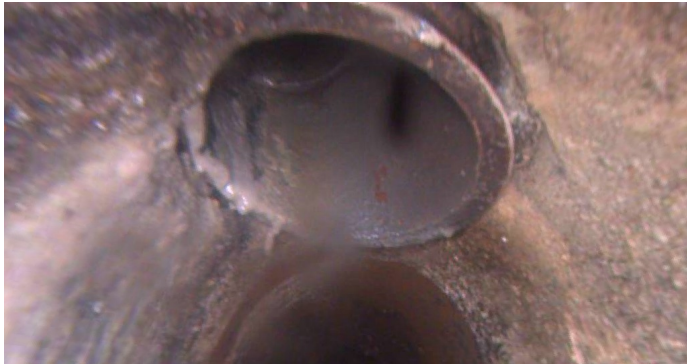
Code: **TB**
Description: **Tap Break-in**

Distance (ft): **6.4**
Structural Grade: **0**
O&M Grade: **0**
Clock Start/From: **12**
Clock To:
1st Value: **4.000**
2nd Value:
Value Percent:
Continuous Index:
Within 8" of Joint:
Remarks:

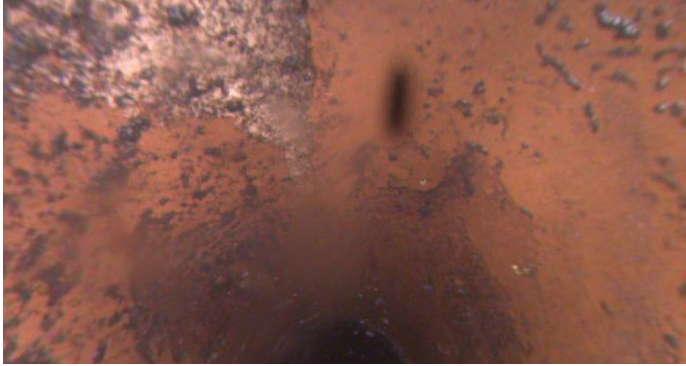
Code: **CL**
Description: **Crack Longitudinal**

Distance (ft): **7.5**
Structural Grade: **2**
O&M Grade: **0**
Clock Start/From: **12**
Clock To:
1st Value:
2nd Value:
Value Percent:
Continuous Index:
Within 8" of Joint:
Remarks:

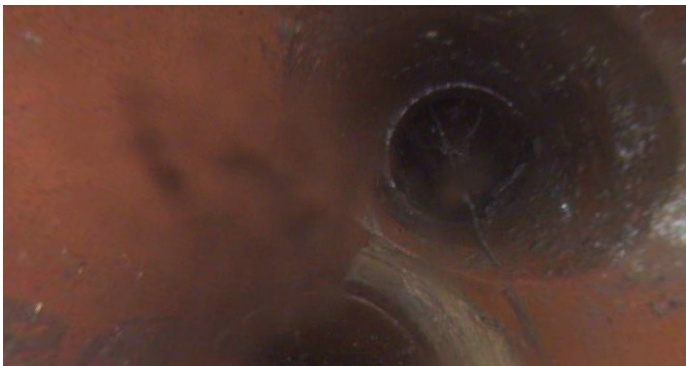
Code: **TF**
Description: **Tap Factory**

Distance (ft): **14.7**
Structural Grade: **0**
O&M Grade: **0**
Clock Start/From: **10**
Clock To:
1st Value: **4.000**
2nd Value:
Value Percent:
Continuous Index:
Within 8" of Joint:
Remarks:

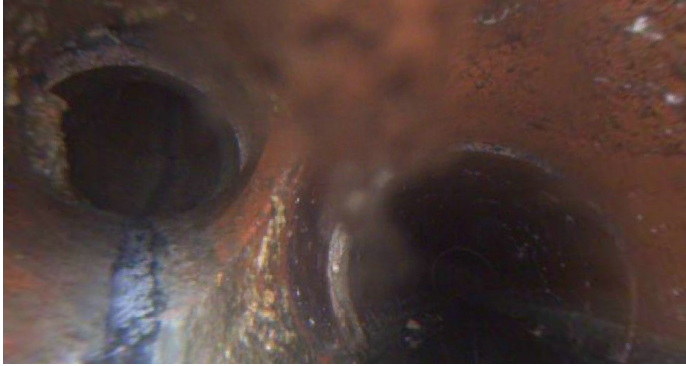
Code: **TF**
Description: **Tap Factory**

Distance (ft): **28.2**
Structural Grade: **0**
O&M Grade: **0**
Clock Start/From: **2**
Clock To:
1st Value: **4.000**
2nd Value:
Value Percent:
Continuous Index:
Within 8" of Joint:
Remarks:

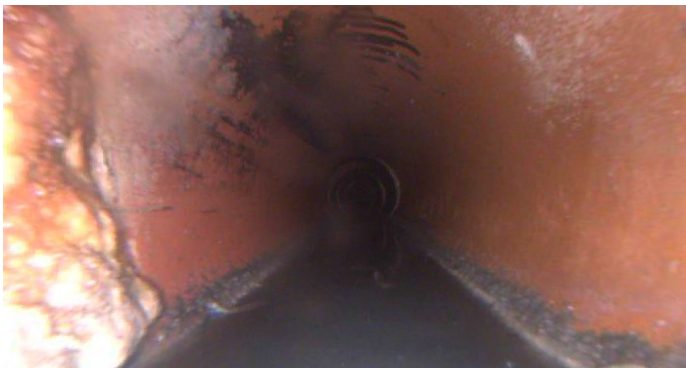
Code: **DAGS**
Description: **Deposits Attached Grease**

Distance (ft): **49.6**
Structural Grade: **0**
O&M Grade: **2**
Clock Start/From: **7**
Clock To: **9**
1st Value:
2nd Value:
Value Percent: **5.000**
Continuous Index:
Within 8" of Joint: **YES**
Remarks:

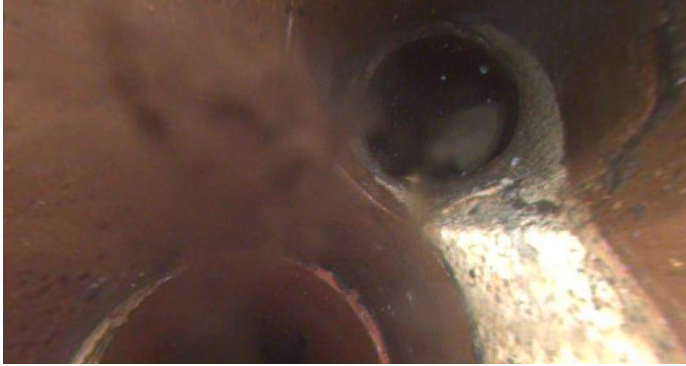
Code: **TF**
Description: **Tap Factory**

Distance (ft): **53.9**
Structural Grade: **0**
O&M Grade: **0**
Clock Start/From: **10**
Clock To:
1st Value: **4.000**
2nd Value:
Value Percent:
Continuous Index:
Within 8" of Joint:
Remarks:

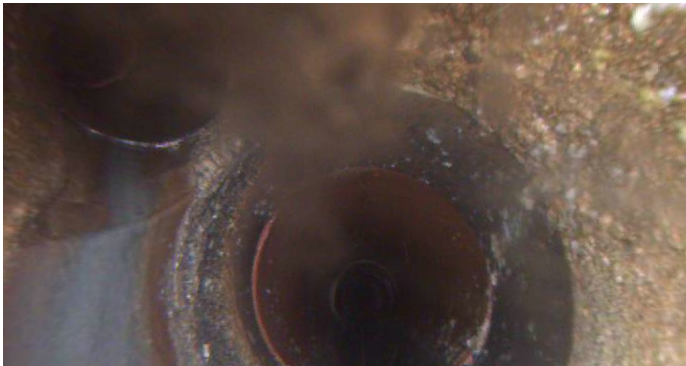
Code: **TF**
Description: **Tap Factory**

Distance (ft): **59.0**
Structural Grade: **0**
O&M Grade: **0**
Clock Start/From: **2**
Clock To:
1st Value: **4.000**
2nd Value:
Value Percent:
Continuous Index:
Within 8" of Joint:
Remarks:

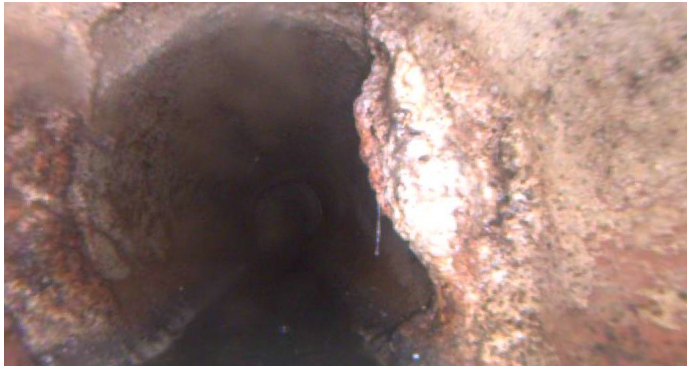
Code: **DAGS**
Description: **Deposits Attached Grease**

Distance (ft): **71.2**
Structural Grade: **0**
O&M Grade: **2**
Clock Start/From: **1**
Clock To: **5**
1st Value:
2nd Value:
Value Percent: **5.000**
Continuous Index:
Within 8" of Joint: **NO**
Remarks:

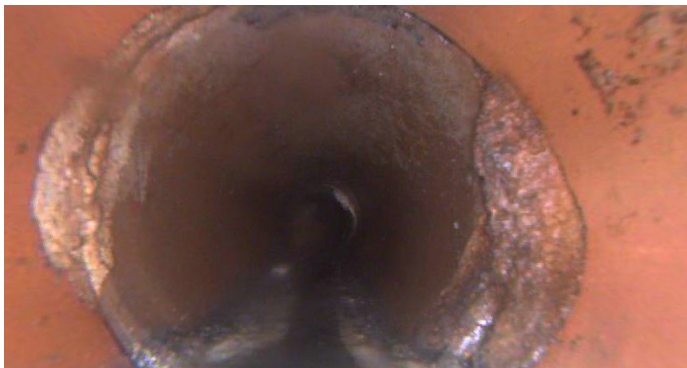
Code: **DAE**
Description: **Deposits Attached Encrustation**

Distance (ft): **86.0**
Structural Grade: **0**
O&M Grade: **2**
Clock Start/From: **7**
Clock To: **5**
1st Value:
2nd Value:
Value Percent: **5.000**
Continuous Index: **S01**
Within 8" of Joint: **YES**
Remarks:

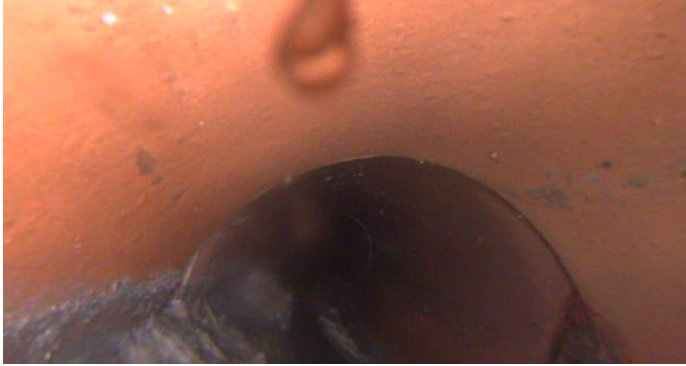
Code: **DAE**
Description: **Deposits Attached Encrustation**

Distance (ft): **129.9**
Structural Grade: **0**
O&M Grade: **2**
Clock Start/From: **7**
Clock To: **5**
1st Value:
2nd Value:
Value Percent: **5.000**
Continuous Index: **F01**
Within 8" of Joint: **YES**
Remarks:

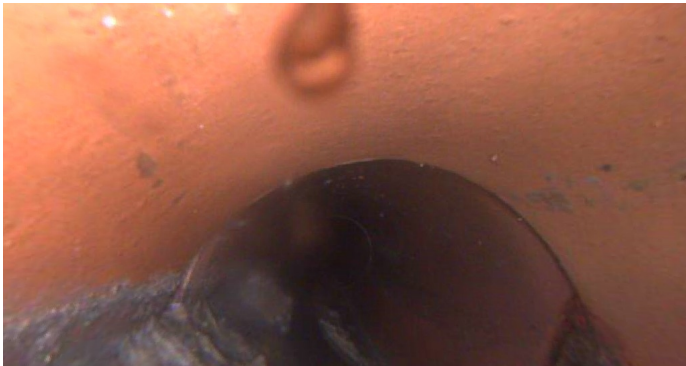
Code: **MSA**
Description: **Abandoned Survey**

Distance (ft): **129.9**
Structural Grade: **0**
O&M Grade: **0**
Clock Start/From:
Clock To:
1st Value:
2nd Value:
Value Percent:
Continuous Index:
Within 8" of Joint: **NO**
Remarks: **Roll max**
