## Profile/Photo Observation Report

Street:	<b>FOXCROFT STREET</b>	Flow Control:	<b>Not Controlled</b>
City:	<b>Hobart, IN</b>	Year Renewed:	
Location:	<b>Yard</b>	Tape/Media #:	
Purpose:	<b>Routine Assessment</b>	Dia/Height:	<b>10"</b>
Use:	<b>Sanitary</b>	Material:	<b>VCP</b>
Drain Area:	<b>NA</b>	Lining:	
Category:	<b>NA</b>		
Comment:	<b>F_S_P_C pipe seperated, flow direction is marked wrong.</b>		
Location Details:		Direction of Survey:	<b>Downstream</b>
US MH:	<b>M-506-011</b>	DS MH:	<b>M-506-012</b>
		Total Length Surveyed (ft):	<b>7.8</b>

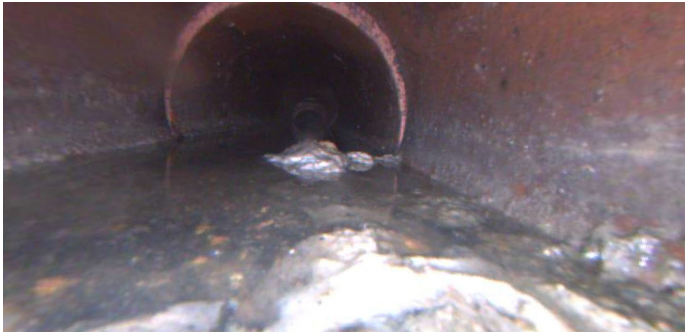
Code:	<b>MWL</b>
Description:	<b>Water Level</b>

Distance (ft):	<b>.0</b>
Structural Grade:	<b>0</b>
O&M Grade:	<b>0</b>
Clock Start/From:	
Clock To:	
1st Value:	
2nd Value:	
Value Percent:	<b>30.000</b>
Continuous Index:	
Within 8" of Joint:	<b>NO</b>
Remarks:

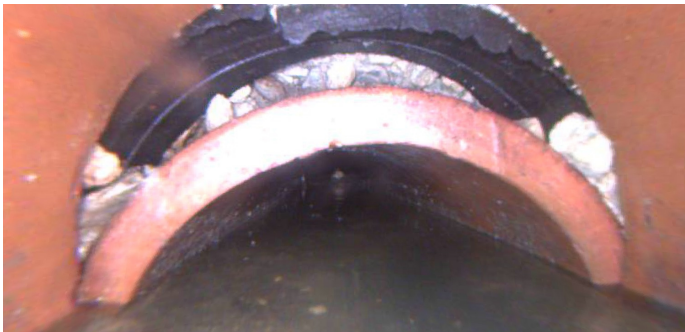
Code:	<b>JOL</b>
Description:	<b>Joint Offset Large</b>

Distance (ft):	<b>7.3</b>
Structural Grade:	<b>2</b>
O&M Grade:	<b>0</b>
Clock Start/From:	
Clock To:	
1st Value:	
2nd Value:	
Value Percent:	
Continuous Index:	
Within 8" of Joint:	<b>NO</b>
Remarks:

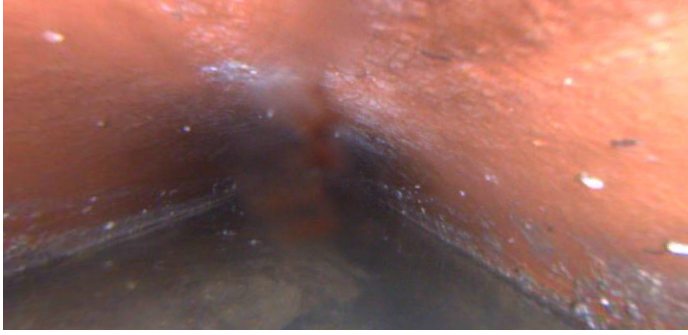
Code:	<b>MSA</b>
Description:	<b>Abandoned Survey</b>
Distance (ft):	<b>7.8</b>
Structural Grade:	<b>0</b>
O&M Grade:	<b>0</b>
Clock Start/From:	
Clock To:	
1st Value:	
2nd Value:	
Value Percent:	
Continuous Index:	
Within 8" of Joint:	<b>NO</b>
Remarks:	<b>jol</b>
