Profile/Photo Observation Report

Street:	FOXCROFT STREET	Flow Control:	Not Controlled
City:	Hobart, IN	Year Renewed:	
Location:	Yard	Tape/Media #:	
Purpose:	Routine Assessment	Dia/Height:	10"
Use:	Sanitary	Material:	VCP
Drain Area:	NA	Lining:	
Category:	NA		
Comment:	P_C build up on pipe, flow direction is marked wrong.		
Location Details:		Direction of Survey:	Upstream
US MH:	M-506-013	DS MH:	M-506-014
		Total Length Surveyed (ft):	6.7

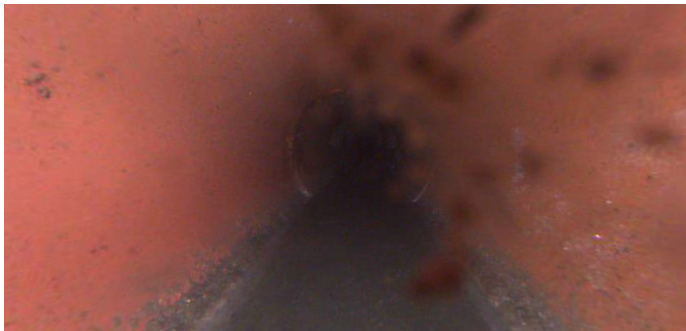
Code: **AMH**
Description: **Manhole**

Distance (ft): **.0**
Structural Grade: **0**
O&M Grade: **0**
Clock Start/From:
Clock To:
1st Value:
2nd Value:
Value Percent:
Continuous Index:
Within 8" of Joint: **NO**
Remarks: **M-506-014**

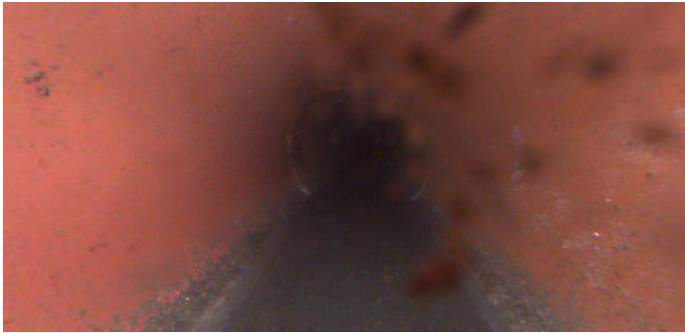
Code:	MWL
Description:	Water Level

Distance (ft):	.0
Structural Grade:	0
O&M Grade:	0
Clock Start/From:	
Clock To:	
1st Value:	
2nd Value:	
Value Percent:	5.000
Continuous Index:	
Within 8" of Joint:	NO
Remarks:

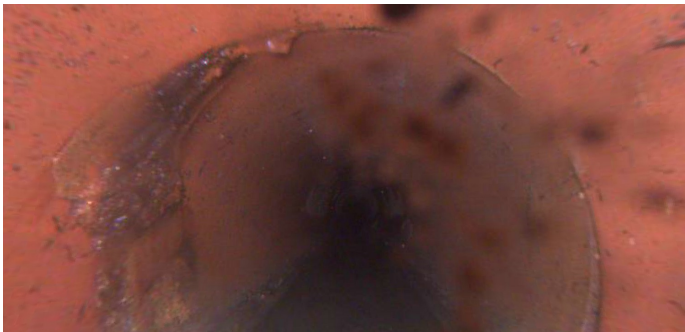
Code:	IW
Description:	Infil Weeper

Distance (ft):	2.2
Structural Grade:	0
O&M Grade:	2
Clock Start/From:	9
Clock To:	11
1st Value:	
2nd Value:	
Value Percent:	
Continuous Index:	
Within 8" of Joint:	YES
Remarks:

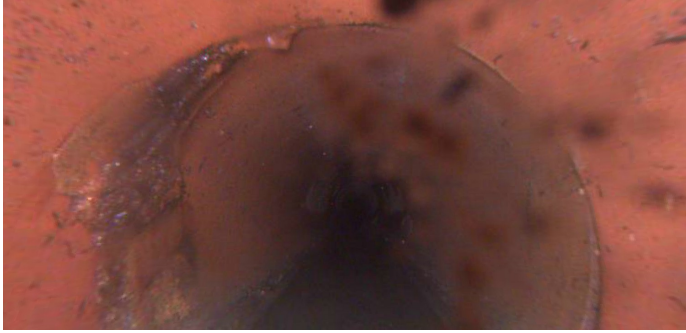
Code:	DAE
Description:	Deposits Attached Encrustation

Distance (ft):	2.2
Structural Grade:	0
O&M Grade:	2
Clock Start/From:	8
Clock To:	12
1st Value:	
2nd Value:	
Value Percent:	5.000
Continuous Index:	
Within 8" of Joint:	YES
Remarks:

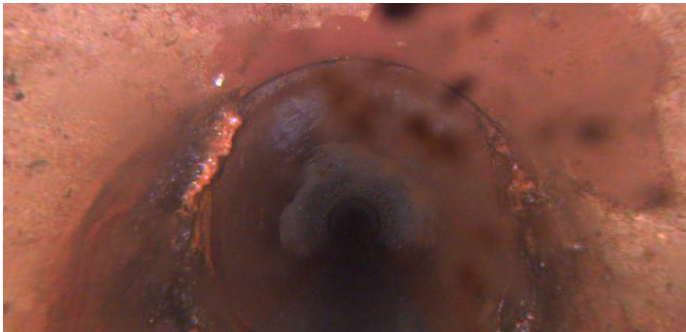
Code:	IW
Description:	Infil Weeper

Distance (ft):	6.0
Structural Grade:	0
O&M Grade:	2
Clock Start/From:	8
Clock To:	4
1st Value:	
2nd Value:	
Value Percent:	
Continuous Index:	
Within 8" of Joint:	YES
Remarks:

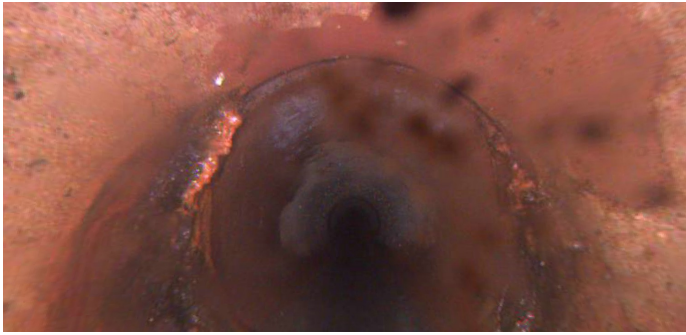
Code: **DAE**
Description: **Deposits Attached Encrustation**

Distance (ft): **6.0**
Structural Grade: **0**
O&M Grade: **2**
Clock Start/From: **8**
Clock To: **4**
1st Value:
2nd Value:
Value Percent: **5.000**
Continuous Index:
Within 8" of Joint: **YES**
Remarks:

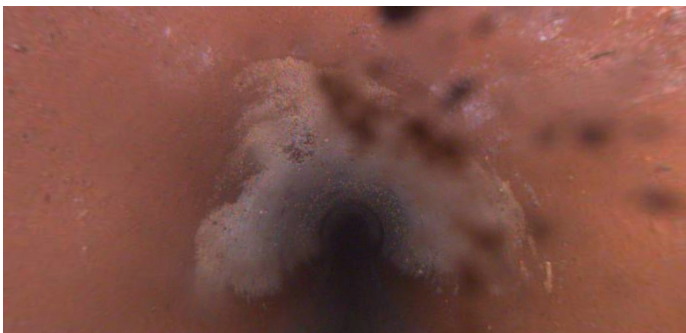
Code: **MSA**
Description: **Abandoned Survey**

Distance (ft): **6.7**
Structural Grade: **0**
O&M Grade: **0**
Clock Start/From:
Clock To:
1st Value:
2nd Value:
Value Percent:
Continuous Index:
Within 8" of Joint: **NO**
Remarks: **DAE**
