Profile/Photo Observation Report

Date:	01/21/2022	Weather:		Coding:	PACP 7.0
Pipe Length (ft):	202.0	Owner:	City of Hobart	Pre Clean:	Heavy Cleaning
P.O.#:	YES502259	Surveyor:	S. Bucklin	PSR:	P-506-014-013
Customer:	City of Hobart	Clean Date:	01/16/2022	Shape:	C

Street:	West 7th Place	Flow Control:	Not Controlled
City:	Hobart, IN	Year Renewed:	
Location:	Local rural streets with light traffic, t	Tape/Media #:	
Purpose:	Routine Assessment	Dia/Height:	10"
Use:	Sanitary Sewage Pipe	Material:	VCP
Drain Area:		Lining:	None
Category:	NA		
Comment:			
Location Details:		Direction of Survey:	Upstream
US MH:	M-506-013	DS MH:	M-506-014
		Total Length Surveyed (ft):	3.6

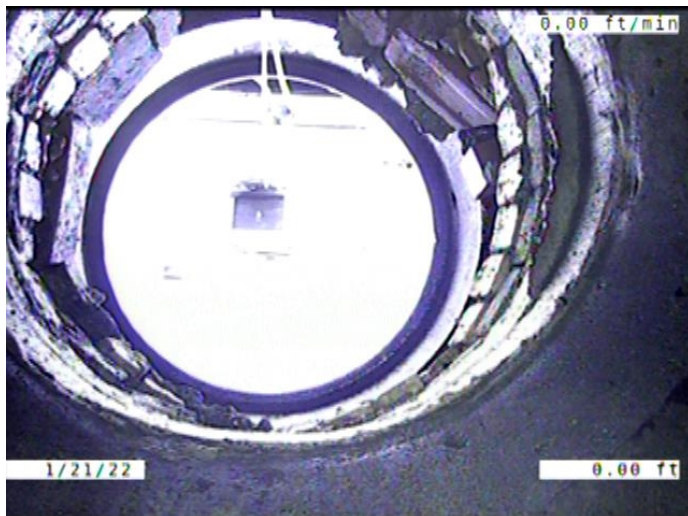
Code:	AMH
Description:	Manhole
Distance (ft):	.0
Structural Grade:	0
O&M Grade:	0
Clock Start/From:	
Clock To:	
1st Value:	
2nd Value:	
Value Percent:	
Continuous Index:	
Within 8" of Joint:	NO
Remarks:	M-506-014

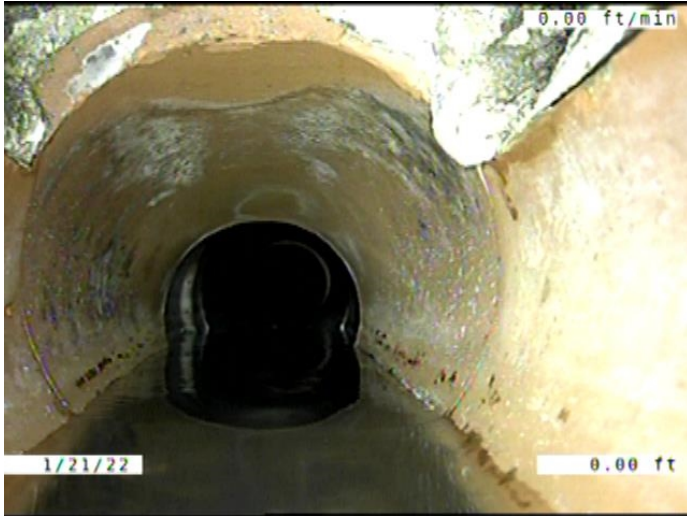
Code: **MWL**
Description: **Miscellaneous Water Level**

Distance (ft): **.0**
Structural Grade: **0**
O&M Grade: **0**
Clock Start/From:
Clock To:
1st Value:
2nd Value:
Value Percent: **10.000**
Continuous Index:
Within 8" of Joint: **NO**
Remarks:

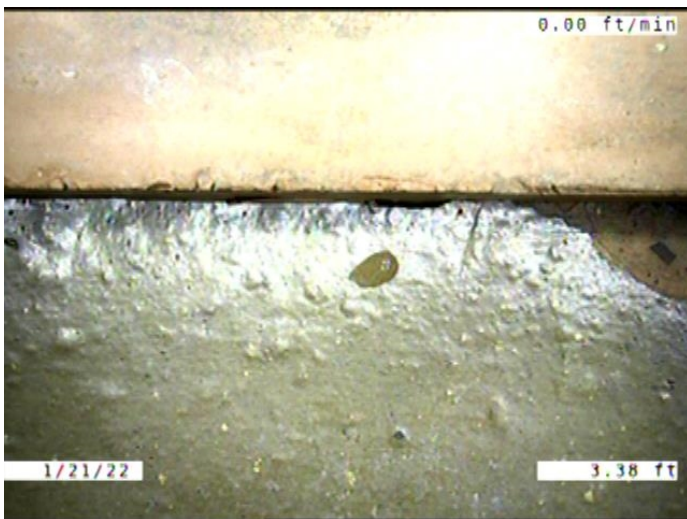
Code: **MSC**
Description: **Miscellaneous Shape/Size Change**

Distance (ft): **3.4**
Structural Grade: **0**
O&M Grade: **0**
Clock Start/From:
Clock To:
1st Value: **10.000**
2nd Value:
Value Percent:
Continuous Index:
Within 8" of Joint: **NO**
Remarks:

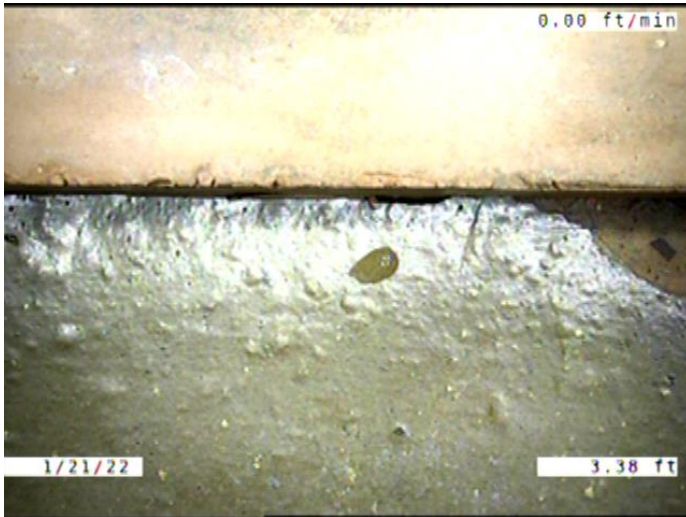
Code: **MGO**
 Description: **Miscellaneous General Observation**

Distance (ft): **3.4**
 Structural Grade: **0**
 O&M Grade: **0**
 Clock Start/From:
 Clock To:
 1st Value:
 2nd Value:
 Value Percent:
 Continuous Index:
 Within 8" of Joint: **NO**
 Remarks: **PIPE CHANGES FROM 8" TO 10"**

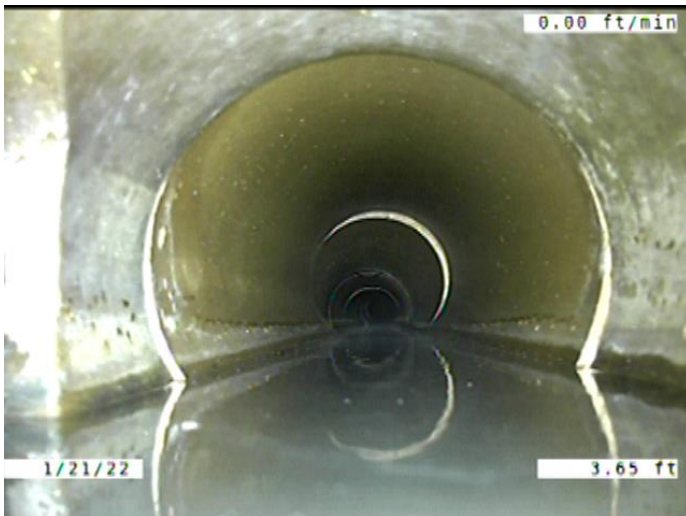
Code: **MSA**
 Description: **Miscellaneous Survey Abandoned**

Distance (ft): **3.6**
 Structural Grade: **0**
 O&M Grade: **0**
 Clock Start/From:
 Clock To:
 1st Value:
 2nd Value:
 Value Percent:
 Continuous Index:
 Within 8" of Joint: **NO**
 Remarks: **MADE IT TO THE POINT OF OVERLAP. REVERSAL COMPLETE**
