Profile/Photo Observation Report

Street:	FOXCROFT STREET	Flow Control:	Not Controlled
City:	Hobart, IN	Year Renewed:	
Location:	Yard	Tape/Media #:	
Purpose:	Routine Assessment	Dia/Height:	10"
Use:	Sanitary	Material:	VCP
Drain Area:	NA	Lining:	
Category:	NA		
Comment:

Location Details:		Direction of Survey:	Upstream
US MH:	M-506-019	DS MH:	M-506-020
		Total Length Surveyed (ft):	2.9

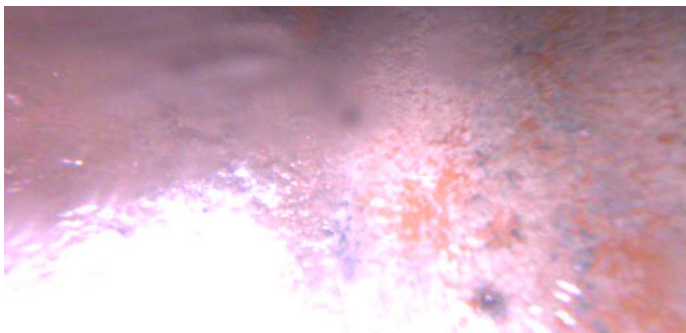
Code: **AMH**
Description: **Manhole**

Distance (ft): **.0**
Structural Grade: **0**
O&M Grade: **0**
Clock Start/From:
Clock To:
1st Value:
2nd Value:
Value Percent:
Continuous Index:
Within 8" of Joint: **NO**
Remarks: **M-506-020**

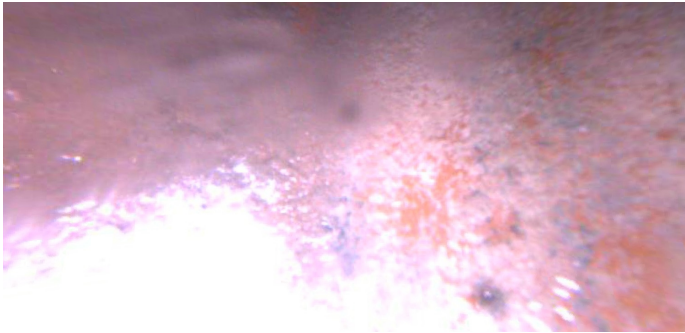
Code:	MWL
Description:	Water Level

Distance (ft):	.0
Structural Grade:	0
O&M Grade:	0
Clock Start/From:	
Clock To:	
1st Value:	
2nd Value:	
Value Percent:	5.000
Continuous Index:	
Within 8" of Joint:	NO
Remarks:

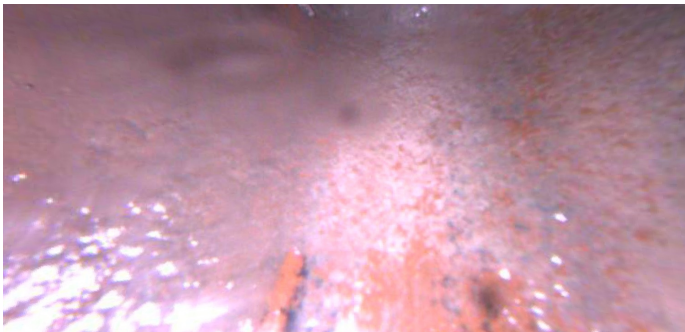
Code:	MSA
Description:	Abandoned Survey

Distance (ft):	2.9
Structural Grade:	0
O&M Grade:	0
Clock Start/From:	
Clock To:	
1st Value:	
2nd Value:	
Value Percent:	
Continuous Index:	
Within 8" of Joint:	NO
Remarks:	not in pipe
