## Profile/Photo Observation Report

Date:	<b>01/18/2022</b>	Weather:		Coding:	<b>PACP 7.0</b>
Pipe Length (ft):	<b>53.6</b>	Owner:	<b>City of Hobart</b>	Pre Clean:	<b>Heavy Cleaning</b>
P.O.#:	<b>YES502259</b>	Surveyor:	<b>S. Bucklin</b>	PSR:	<b>P-506-025-024</b>
Customer:	<b>City of Hobart</b>	Clean Date:	<b>01/16/2021</b>	Shape:	<b>C</b>

Street:	<b>River Terrace</b>	Flow Control:	<b>Not Controlled</b>
City:	<b>Hobart, IN</b>	Year Renewed:	
Location:	<b>Local rural streets with light traffic, t</b>	Tape/Media #:	
Purpose:	<b>Routine Assessment</b>	Dia/Height:	<b>10"</b>
Use:	<b>Sanitary Sewage Pipe</b>	Material:	<b>VCP</b>
Drain Area:		Lining:	<b>None</b>
Category:	<b>NA</b>		
Comment:			
Location Details:		Direction of Survey:	<b>Upstream</b>
US MH:	<b>M-506-024</b>	DS MH:	<b>M-506-025</b>
		Total Length Surveyed (ft):	<b>53.6</b>

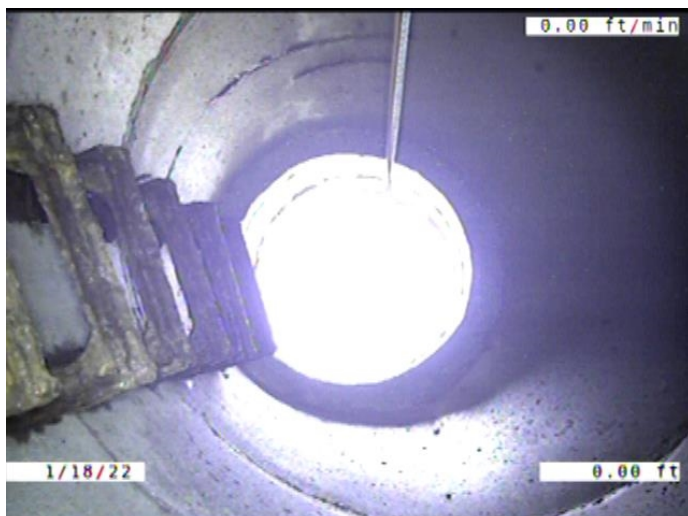
Code: **AMH**  
 Description: **Manhole**

Distance (ft): **.0**  
 Structural Grade: **0**  
 O&M Grade: **0**  
 Clock Start/From:  
 Clock To:  
 1st Value:  
 2nd Value:  
 Value Percent:  
 Continuous Index:  
 Within 8" of Joint: **NO**  
 Remarks: **M-506-025**

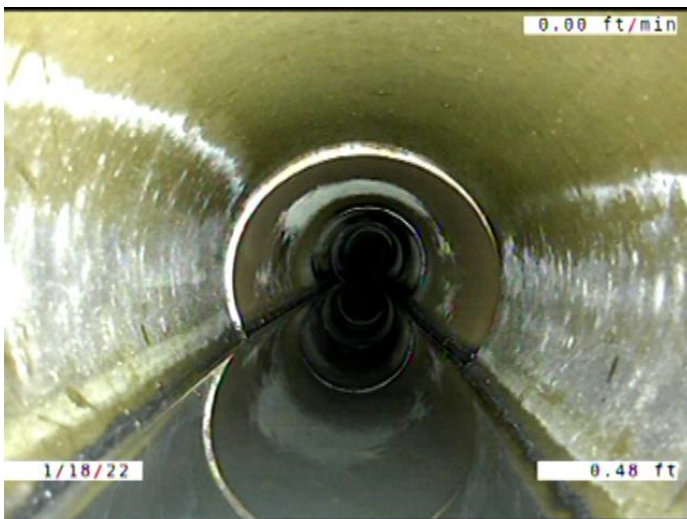
Code: **MWLS**  
Description: **Miscellaneous Water Level Sag**

Distance (ft): **.5**  
Structural Grade: **2**  
O&M Grade: **0**  
Clock Start/From:  
Clock To:  
1st Value:  
2nd Value:  
Value Percent: **10.000**  
Continuous Index: **S01**  
Within 8" of Joint: **NO**  
Remarks:

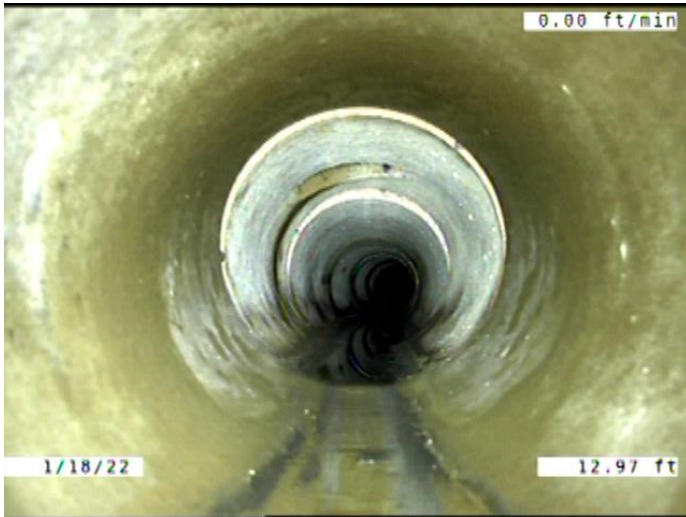
Code: **MWLS**  
Description: **Miscellaneous Water Level Sag**

Distance (ft): **13.0**  
Structural Grade: **2**  
O&M Grade: **0**  
Clock Start/From:  
Clock To:  
1st Value:  
2nd Value:  
Value Percent: **10.000**  
Continuous Index: **F01**  
Within 8" of Joint: **NO**  
Remarks:
