Profile/Photo Observation Report

Street:	FOXCROFT STREET	Flow Control:	Not Controlled
City:	Hobart, IN	Year Renewed:	
Location:	Yard	Tape/Media #:	
Purpose:	Routine Assessment	Dia/Height:	10"
Use:	Sanitary	Material:	RCP
Drain Area:	NA	Lining:	
Category:	NA		
Comment:	P_C debris, flow direction is marked wrong.		
Location Details:		Direction of Survey:	Downstream
US MH:	M-506-026	DS MH:	M-506-029
		Total Length Surveyed (ft):	29.6

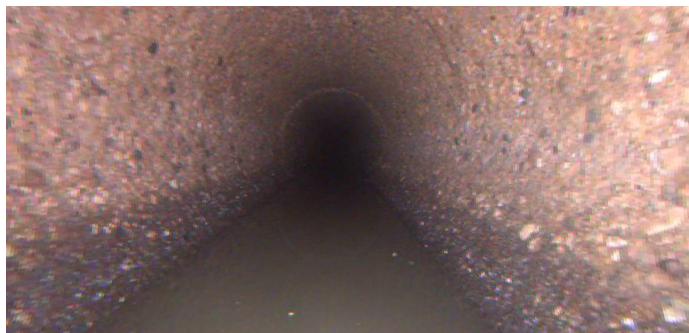
Code: **AMH**
 Description: **Manhole**

Distance (ft): **.0**
 Structural Grade: **0**
 O&M Grade: **0**
 Clock Start/From:
 Clock To:
 1st Value:
 2nd Value:
 Value Percent:
 Continuous Index:
 Within 8" of Joint: **NO**
 Remarks: **M-506-026**

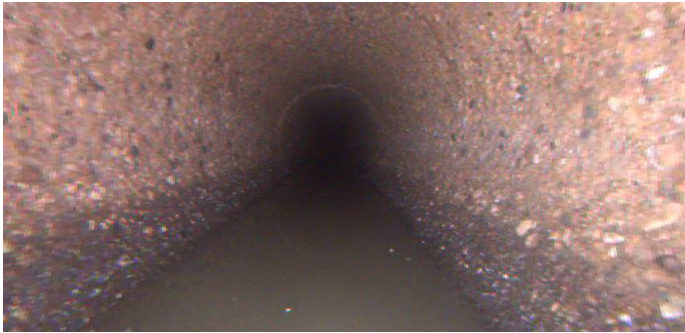
Code:	MWL
Description:	Water Level

Distance (ft):	.0
Structural Grade:	0
O&M Grade:	0
Clock Start/From:	
Clock To:	
1st Value:	
2nd Value:	
Value Percent:	5.000
Continuous Index:	
Within 8" of Joint:	NO
Remarks:

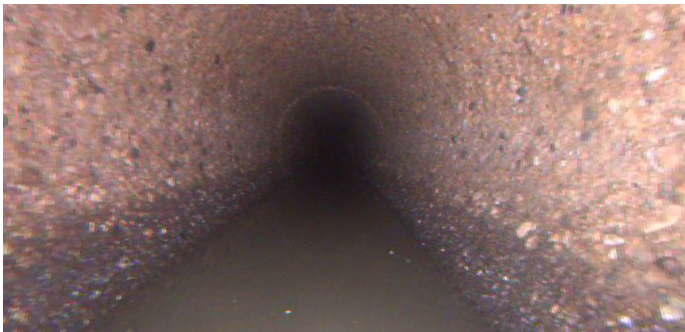
Code:	SAV
Description:	Surface Aggregate Visible

Distance (ft):	.0
Structural Grade:	3
O&M Grade:	0
Clock Start/From:	7
Clock To:	5
1st Value:	
2nd Value:	
Value Percent:	
Continuous Index:	S01
Within 8" of Joint:	NO
Remarks:

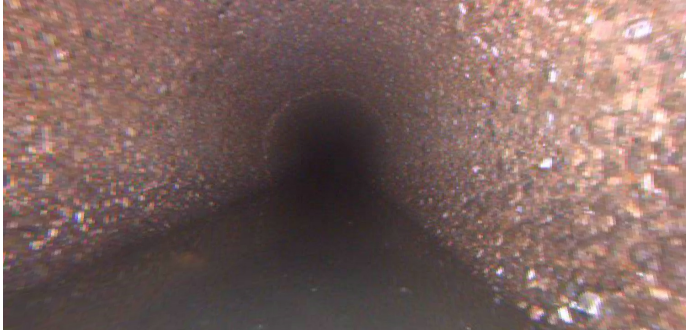
Code: **MSA**
Description: **Abandoned Survey**

Distance (ft): **29.6**
Structural Grade: **0**
O&M Grade: **0**
Clock Start/From:
Clock To:
1st Value:
2nd Value:
Value Percent:
Continuous Index:
Within 8" of Joint: **NO**
Remarks: **no blockage**

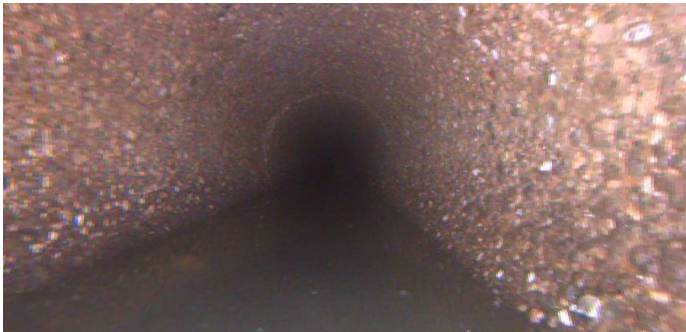
Code: **SAV**
Description: **Surface Aggregate Visible**

Distance (ft): **29.6**
Structural Grade: **3**
O&M Grade: **0**
Clock Start/From: **7**
Clock To: **5**
1st Value:
2nd Value:
Value Percent:
Continuous Index: **F01**
Within 8" of Joint: **NO**
Remarks:
