Profile/Photo Observation Report

Date:	04/06/2018	Weather:		Coding:	PACP 6.0
Pipe Length (ft):	250.5	Owner:	NA	Pre Clean:	No Pre-Cleaning
P.O.#:		Surveyor:	Mark Ruby	PSR:	P-506-030-029
Customer:		Clean Date:	01/01/1900	Shape:	C

Street:	RIVER TERR	Flow Control:	Not Controlled
City:	Hobart, IN	Year Renewed:	
Location:	Yard	Tape/Media #:	
Purpose:	Routine Assessment	Dia/Height:	10"
Use:	Sanitary	Material:	VCP
Drain Area:	NA	Lining:	
Category:	NA		
Comment:			
Location Details:		Direction of Survey:	Downstream
US MH:	M-506-029	DS MH:	M-506-030
		Total Length Surveyed (ft):	82.7

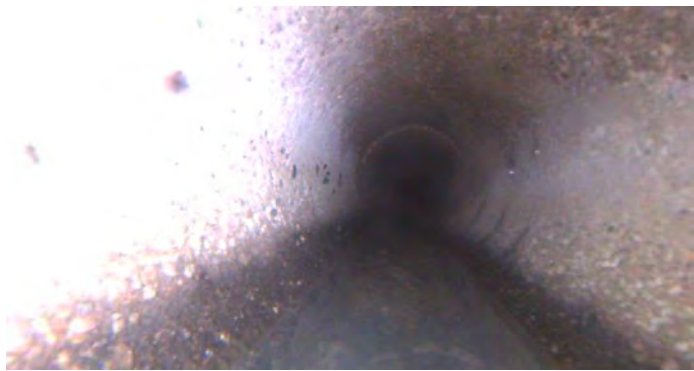
Code: **AMH**
 Description: **Manhole**

Distance (ft): **.0**
 Structural Grade: **0**
 O&M Grade: **0**
 Clock Start/From:
 Clock To:
 1st Value:
 2nd Value:
 Value Percent:
 Continuous Index:
 Within 8" of Joint: **NO**
 Remarks: **M-506-029**

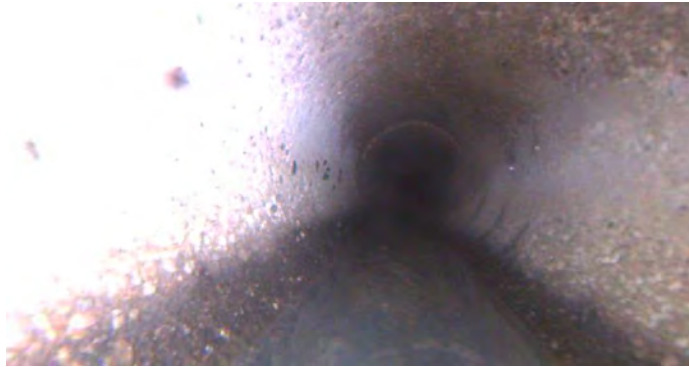
Code: **MWL**
Description: **Water Level**

Distance (ft): **.0**
Structural Grade: **0**
O&M Grade: **0**
Clock Start/From:
Clock To:
1st Value:
2nd Value:
Value Percent: **10.000**
Continuous Index:
Within 8" of Joint: **NO**
Remarks:

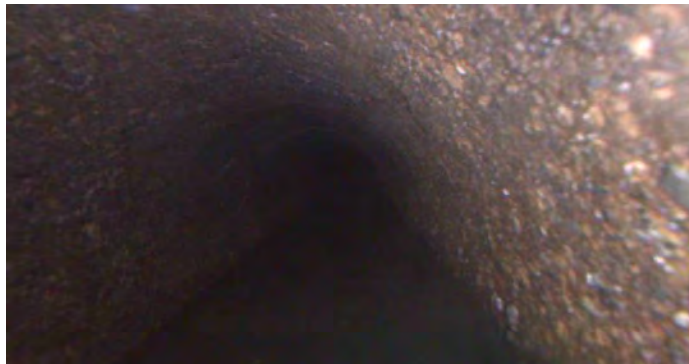
Code: **MSA**
Description: **Abandoned Survey**

Distance (ft): **82.7**
Structural Grade: **0**
O&M Grade: **0**
Clock Start/From:
Clock To:
1st Value:
2nd Value:
Value Percent:
Continuous Index:
Within 8" of Joint: **NO**
Remarks: **No blockage**
