Profile/Photo Observation Report

Date:	04/06/2018	Weather:		Coding:	PACP 6.0
Pipe Length (ft):	192.4	Owner:	NA	Pre Clean:	No Pre-Cleaning
P.O.#:		Surveyor:	Jen Costello	PSR:	P-506-032-031
Customer:		Clean Date:	01/01/1900	Shape:	C

Street:	RIVER TERR	Flow Control:	Not Controlled
City:	Hobart, IN	Year Renewed:	
Location:	Yard	Tape/Media #:	
Purpose:	Routine Assessment	Dia/Height:	10"
Use:	Sanitary	Material:	VCP
Drain Area:	NA	Lining:	
Category:	NA		
Comment:	Flow direction is marked wrong.		
Location Details:		Direction of Survey:	Downstream
US MH:	M-506-031	DS MH:	M-506-032
		Total Length Surveyed (ft):	187.2

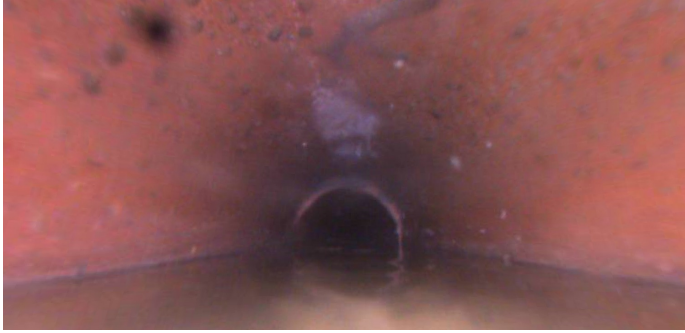
Code: **DAGS**
Description: **Deposits Attached Grease**

Distance (ft): **14.5**
Structural Grade: **0**
O&M Grade: **2**
Clock Start/From: **8**
Clock To: **4**
1st Value:
2nd Value:
Value Percent: **5.000**
Continuous Index: **F01**
Within 8" of Joint: **NO**
Remarks:

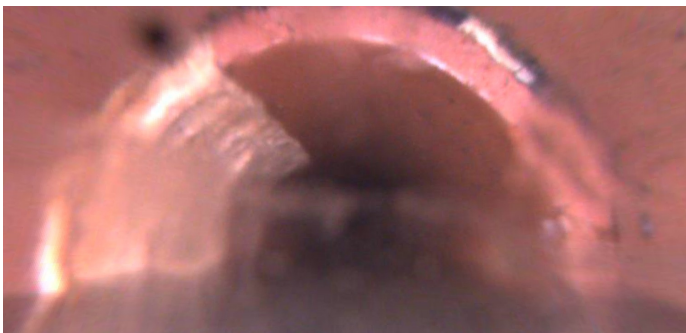
Code: **JOM**
Description: **Joint Offset Medium**

Distance (ft): **50.2**
Structural Grade: **1**
O&M Grade: **0**
Clock Start/From:
Clock To:
1st Value:
2nd Value:
Value Percent:
Continuous Index:
Within 8" of Joint: **NO**
Remarks:

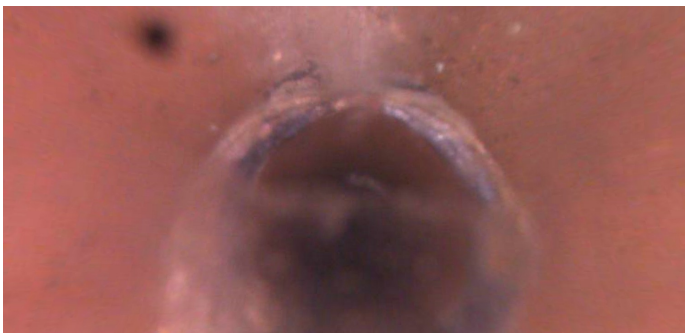
Code: **DAE**
Description: **Deposits Attached Encrustation**

Distance (ft): **69.6**
Structural Grade: **0**
O&M Grade: **2**
Clock Start/From: **8**
Clock To: **4**
1st Value:
2nd Value:
Value Percent: **10.000**
Continuous Index:
Within 8" of Joint: **YES**
Remarks:

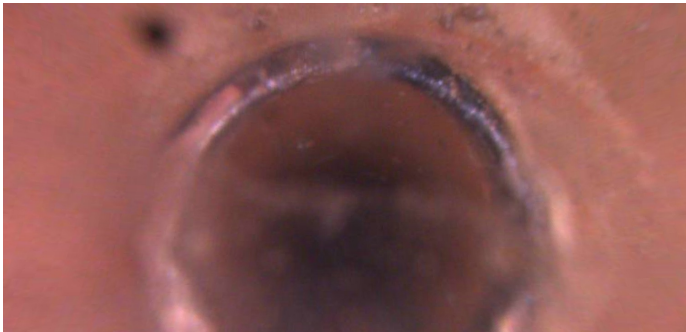
Code: **IW**
Description: **Infil Weeper**

Distance (ft): **76.0**
Structural Grade: **0**
O&M Grade: **2**
Clock Start/From: **8**
Clock To: **4**
1st Value:
2nd Value:
Value Percent:
Continuous Index:
Within 8" of Joint: **YES**
Remarks:

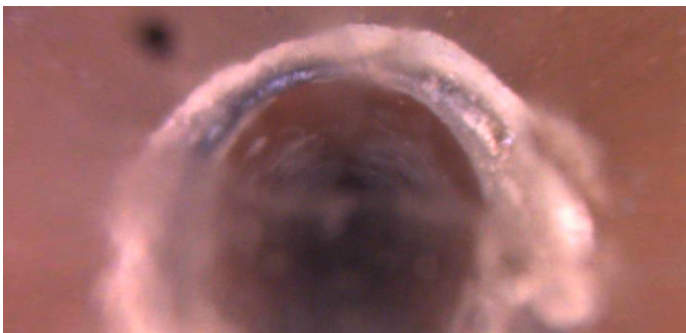
Code: **DAE**
Description: **Deposits Attached Encrustation**

Distance (ft): **95.8**
Structural Grade: **0**
O&M Grade: **2**
Clock Start/From: **8**
Clock To: **4**
1st Value:
2nd Value:
Value Percent: **10.000**
Continuous Index:
Within 8" of Joint: **YES**
Remarks:

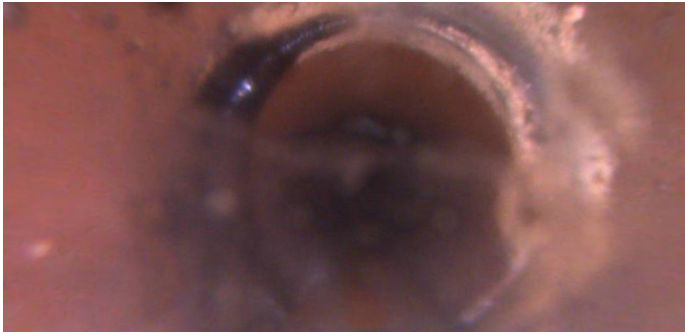
Code: **IW**
Description: **Infil Weeper**

Distance (ft): **111.7**
Structural Grade: **0**
O&M Grade: **2**
Clock Start/From: **8**
Clock To: **4**
1st Value:
2nd Value:
Value Percent:
Continuous Index:
Within 8" of Joint: **YES**
Remarks:

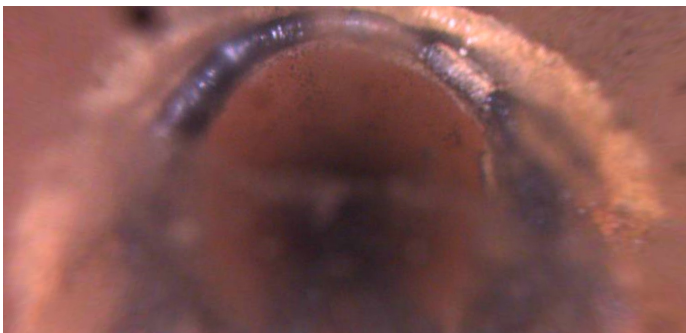
Code: **DAE**
Description: **Deposits Attached Encrustation**

Distance (ft): **117.7**
Structural Grade: **0**
O&M Grade: **2**
Clock Start/From: **8**
Clock To: **4**
1st Value:
2nd Value:
Value Percent: **5.000**
Continuous Index:
Within 8" of Joint: **YES**
Remarks:

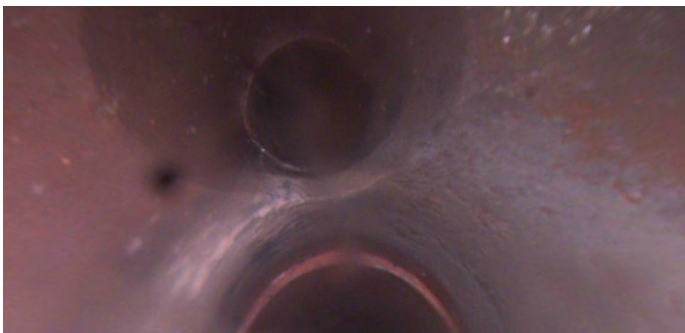
Code: **TF**
Description: **Tap Factory**

Distance (ft): **135.0**
Structural Grade: **0**
O&M Grade: **0**
Clock Start/From: **12**
Clock To:
1st Value: **4.000**
2nd Value:
Value Percent:
Continuous Index:
Within 8" of Joint:
Remarks:

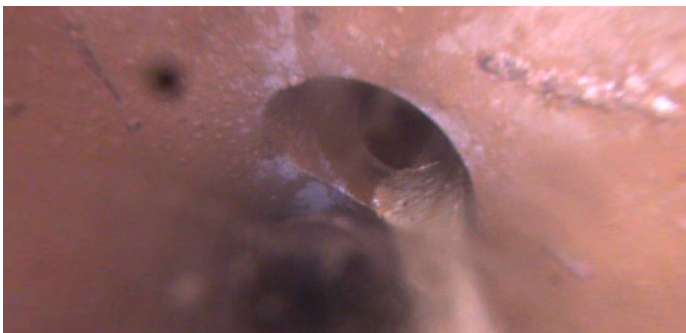
Code: **TFD**
Description: **Tap Factory Defective**

Distance (ft): **148.6**
Structural Grade: **0**
O&M Grade: **2**
Clock Start/From: **1**
Clock To:
1st Value: **4.000**
2nd Value:
Value Percent:
Continuous Index:
Within 8" of Joint:
Remarks: **dae**

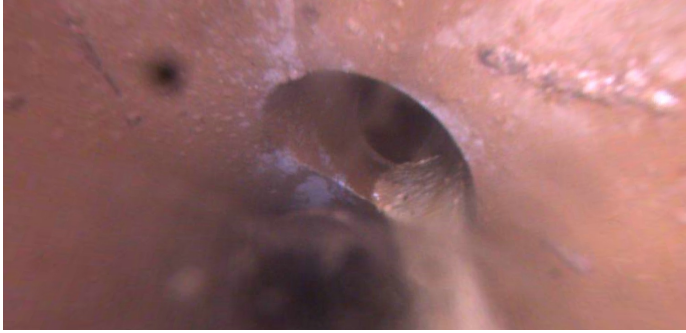
Code: **DAE**
Description: **Deposits Attached Encrustation**

Distance (ft): **148.6**
Structural Grade: **0**
O&M Grade: **2**
Clock Start/From: **1**
Clock To: **4**
1st Value:
2nd Value:
Value Percent: **5.000**
Continuous Index:
Within 8" of Joint: **NO**
Remarks:

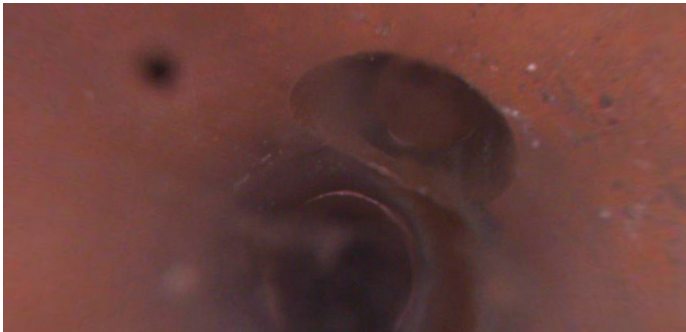
Code: **TF**
Description: **Tap Factory**

Distance (ft): **182.4**
Structural Grade: **0**
O&M Grade: **0**
Clock Start/From: **1**
Clock To:
1st Value: **4.000**
2nd Value:
Value Percent:
Continuous Index:
Within 8" of Joint:
Remarks:
