Profile/Photo Observation Report

Date:	04/06/2018	Weather:		Coding:	PACP 6.0
Pipe Length (ft):	192.4	Owner:	NA	Pre Clean:	No Pre-Cleaning
P.O.#:		Surveyor:	Jen Costello	PSR:	P-506-032-031
Customer:		Clean Date:	01/01/1900	Shape:	C

Street:	FOXCROFT STREET	Flow Control:	Not Controlled
City:	Hobart, IN	Year Renewed:	
Location:	Yard	Tape/Media #:	
Purpose:	Routine Assessment	Dia/Height:	10"
Use:	Sanitary	Material:	VCP
Drain Area:	NA	Lining:	
Category:	NA		
Comment:	Flow direction is marked wrong.		
Location Details:		Direction of Survey:	Downstream
US MH:	M-506-031	DS MH:	M-506-032
		Total Length Surveyed (ft):	187.2

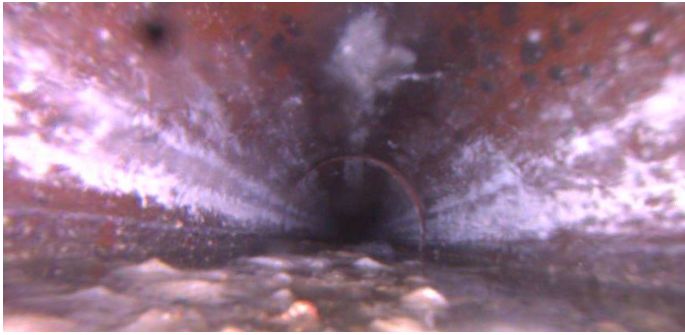
Code: **DAGS**
Description: **Deposits Attached Grease**

Distance (ft): **.0**
Structural Grade: **0**
O&M Grade: **2**
Clock Start/From: **8**
Clock To: **4**
1st Value:
2nd Value:
Value Percent: **5.000**
Continuous Index: **S01**
Within 8" of Joint: **NO**
Remarks:

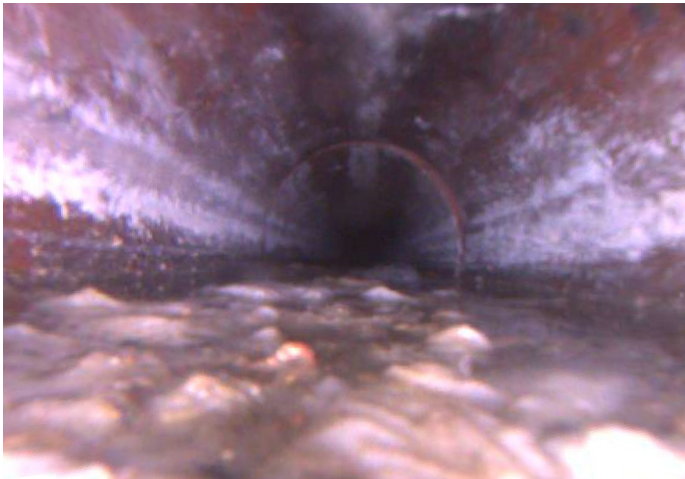
Code: **AMH**
Description: **Manhole**

Distance (ft): **.0**
Structural Grade: **0**
O&M Grade: **0**
Clock Start/From:
Clock To:
1st Value:
2nd Value:
Value Percent:
Continuous Index:
Within 8" of Joint: **NO**
Remarks: **M-506-031**

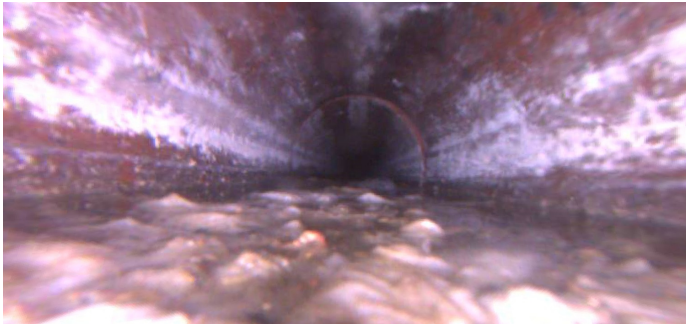
Code: **MWL**
Description: **Water Level**

Distance (ft): **.0**
Structural Grade: **0**
O&M Grade: **0**
Clock Start/From:
Clock To:
1st Value:
2nd Value:
Value Percent: **20.000**
Continuous Index:
Within 8" of Joint: **NO**
Remarks:

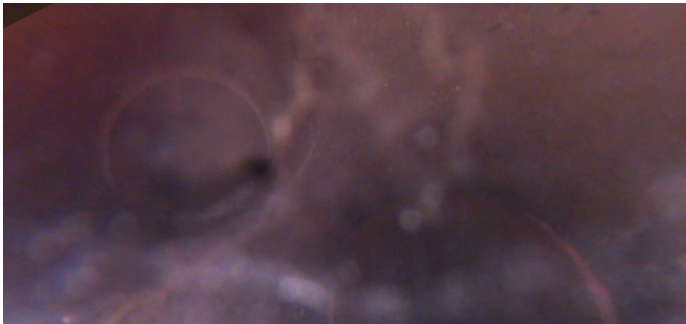
Code: **TF**
Description: **Tap Factory**

Distance (ft): **11.7**
Structural Grade: **0**
O&M Grade: **0**
Clock Start/From: **10**
Clock To:
1st Value: **4.000**
2nd Value:
Value Percent:
Continuous Index:
Within 8" of Joint:
Remarks:

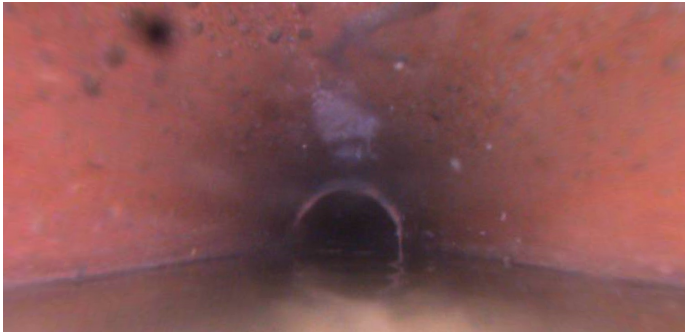
Code: **DAGS**
Description: **Deposits Attached Grease**

Distance (ft): **14.5**
Structural Grade: **0**
O&M Grade: **2**
Clock Start/From: **8**
Clock To: **4**
1st Value:
2nd Value:
Value Percent: **5.000**
Continuous Index: **F01**
Within 8" of Joint: **NO**
Remarks:

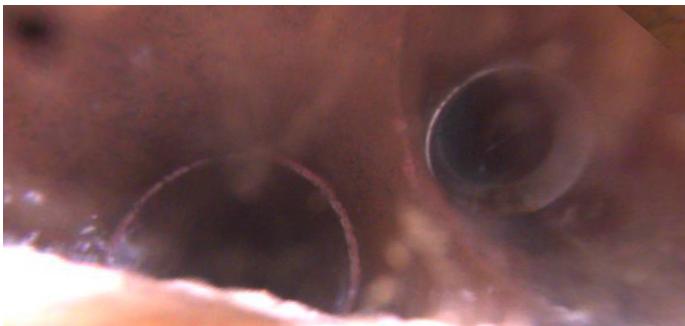
Code: **TF**
Description: **Tap Factory**

Distance (ft): **25.6**
Structural Grade: **0**
O&M Grade: **0**
Clock Start/From: **2**
Clock To:
1st Value: **4.000**
2nd Value:
Value Percent:
Continuous Index:
Within 8" of Joint:
Remarks:

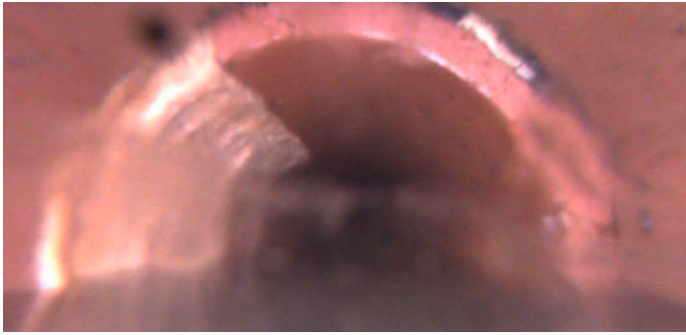
Code: **DAE**
Description: **Deposits Attached Encrustation**

Distance (ft): **50.2**
Structural Grade: **0**
O&M Grade: **2**
Clock Start/From: **8**
Clock To: **12**
1st Value:
2nd Value:
Value Percent: **5.000**
Continuous Index:
Within 8" of Joint: **YES**
Remarks:

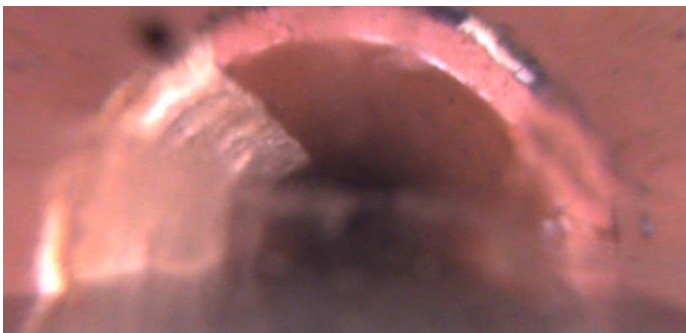
Code: **JOM**
Description: **Joint Offset Medium**

Distance (ft): **50.2**
Structural Grade: **1**
O&M Grade: **0**
Clock Start/From:
Clock To:
1st Value:
2nd Value:
Value Percent:
Continuous Index:
Within 8" of Joint: **NO**
Remarks:

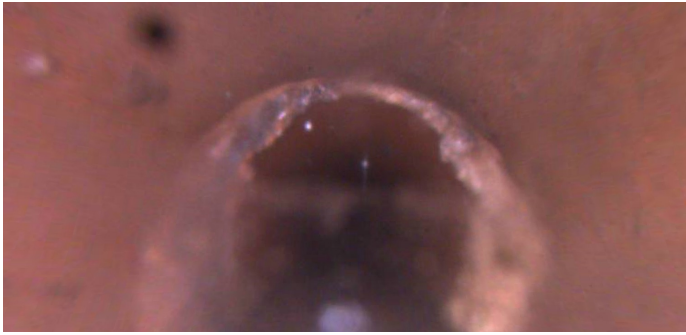
Code: **DAE**
Description: **Deposits Attached Encrustation**

Distance (ft): **61.7**
Structural Grade: **0**
O&M Grade: **2**
Clock Start/From: **8**
Clock To: **4**
1st Value:
2nd Value:
Value Percent: **10.000**
Continuous Index:
Within 8" of Joint: **YES**
Remarks:

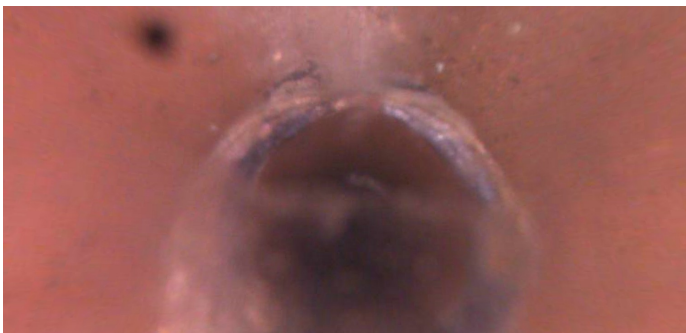
Code: **DAE**
Description: **Deposits Attached Encrustation**

Distance (ft): **69.6**
Structural Grade: **0**
O&M Grade: **2**
Clock Start/From: **8**
Clock To: **4**
1st Value:
2nd Value:
Value Percent: **10.000**
Continuous Index:
Within 8" of Joint: **YES**
Remarks:

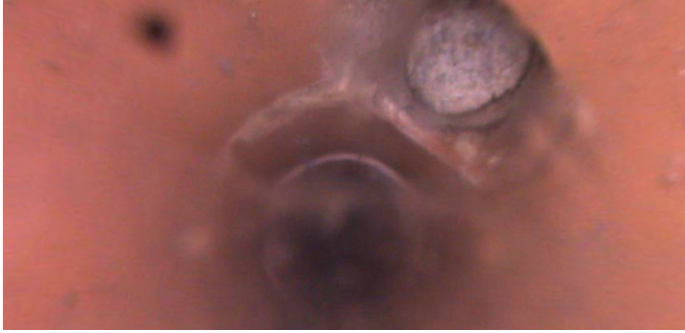
Code: **TF**
Description: **Tap Factory**

Distance (ft): **71.1**
Structural Grade: **0**
O&M Grade: **0**
Clock Start/From: **1**
Clock To:
1st Value: **4.000**
2nd Value:
Value Percent:
Continuous Index:
Within 8" of Joint:
Remarks:

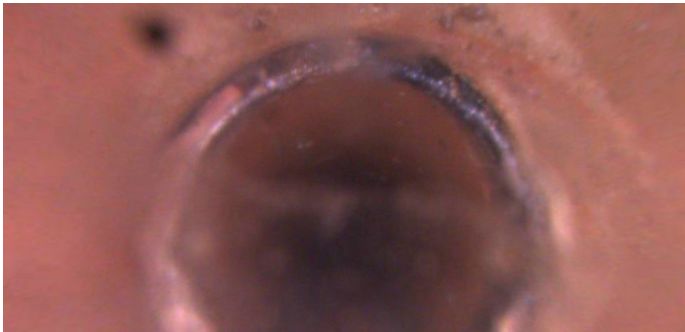
Code: **IW**
Description: **Infil Weeper**

Distance (ft): **76.0**
Structural Grade: **0**
O&M Grade: **2**
Clock Start/From: **8**
Clock To: **4**
1st Value:
2nd Value:
Value Percent:
Continuous Index:
Within 8" of Joint: **YES**
Remarks:

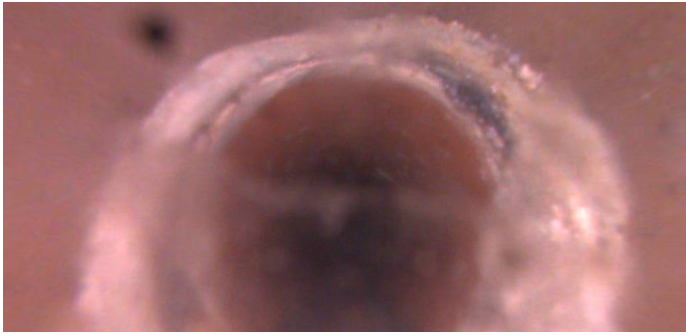
Code: **DAE**
Description: **Deposits Attached Encrustation**

Distance (ft): **87.9**
Structural Grade: **0**
O&M Grade: **2**
Clock Start/From: **8**
Clock To: **4**
1st Value:
2nd Value:
Value Percent: **5.000**
Continuous Index:
Within 8" of Joint: **YES**
Remarks:

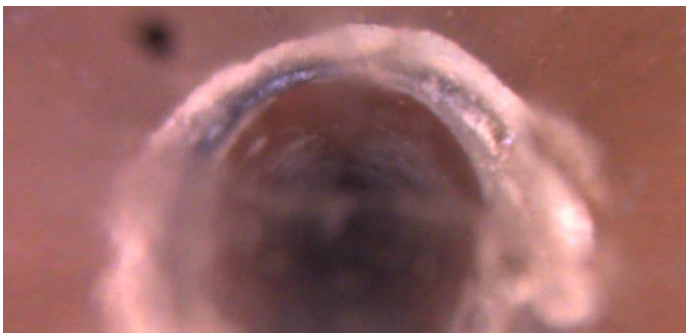
Code: **DAE**
Description: **Deposits Attached Encrustation**

Distance (ft): **95.8**
Structural Grade: **0**
O&M Grade: **2**
Clock Start/From: **8**
Clock To: **4**
1st Value:
2nd Value:
Value Percent: **10.000**
Continuous Index:
Within 8" of Joint: **YES**
Remarks:

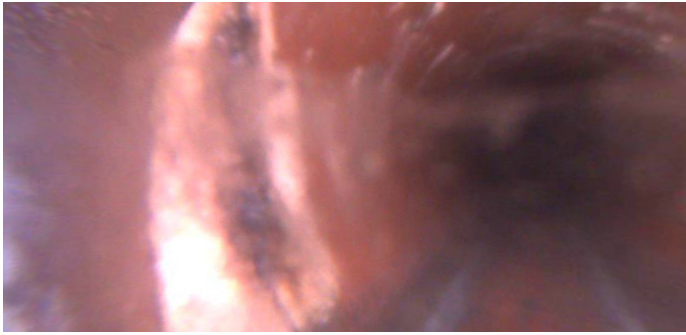
Code: **DAE**
Description: **Deposits Attached Encrustation**

Distance (ft): **100.1**
Structural Grade: **0**
O&M Grade: **2**
Clock Start/From: **8**
Clock To: **11**
1st Value:
2nd Value:
Value Percent: **5.000**
Continuous Index:
Within 8" of Joint: **YES**
Remarks:

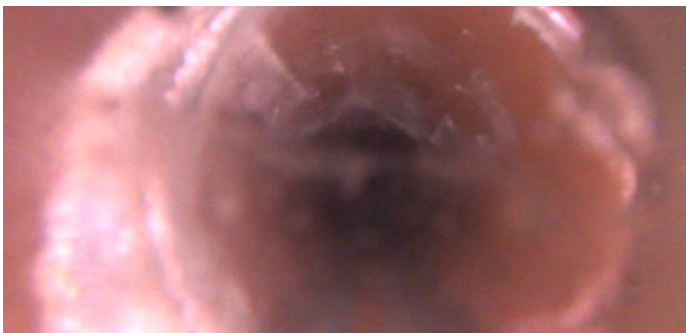
Code: **DAE**
Description: **Deposits Attached Encrustation**

Distance (ft): **103.9**
Structural Grade: **0**
O&M Grade: **2**
Clock Start/From: **7**
Clock To: **12**
1st Value:
2nd Value:
Value Percent: **5.000**
Continuous Index:
Within 8" of Joint: **YES**
Remarks:

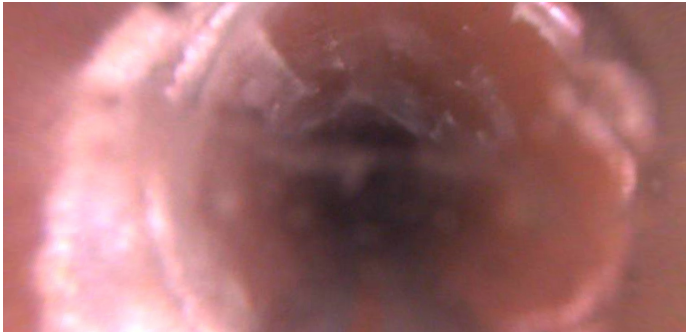
Code: **CL**
Description: **Crack Longitudinal**

Distance (ft): **103.9**
Structural Grade: **2**
O&M Grade: **0**
Clock Start/From: **11**
Clock To:
1st Value:
2nd Value:
Value Percent:
Continuous Index:
Within 8" of Joint: **YES**
Remarks:

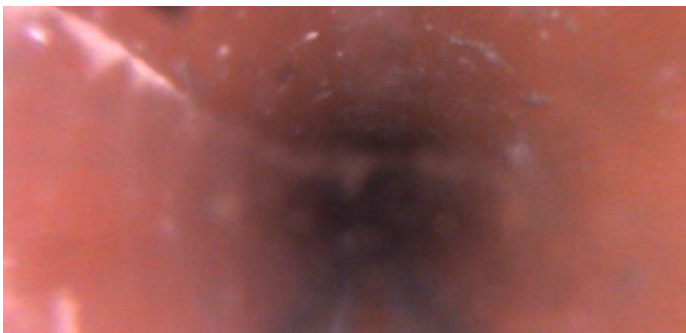
Code: **CL**
Description: **Crack Longitudinal**

Distance (ft): **108.2**
Structural Grade: **2**
O&M Grade: **0**
Clock Start/From: **10**
Clock To:
1st Value:
2nd Value:
Value Percent:
Continuous Index:
Within 8" of Joint: **YES**
Remarks:

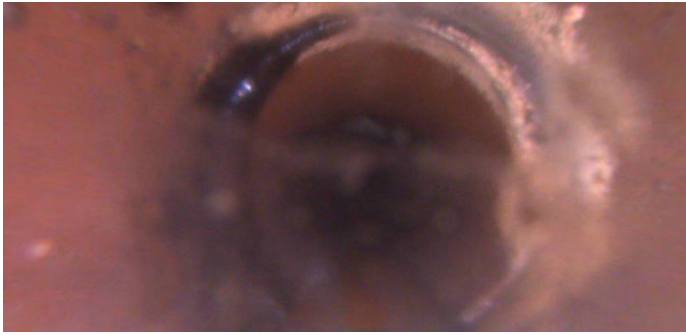
Code: **IW**
Description: **Infil Weeper**

Distance (ft): **111.7**
Structural Grade: **0**
O&M Grade: **2**
Clock Start/From: **8**
Clock To: **4**
1st Value:
2nd Value:
Value Percent:
Continuous Index:
Within 8" of Joint: **YES**
Remarks:

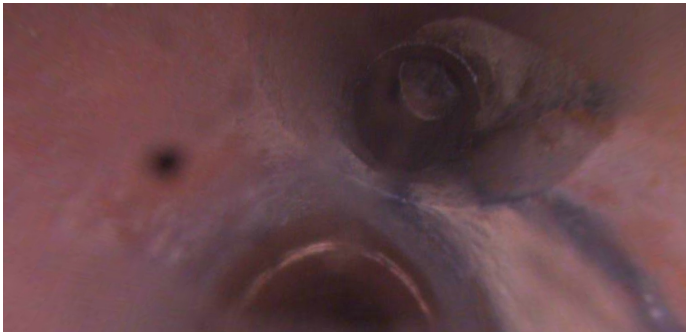
Code: **TF**
Description: **Tap Factory**

Distance (ft): **113.1**
Structural Grade: **0**
O&M Grade: **0**
Clock Start/From: **1**
Clock To:
1st Value: **4.000**
2nd Value:
Value Percent:
Continuous Index:
Within 8" of Joint:
Remarks:

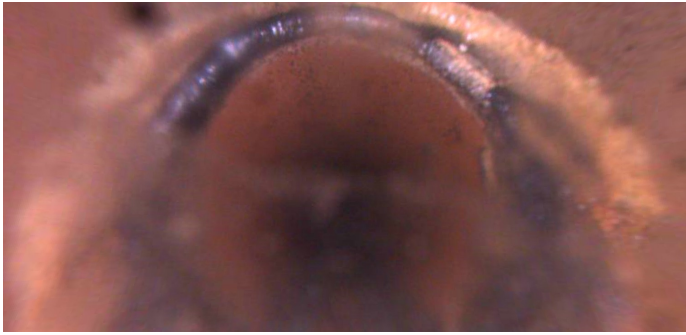
Code: **IW**
Description: **Infil Weeper**

Distance (ft): **117.7**
Structural Grade: **0**
O&M Grade: **2**
Clock Start/From: **8**
Clock To: **4**
1st Value:
2nd Value:
Value Percent:
Continuous Index:
Within 8" of Joint: **YES**
Remarks:

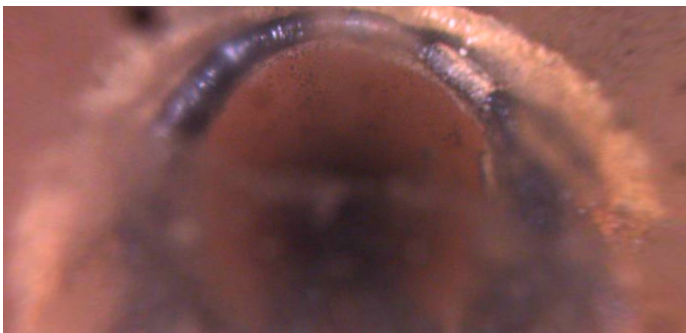
Code: **DAE**
Description: **Deposits Attached Encrustation**

Distance (ft): **117.7**
Structural Grade: **0**
O&M Grade: **2**
Clock Start/From: **8**
Clock To: **4**
1st Value:
2nd Value:
Value Percent: **5.000**
Continuous Index:
Within 8" of Joint: **YES**
Remarks:

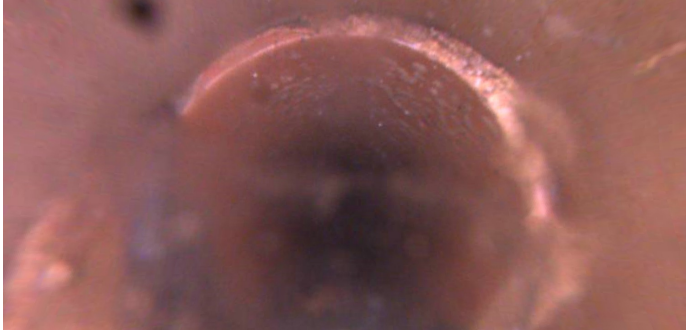
Code: **IW**
Description: **Infil Weeper**

Distance (ft): **129.7**
Structural Grade: **0**
O&M Grade: **2**
Clock Start/From: **8**
Clock To: **4**
1st Value:
2nd Value:
Value Percent:
Continuous Index:
Within 8" of Joint: **YES**
Remarks:

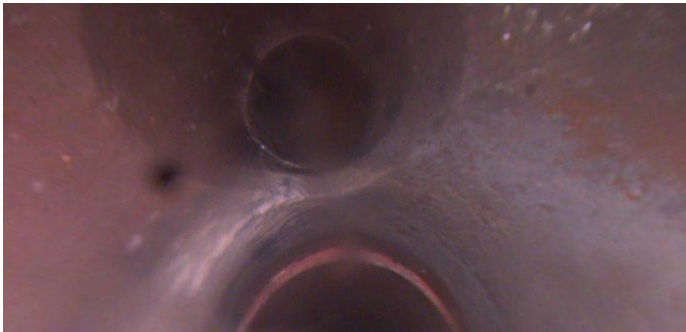
Code: **TF**
Description: **Tap Factory**

Distance (ft): **135.0**
Structural Grade: **0**
O&M Grade: **0**
Clock Start/From: **12**
Clock To:
1st Value: **4.000**
2nd Value:
Value Percent:
Continuous Index:
Within 8" of Joint:
Remarks:

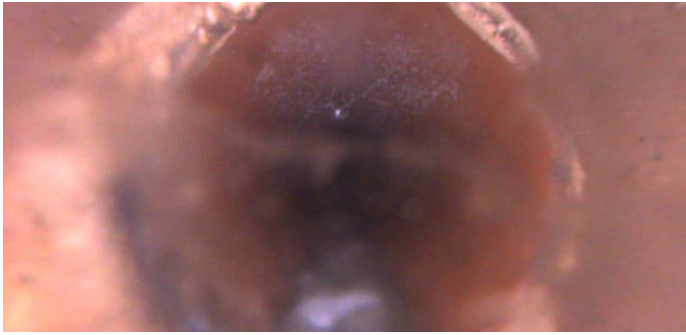
Code: **DAE**
Description: **Deposits Attached Encrustation**

Distance (ft): **139.7**
Structural Grade: **0**
O&M Grade: **2**
Clock Start/From: **8**
Clock To: **4**
1st Value:
2nd Value:
Value Percent: **5.000**
Continuous Index: **S02**
Within 8" of Joint: **YES**
Remarks:

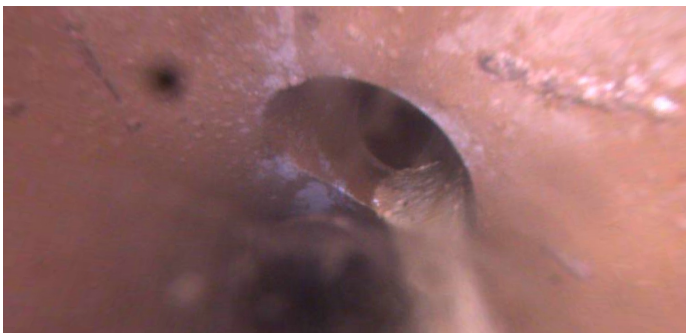
Code: **TFD**
Description: **Tap Factory Defective**

Distance (ft): **148.6**
Structural Grade: **0**
O&M Grade: **2**
Clock Start/From: **1**
Clock To:
1st Value: **4.000**
2nd Value:
Value Percent:
Continuous Index:
Within 8" of Joint:
Remarks: **dae**

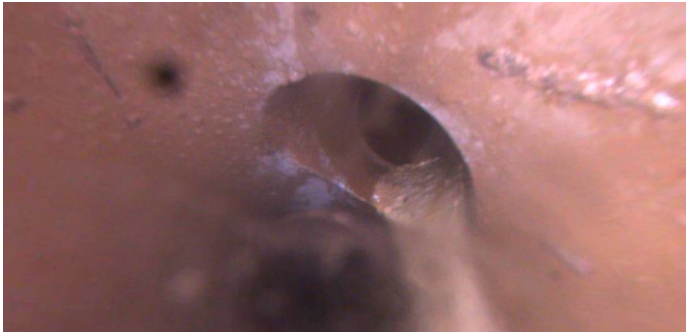
Code: **DAE**
Description: **Deposits Attached Encrustation**

Distance (ft): **148.6**
Structural Grade: **0**
O&M Grade: **2**
Clock Start/From: **1**
Clock To: **4**
1st Value:
2nd Value:
Value Percent: **5.000**
Continuous Index:
Within 8" of Joint: **NO**
Remarks:

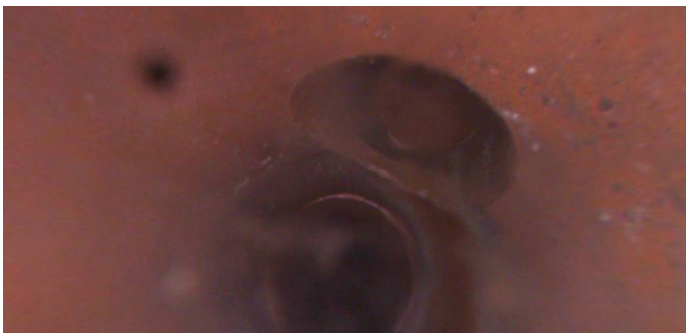
Code: **TF**
Description: **Tap Factory**

Distance (ft): **182.4**
Structural Grade: **0**
O&M Grade: **0**
Clock Start/From: **1**
Clock To:
1st Value: **4.000**
2nd Value:
Value Percent:
Continuous Index:
Within 8" of Joint:
Remarks:

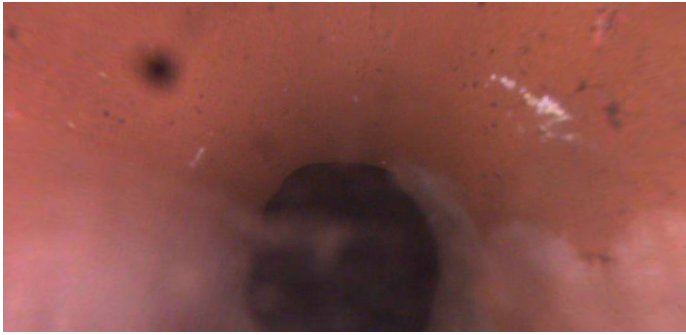
Code: **DAE**
Description: **Deposits Attached Encrustation**

Distance (ft): **185.2**
Structural Grade: **0**
O&M Grade: **2**
Clock Start/From: **8**
Clock To: **4**
1st Value:
2nd Value:
Value Percent: **5.000**
Continuous Index: **F02**
Within 8" of Joint: **YES**
Remarks:
