## Profile/Photo Observation Report

Street:	<b>S WISCONSIN ST</b>	Flow Control:	<b>Not Controlled</b>
City:	<b>Hobart, IN</b>	Year Renewed:	
Location:	<b>Yard</b>	Tape/Media #:	
Purpose:	<b>Routine Assessment</b>	Dia/Height:	<b>8"</b>
Use:	<b>Sanitary</b>	Material:	<b>PVC</b>
Drain Area:	<b>NA</b>	Lining:	
Category:	<b>NA</b>		
Comment:

Location Details:		Direction of Survey:	<b>Upstream</b>
US MH:	<b>M-506-034</b>	DS MH:	<b>M-506-035</b>
		Total Length Surveyed (ft):	<b>392.6</b>

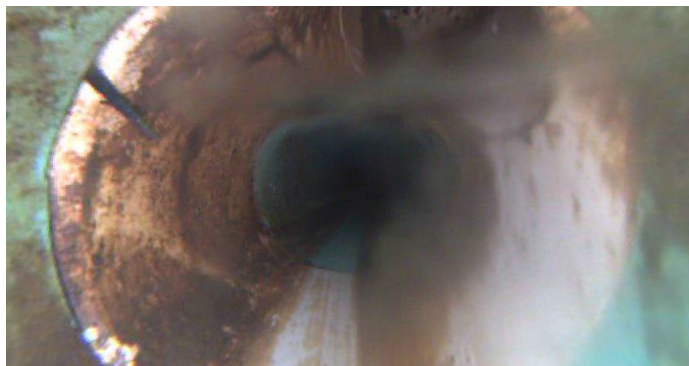
Code: **AMH**  
 Description: **Manhole**

Distance (ft): **.0**  
 Structural Grade: **0**  
 O&M Grade: **0**  
 Clock Start/From:  
 Clock To:  
 1st Value:  
 2nd Value:  
 Value Percent:  
 Continuous Index:  
 Within 8" of Joint: **NO**  
 Remarks: **M-506-035**

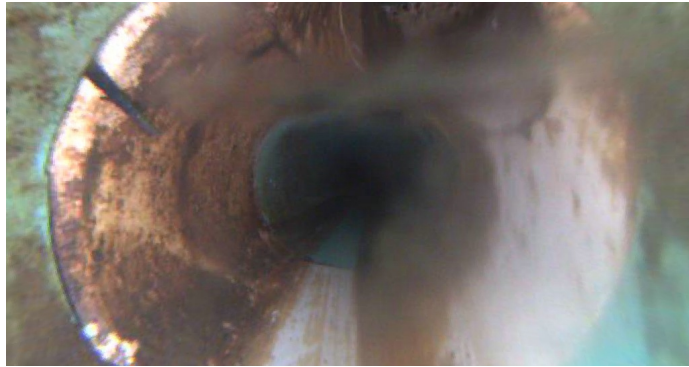
Code: **MWL**  
Description: **Water Level**

Distance (ft): **.0**  
Structural Grade: **0**  
O&M Grade: **0**  
Clock Start/From:  
Clock To:  
1st Value:  
2nd Value:  
Value Percent: **10.000**  
Continuous Index:  
Within 8" of Joint: **NO**  
Remarks:

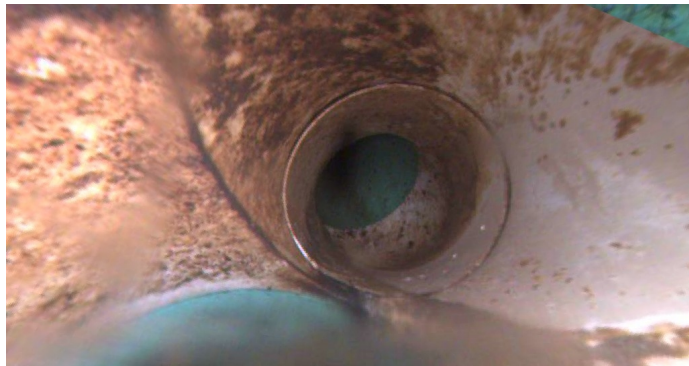
Code: **TF**  
Description: **Tap Factory**

Distance (ft): **.5**  
Structural Grade: **0**  
O&M Grade: **0**  
Clock Start/From: **1**  
Clock To:  
1st Value: **4.000**  
2nd Value:  
Value Percent:  
Continuous Index:  
Within 8" of Joint:  
Remarks:

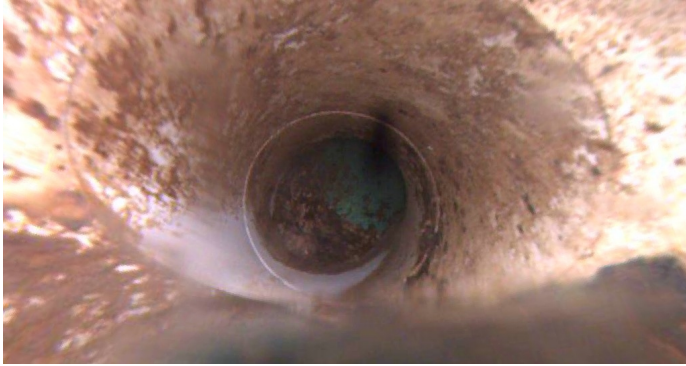
Code: **TF**  
Description: **Tap Factory**

Distance (ft): **15.8**  
Structural Grade: **0**  
O&M Grade: **0**  
Clock Start/From: **12**  
Clock To:  
1st Value: **4.000**  
2nd Value:  
Value Percent:  
Continuous Index:  
Within 8" of Joint:  
Remarks:

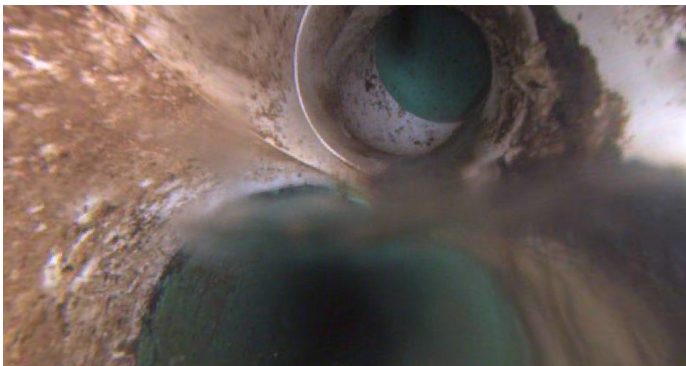
Code: **TF**  
Description: **Tap Factory**

Distance (ft): **134.2**  
Structural Grade: **0**  
O&M Grade: **0**  
Clock Start/From: **1**  
Clock To:  
1st Value: **4.000**  
2nd Value:  
Value Percent:  
Continuous Index:  
Within 8" of Joint:  
Remarks:

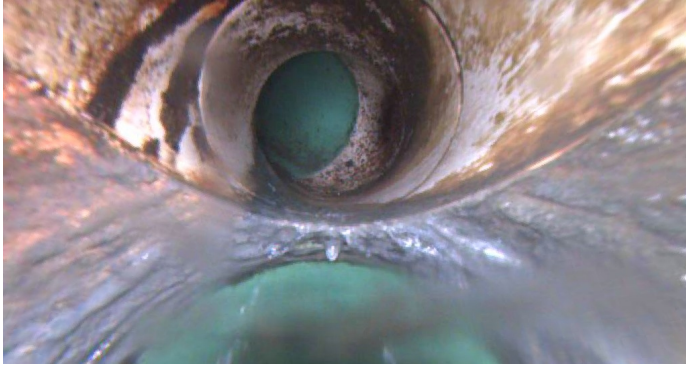
Code: **TFA**  
Description: **Tap Factory Active**

Distance (ft): **143.0**  
Structural Grade: **0**  
O&M Grade: **0**  
Clock Start/From: **12**  
Clock To:  
1st Value: **4.000**  
2nd Value:  
Value Percent:  
Continuous Index:  
Within 8" of Joint:  
Remarks:

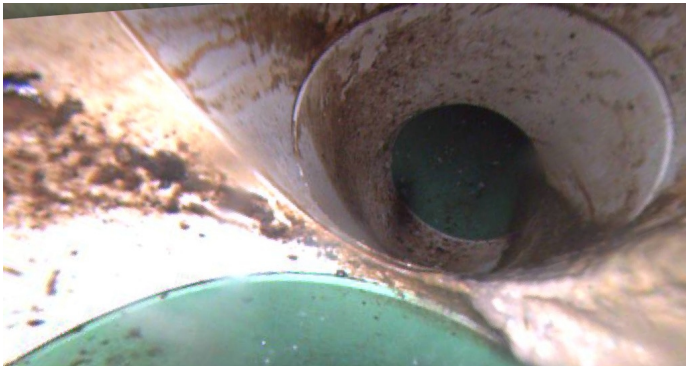
Code: **TF**  
Description: **Tap Factory**

Distance (ft): **311.3**  
Structural Grade: **0**  
O&M Grade: **0**  
Clock Start/From: **2**  
Clock To:  
1st Value: **4.000**  
2nd Value:  
Value Percent:  
Continuous Index:  
Within 8" of Joint:  
Remarks:

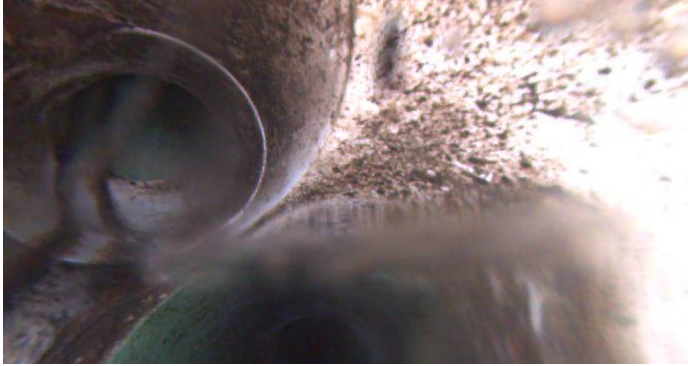
Code: **TF**  
Description: **Tap Factory**

Distance (ft): **346.9**  
Structural Grade: **0**  
O&M Grade: **0**  
Clock Start/From: **10**  
Clock To:  
1st Value: **4.000**  
2nd Value:  
Value Percent:  
Continuous Index:  
Within 8" of Joint:  
Remarks:

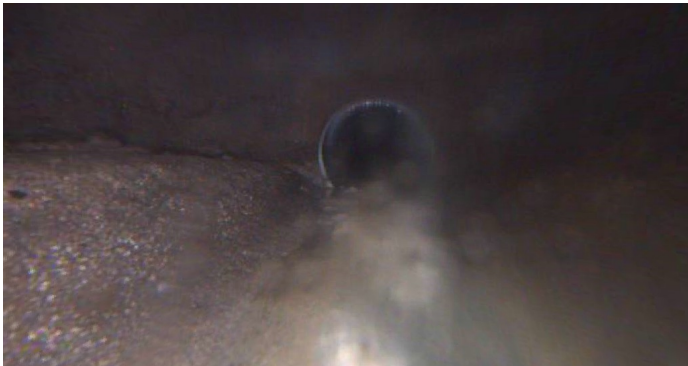
Code: **AMH**  
Description: **Manhole**

Distance (ft): **392.6**  
Structural Grade: **0**  
O&M Grade: **0**  
Clock Start/From:  
Clock To:  
1st Value:  
2nd Value:  
Value Percent:  
Continuous Index:  
Within 8" of Joint: **NO**  
Remarks: **M-506-034**
