## Profile/Photo Observation Report

Street:	<b>FOXCROFT STREET</b>	Flow Control:	<b>Not Controlled</b>
City:	<b>Hobart, IN</b>	Year Renewed:	
Location:	<b>Yard</b>	Tape/Media #:	
Purpose:	<b>Routine Assessment</b>	Dia/Height:	<b>8"</b>
Use:	<b>Sanitary</b>	Material:	<b>PVC</b>
Drain Area:	<b>NA</b>	Lining:	
Category:	<b>NA</b>		
Comment:

Location Details:		Direction of Survey:	<b>Upstream</b>
US MH:	<b>M-506-034</b>	DS MH:	<b>M-506-035</b>
		Total Length Surveyed (ft):	<b>392.6</b>

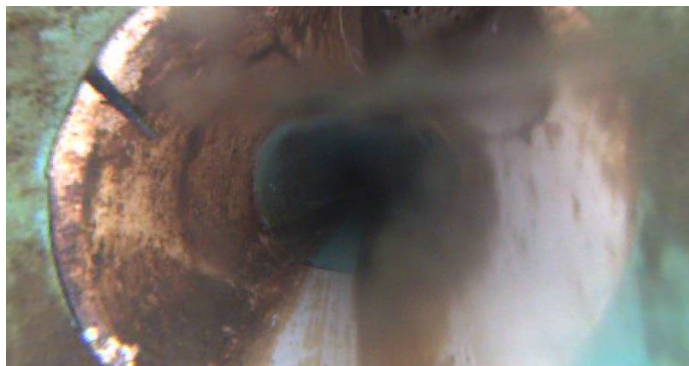
Code: **AMH**  
 Description: **Manhole**

Distance (ft): **.0**  
 Structural Grade: **0**  
 O&M Grade: **0**  
 Clock Start/From:  
 Clock To:  
 1st Value:  
 2nd Value:  
 Value Percent:  
 Continuous Index:  
 Within 8" of Joint: **NO**  
 Remarks: **M-506-035**

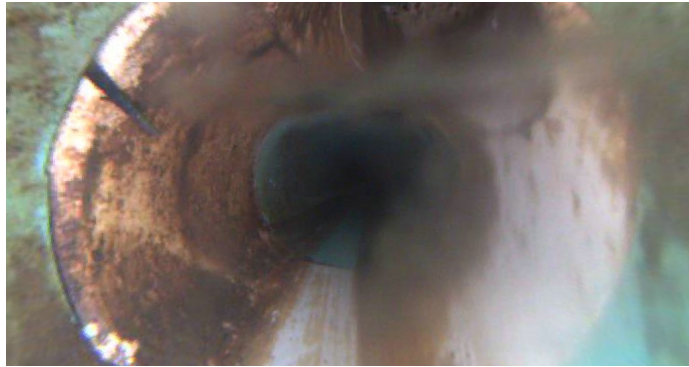
Code: **MWL**  
Description: **Water Level**

Distance (ft): **.0**  
Structural Grade: **0**  
O&M Grade: **0**  
Clock Start/From:  
Clock To:  
1st Value:  
2nd Value:  
Value Percent: **10.000**  
Continuous Index:  
Within 8" of Joint: **NO**  
Remarks:

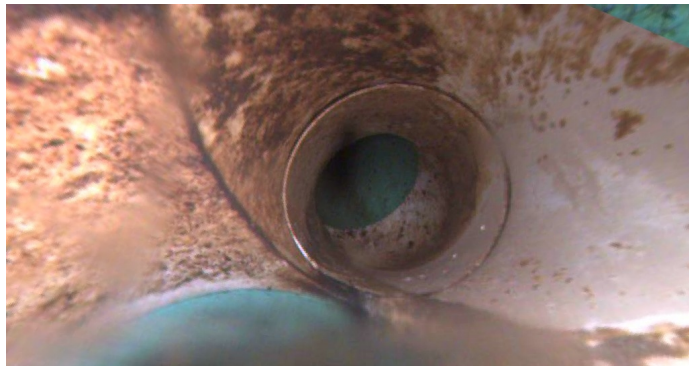
Code: **TF**  
Description: **Tap Factory**

Distance (ft): **.5**  
Structural Grade: **0**  
O&M Grade: **0**  
Clock Start/From: **1**  
Clock To:  
1st Value: **4.000**  
2nd Value:  
Value Percent:  
Continuous Index:  
Within 8" of Joint:  
Remarks:

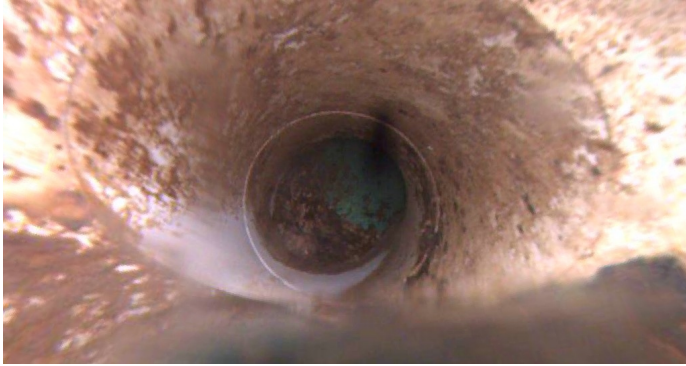
Code: **TF**  
Description: **Tap Factory**

Distance (ft): **15.8**  
Structural Grade: **0**  
O&M Grade: **0**  
Clock Start/From: **12**  
Clock To:  
1st Value: **4.000**  
2nd Value:  
Value Percent:  
Continuous Index:  
Within 8" of Joint:  
Remarks:

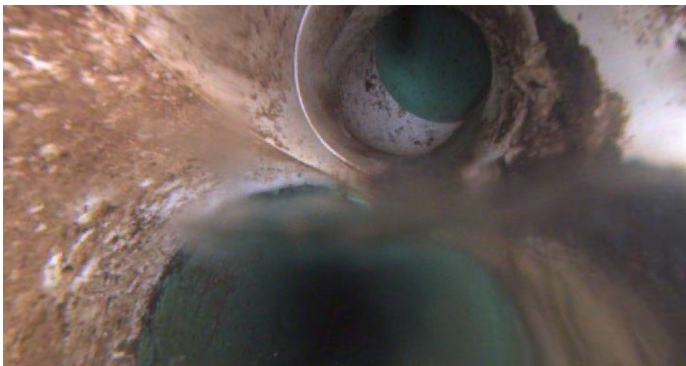
Code: **TF**  
Description: **Tap Factory**

Distance (ft): **134.2**  
Structural Grade: **0**  
O&M Grade: **0**  
Clock Start/From: **1**  
Clock To:  
1st Value: **4.000**  
2nd Value:  
Value Percent:  
Continuous Index:  
Within 8" of Joint:  
Remarks:

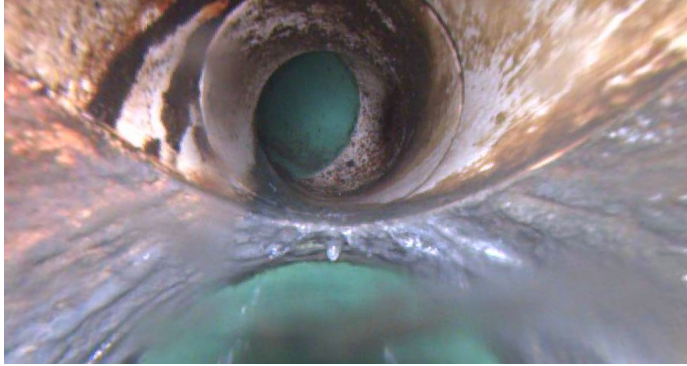
Code: **TFA**  
Description: **Tap Factory Active**

Distance (ft): **143.0**  
Structural Grade: **0**  
O&M Grade: **0**  
Clock Start/From: **12**  
Clock To:  
1st Value: **4.000**  
2nd Value:  
Value Percent:  
Continuous Index:  
Within 8" of Joint:  
Remarks:

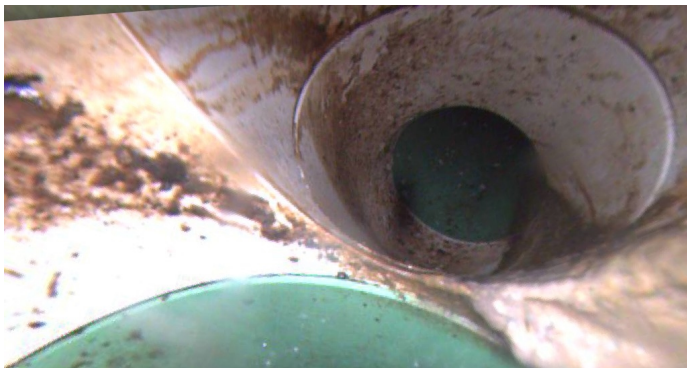
Code: **TF**  
Description: **Tap Factory**

Distance (ft): **311.3**  
Structural Grade: **0**  
O&M Grade: **0**  
Clock Start/From: **2**  
Clock To:  
1st Value: **4.000**  
2nd Value:  
Value Percent:  
Continuous Index:  
Within 8" of Joint:  
Remarks:

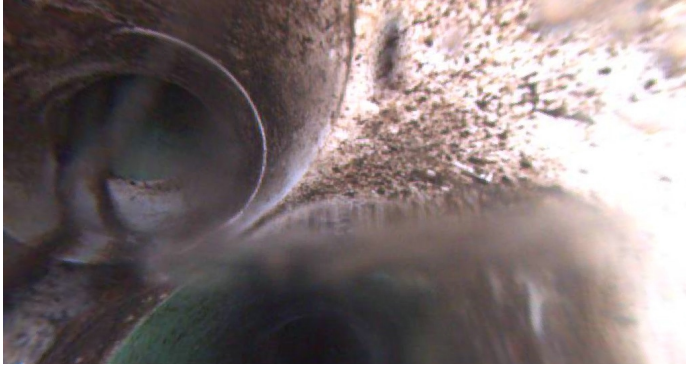
Code: **TF**  
Description: **Tap Factory**

Distance (ft): **346.9**  
Structural Grade: **0**  
O&M Grade: **0**  
Clock Start/From: **10**  
Clock To:  
1st Value: **4.000**  
2nd Value:  
Value Percent:  
Continuous Index:  
Within 8" of Joint:  
Remarks:

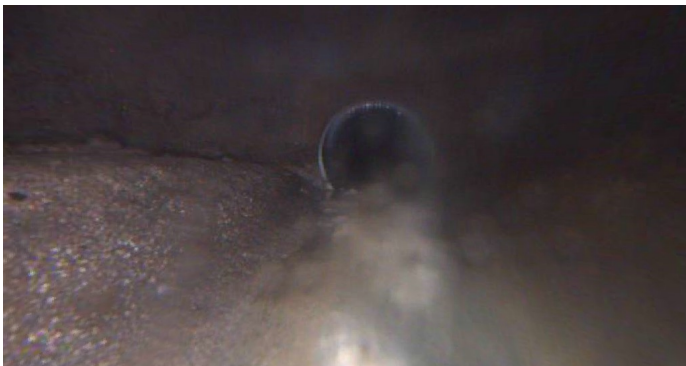
Code: **AMH**  
Description: **Manhole**

Distance (ft): **392.6**  
Structural Grade: **0**  
O&M Grade: **0**  
Clock Start/From:  
Clock To:  
1st Value:  
2nd Value:  
Value Percent:  
Continuous Index:  
Within 8" of Joint: **NO**  
Remarks: **M-506-034**
