Profile/Photo Observation Report

Date:	04/10/2018	Weather:		Coding:	PACP 6.0
Pipe Length (ft):	416.9	Owner:	NA	Pre Clean:	No Pre-Cleaning
P.O.#:		Surveyor:	Jen Costello	PSR:	P-506-035-001
Customer:		Clean Date:	01/01/1900	Shape:	C

Street:	S WISCONSIN ST	Flow Control:	Not Controlled
City:	Hobart, IN	Year Renewed:	
Location:	Yard	Tape/Media #:	
Purpose:	Routine Assessment	Dia/Height:	8"
Use:	Sanitary	Material:	PVC
Drain Area:	NA	Lining:	
Category:	NA		
Comment:

Location Details:		Direction of Survey:	Downstream
US MH:	M-506-035	DS MH:	M-506-001
		Total Length Surveyed (ft):	180.9

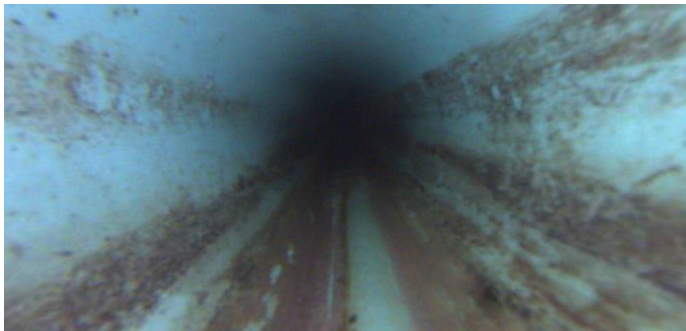
Code:	MWL
Description:	Water Level

Distance (ft):	.0
Structural Grade:	0
O&M Grade:	0
Clock Start/From:	
Clock To:	
1st Value:	
2nd Value:	
Value Percent:	5.000
Continuous Index:	
Within 8" of Joint:	NO
Remarks:

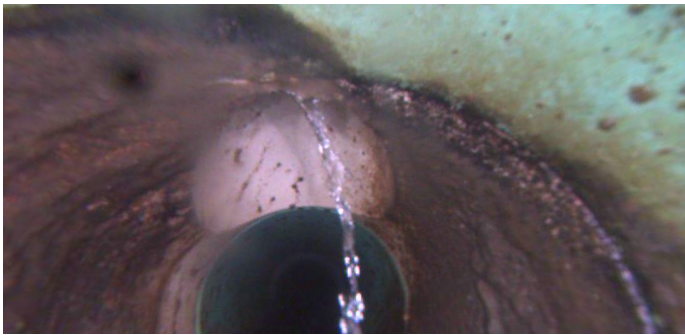
Code:	TFA
Description:	Tap Factory Active

Distance (ft):	75.7
Structural Grade:	0
O&M Grade:	0
Clock Start/From:	12
Clock To:	
1st Value:	4.000
2nd Value:	
Value Percent:	
Continuous Index:	
Within 8" of Joint:	
Remarks:

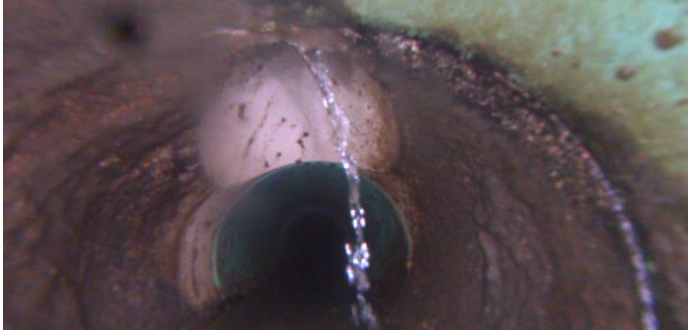
Code:	DAGS
Description:	Deposits Attached Grease
Distance (ft):	75.7
Structural Grade:	0
O&M Grade:	2
Clock Start/From:	8
Clock To:	4
1st Value:	
2nd Value:	
Value Percent:	5.000
Continuous Index:	
Within 8" of Joint:	NO
Remarks:

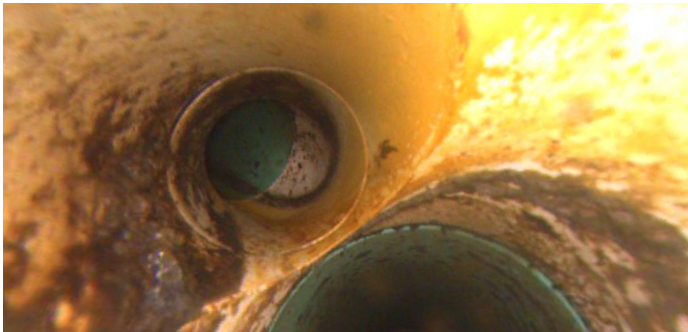
Code:	TF
Description:	Tap Factory
Distance (ft):	112.3
Structural Grade:	0
O&M Grade:	0
Clock Start/From:	1
Clock To:	
1st Value:	4.000
2nd Value:	
Value Percent:	
Continuous Index:	
Within 8" of Joint:	
Remarks:

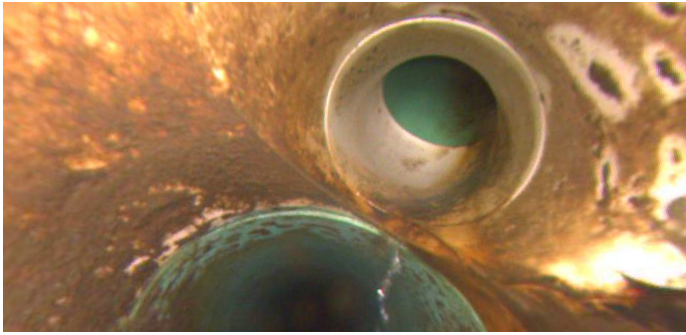
Code: **TFA**
Description: **Tap Factory Active**

Distance (ft): **122.9**
Structural Grade: **0**
O&M Grade: **0**
Clock Start/From: **11**
Clock To:
1st Value: **4.000**
2nd Value:
Value Percent:
Continuous Index:
Within 8" of Joint:
Remarks:

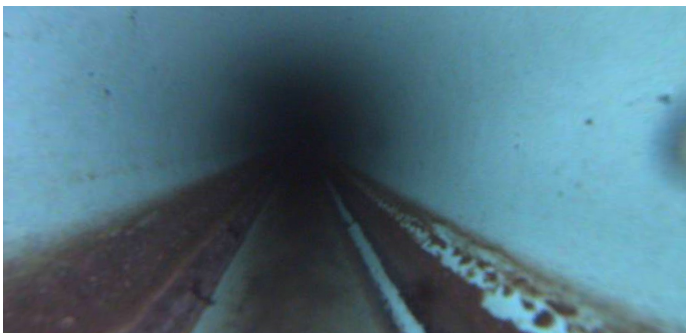
Code: **MSA**
Description: **Abandoned Survey**

Distance (ft): **180.9**
Structural Grade: **0**
O&M Grade: **0**
Clock Start/From:
Clock To:
1st Value:
2nd Value:
Value Percent:
Continuous Index:
Within 8" of Joint: **NO**
Remarks: **unknown**
