Profile/Photo Observation Report

Street:	FOXCROFT STREET	Flow Control:	Not Controlled
City:	Hobart, IN	Year Renewed:	
Location:	Yard	Tape/Media #:	
Purpose:	Routine Assessment	Dia/Height:	8"
Use:	Sanitary	Material:	PVC
Drain Area:	NA	Lining:	
Category:	NA		
Comment:			
Location Details:		Direction of Survey:	Downstream
US MH:	M-506-035	DS MH:	M-506-001
		Total Length Surveyed (ft):	180.9

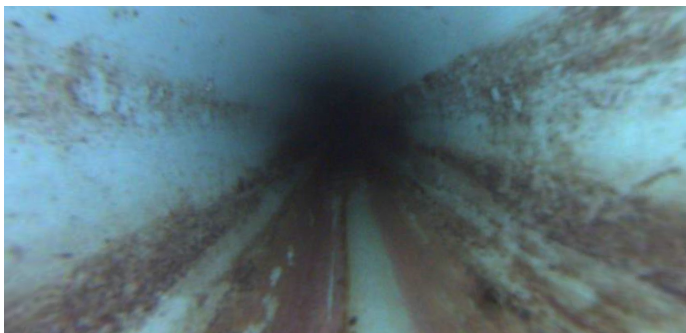
Code: **AMH**
Description: **Manhole**

Distance (ft): **.0**
Structural Grade: **0**
O&M Grade: **0**
Clock Start/From:
Clock To:
1st Value:
2nd Value:
Value Percent:
Continuous Index:
Within 8" of Joint: **NO**
Remarks: **M-506-035**

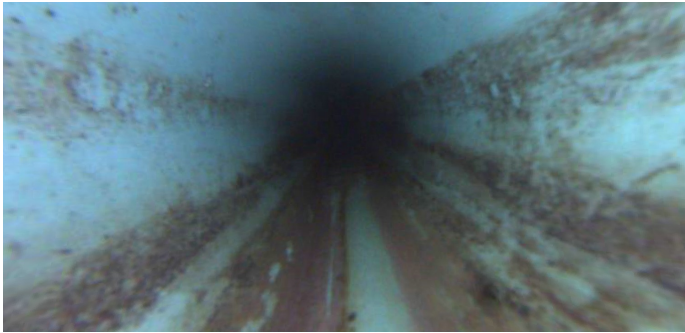
Code:	MWL
Description:	Water Level

Distance (ft):	.0
Structural Grade:	0
O&M Grade:	0
Clock Start/From:	
Clock To:	
1st Value:	
2nd Value:	
Value Percent:	5.000
Continuous Index:	
Within 8" of Joint:	NO
Remarks:

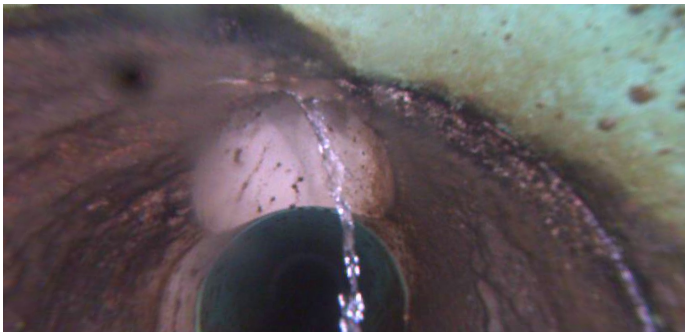
Code:	TFA
Description:	Tap Factory Active

Distance (ft):	75.7
Structural Grade:	0
O&M Grade:	0
Clock Start/From:	12
Clock To:	
1st Value:	4.000
2nd Value:	
Value Percent:	
Continuous Index:	
Within 8" of Joint:	
Remarks:

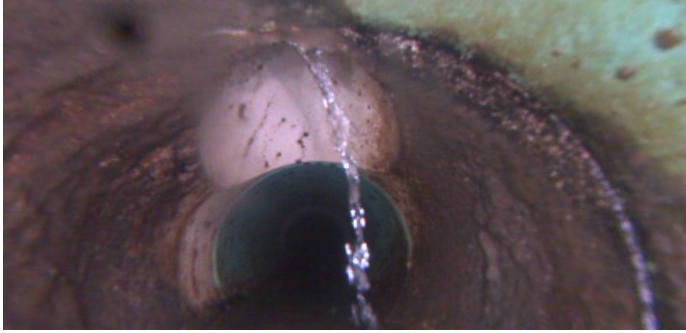
Code: **DAGS**
Description: **Deposits Attached Grease**

Distance (ft): **75.7**
Structural Grade: **0**
O&M Grade: **2**
Clock Start/From: **8**
Clock To: **4**
1st Value:
2nd Value:
Value Percent: **5.000**
Continuous Index:
Within 8" of Joint: **NO**
Remarks:

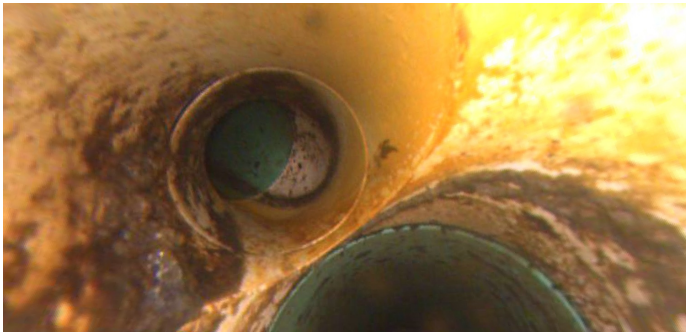
Code: **TF**
Description: **Tap Factory**

Distance (ft): **112.3**
Structural Grade: **0**
O&M Grade: **0**
Clock Start/From: **1**
Clock To:
1st Value: **4.000**
2nd Value:
Value Percent:
Continuous Index:
Within 8" of Joint:
Remarks:

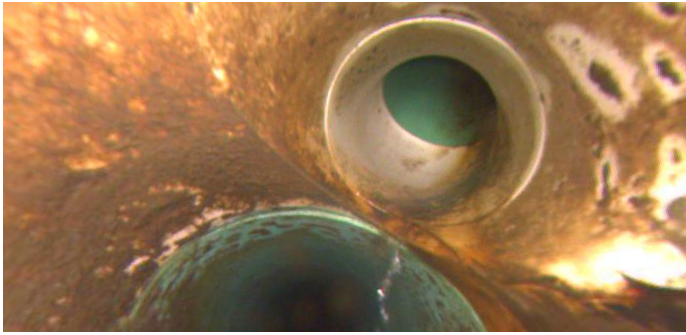
Code: **TFA**
Description: **Tap Factory Active**

Distance (ft): **122.9**
Structural Grade: **0**
O&M Grade: **0**
Clock Start/From: **11**
Clock To:
1st Value: **4.000**
2nd Value:
Value Percent:
Continuous Index:
Within 8" of Joint:
Remarks:

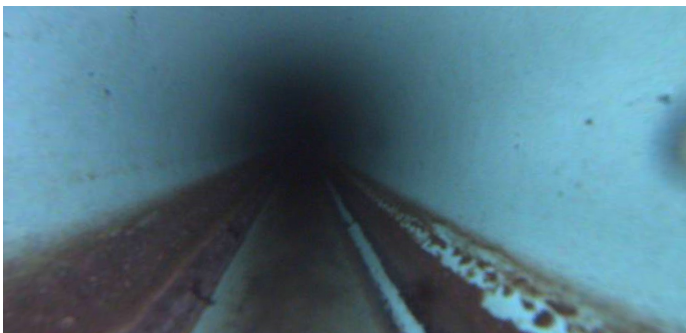
Code: **MSA**
Description: **Abandoned Survey**

Distance (ft): **180.9**
Structural Grade: **0**
O&M Grade: **0**
Clock Start/From:
Clock To:
1st Value:
2nd Value:
Value Percent:
Continuous Index:
Within 8" of Joint: **NO**
Remarks: **unknown**
