Profile/Photo Observation Report

Date:	04/12/2018	Weather:		Coding:	PACP 6.0
Pipe Length (ft):	279.8	Owner:	NA	Pre Clean:	No Pre-Cleaning
P.O.#:		Surveyor:	Jen Costello	PSR:	P-506-036-037
Customer:		Clean Date:	01/01/1900	Shape:	C

Street:	FOXCROFT STREET	Flow Control:	Not Controlled
City:	Hobart, IN	Year Renewed:	
Location:	Yard	Tape/Media #:	
Purpose:	Routine Assessment	Dia/Height:	8"
Use:	Sanitary	Material:	PVC
Drain Area:	NA	Lining:	
Category:	NA		
Comment:	Flow direction is marked wrong.		
Location Details:		Direction of Survey:	Downstream
US MH:	M-506-037	DS MH:	M-506-036
		Total Length Surveyed (ft):	275.4

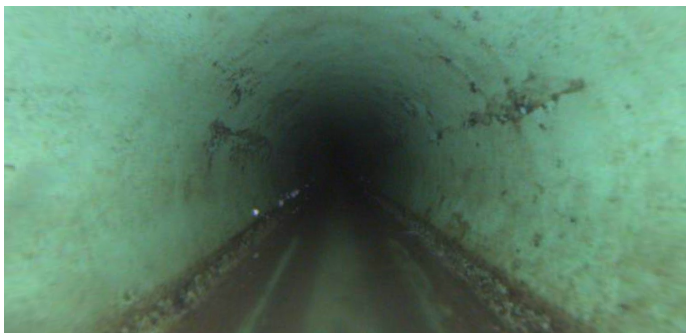
Code: **AMH**
Description: **Manhole**

Distance (ft): **.0**
Structural Grade: **0**
O&M Grade: **0**
Clock Start/From:
Clock To:
1st Value:
2nd Value:
Value Percent:
Continuous Index:
Within 8" of Joint: **NO**
Remarks: **M-506-037**

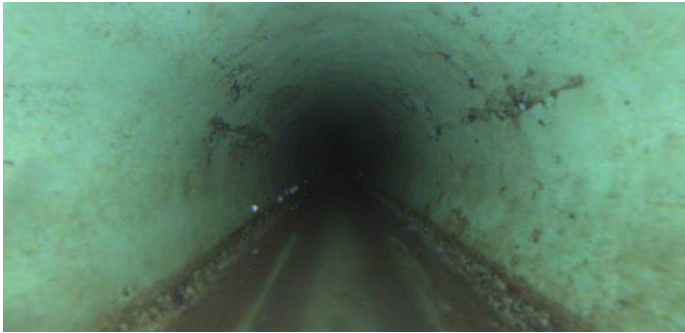
Code:	MWL
Description:	Water Level

Distance (ft):	.0
Structural Grade:	0
O&M Grade:	0
Clock Start/From:	
Clock To:	
1st Value:	
2nd Value:	
Value Percent:	5.000
Continuous Index:	
Within 8" of Joint:	NO
Remarks:

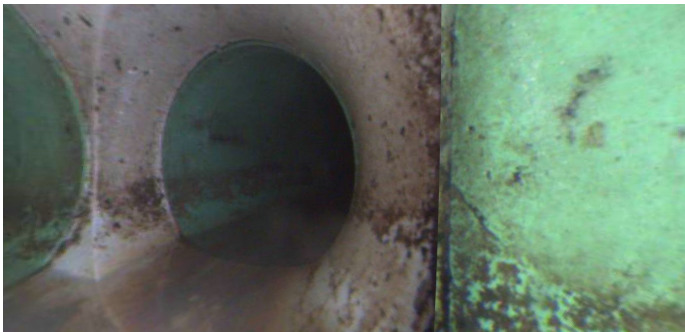
Code:	TFA
Description:	Tap Factory Active

Distance (ft):	72.9
Structural Grade:	0
O&M Grade:	0
Clock Start/From:	3
Clock To:	
1st Value:	4.000
2nd Value:	
Value Percent:	
Continuous Index:	
Within 8" of Joint:	
Remarks:

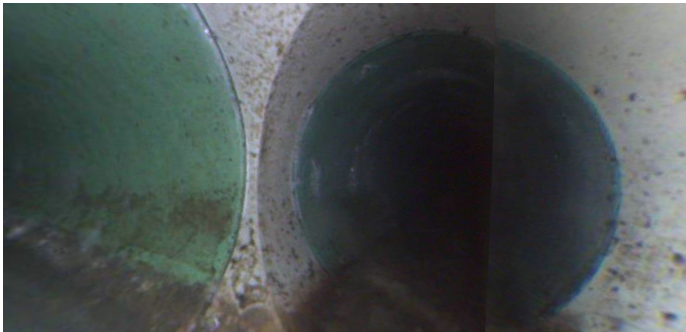
Code: **TFA**
Description: **Tap Factory Active**

Distance (ft): **146.5**
Structural Grade: **0**
O&M Grade: **0**
Clock Start/From: **3**
Clock To:
1st Value: **4.000**
2nd Value:
Value Percent:
Continuous Index:
Within 8" of Joint:
Remarks:
