## Profile/Photo Observation Report

Date:	<b>04/12/2018</b>	Weather:		Coding:	<b>PACP 6.0</b>
Pipe Length (ft):	<b>422.0</b>	Owner:	<b>NA</b>	Pre Clean:	<b>No Pre-Cleaning</b>
P.O.#:		Surveyor:	<b>Jen Costello</b>	PSR:	<b>P-506-037-038</b>
Customer:		Clean Date:	<b>01/01/1900</b>	Shape:	<b>C</b>

Street:	<b>IAN DR</b>	Flow Control:	<b>Not Controlled</b>
City:	<b>Hobart, IN</b>	Year Renewed:	
Location:	<b>Yard</b>	Tape/Media #:	
Purpose:	<b>Routine Assessment</b>	Dia/Height:	<b>8"</b>
Use:	<b>Sanitary</b>	Material:	<b>PVC</b>
Drain Area:	<b>NA</b>	Lining:	
Category:	<b>NA</b>		
Comment:	<b>Flow direction is marked wrong.</b>

Location Details:		Direction of Survey:	<b>Upstream</b>
US MH:	<b>M-506-038</b>	DS MH:	<b>M-506-037</b>
		Total Length Surveyed (ft):	<b>416.0</b>

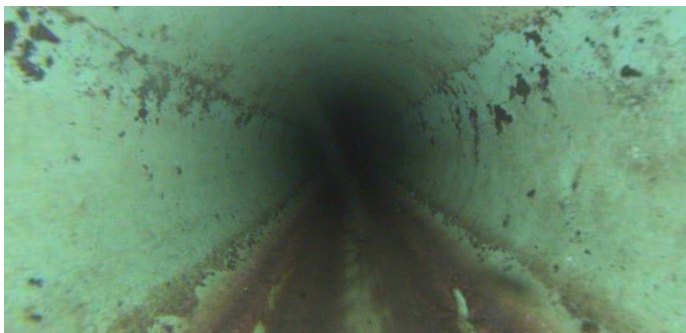
Code: **AMH**  
Description: **Manhole**

Distance (ft): **.0**  
Structural Grade: **0**  
O&M Grade: **0**  
Clock Start/From:  
Clock To:  
1st Value:  
2nd Value:  
Value Percent:  
Continuous Index:  
Within 8" of Joint: **NO**  
Remarks: **M-506-037**

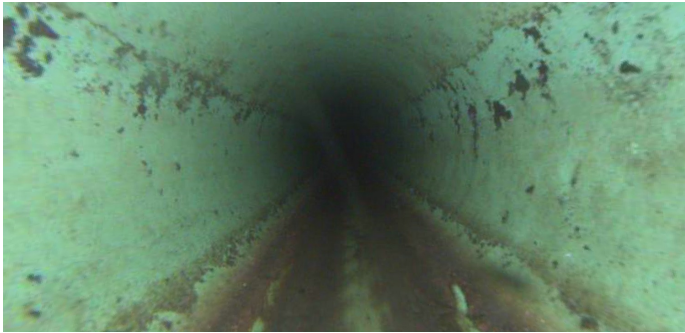
Code:	<b>MWL</b>
Description:	<b>Water Level</b>

Distance (ft):	<b>.0</b>
Structural Grade:	<b>0</b>
O&M Grade:	<b>0</b>
Clock Start/From:	
Clock To:	
1st Value:	
2nd Value:	
Value Percent:	<b>5.000</b>
Continuous Index:	
Within 8" of Joint:	<b>NO</b>
Remarks:

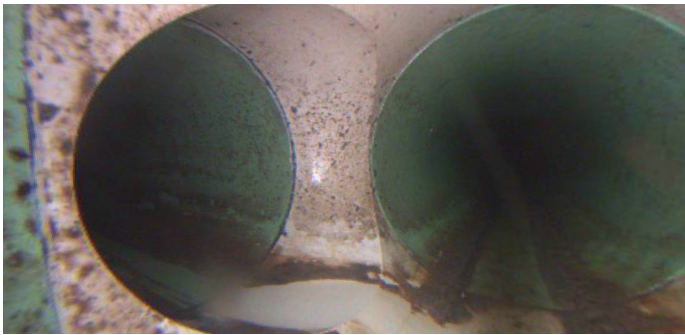
Code:	<b>TFA</b>
Description:	<b>Tap Factory Active</b>

Distance (ft):	<b>7.1</b>
Structural Grade:	<b>0</b>
O&M Grade:	<b>0</b>
Clock Start/From:	<b>9</b>
Clock To:	
1st Value:	<b>4.000</b>
2nd Value:	
Value Percent:	
Continuous Index:	
Within 8" of Joint:	
Remarks:

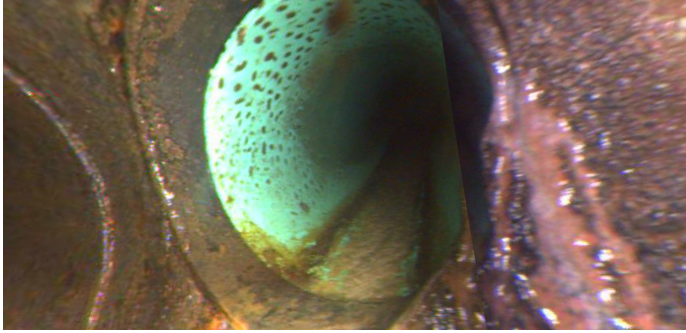
Code: **TB**  
Description: **Tap Break-in**

Distance (ft): **69.8**  
Structural Grade: **0**  
O&M Grade: **0**  
Clock Start/From: **10**  
Clock To:  
1st Value: **4.000**  
2nd Value:  
Value Percent:  
Continuous Index:  
Within 8" of Joint:  
Remarks:

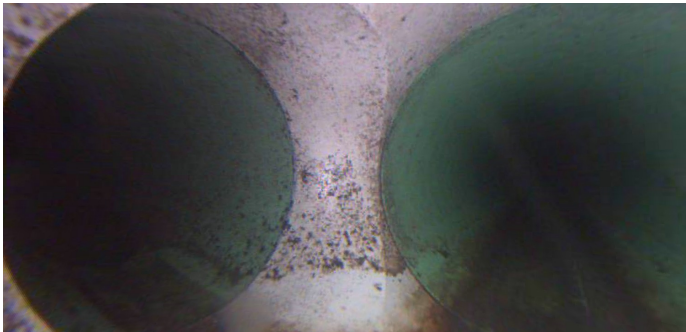
Code: **TF**  
Description: **Tap Factory**

Distance (ft): **97.1**  
Structural Grade: **0**  
O&M Grade: **0**  
Clock Start/From: **9**  
Clock To:  
1st Value: **4.000**  
2nd Value:  
Value Percent:  
Continuous Index:  
Within 8" of Joint:  
Remarks:

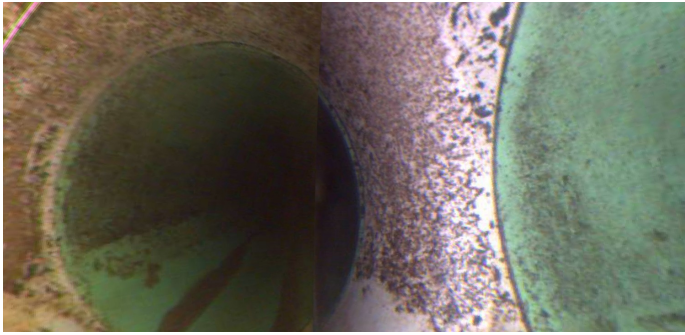
Code: **TF**  
Description: **Tap Factory**

Distance (ft): **181.0**  
Structural Grade: **0**  
O&M Grade: **0**  
Clock Start/From: **9**  
Clock To:  
1st Value: **4.000**  
2nd Value:  
Value Percent:  
Continuous Index:  
Within 8" of Joint:  
Remarks:

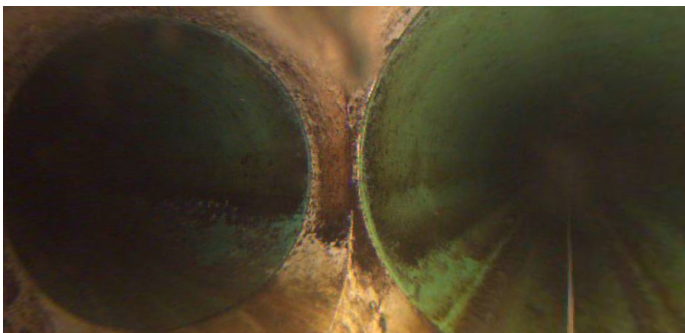
Code: **TF**  
Description: **Tap Factory**

Distance (ft): **195.3**  
Structural Grade: **0**  
O&M Grade: **0**  
Clock Start/From: **9**  
Clock To:  
1st Value: **4.000**  
2nd Value:  
Value Percent:  
Continuous Index:  
Within 8" of Joint:  
Remarks:

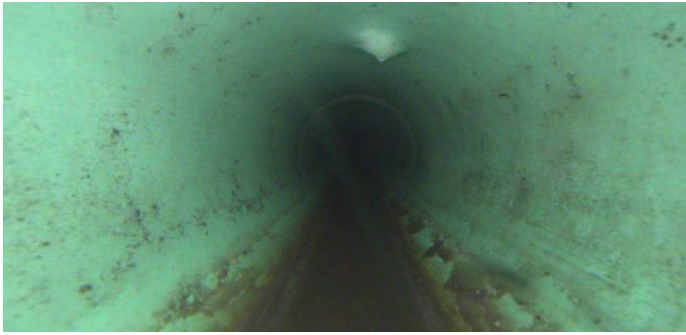
Code: **D**  
Description: **Deformed**

Distance (ft): **240.6**  
Structural Grade: **4**  
O&M Grade: **0**  
Clock Start/From:  
Clock To:  
1st Value:  
2nd Value:  
Value Percent: **5.000**  
Continuous Index:  
Within 8" of Joint: **NO**  
Remarks:

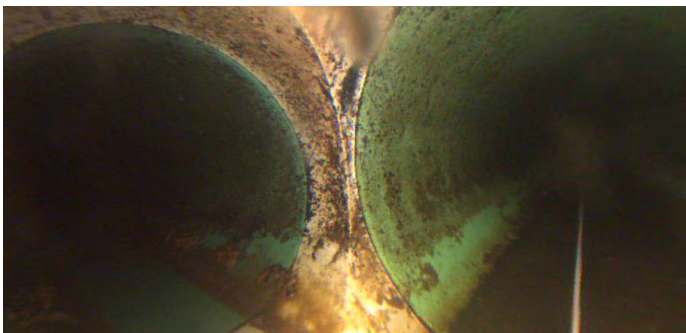
Code: **TF**  
Description: **Tap Factory**

Distance (ft): **280.2**  
Structural Grade: **0**  
O&M Grade: **0**  
Clock Start/From: **3**  
Clock To:  
1st Value: **4.000**  
2nd Value:  
Value Percent:  
Continuous Index:  
Within 8" of Joint:  
Remarks:

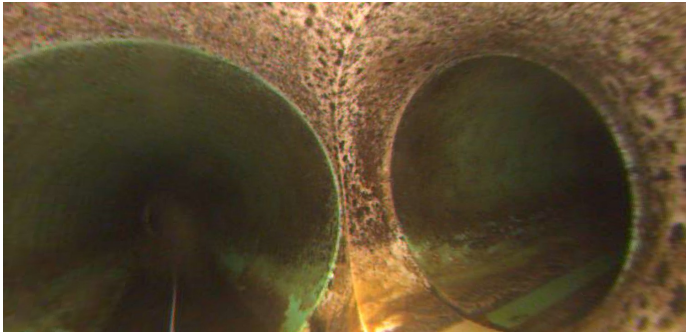
Code: **TF**  
Description: **Tap Factory**

Distance (ft): **285.0**  
Structural Grade: **0**  
O&M Grade: **0**  
Clock Start/From: **9**  
Clock To:  
1st Value: **4.000**  
2nd Value:  
Value Percent:  
Continuous Index:  
Within 8" of Joint:  
Remarks:

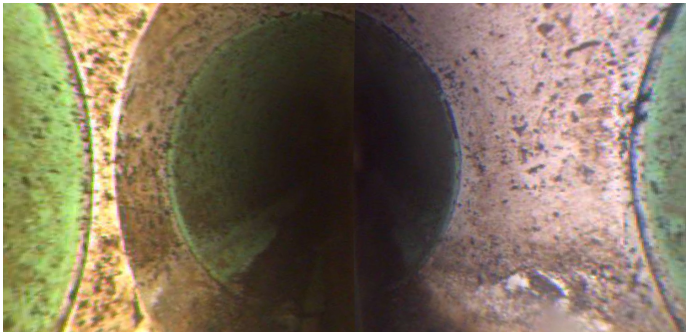
Code: **TF**  
Description: **Tap Factory**

Distance (ft): **368.2**  
Structural Grade: **0**  
O&M Grade: **0**  
Clock Start/From: **9**  
Clock To:  
1st Value: **4.000**  
2nd Value:  
Value Percent:  
Continuous Index:  
Within 8" of Joint:  
Remarks:

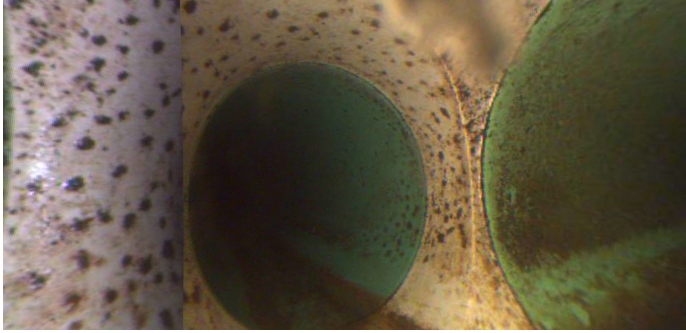
Code: **TFA**  
Description: **Tap Factory Active**

Distance (ft): **373.0**  
Structural Grade: **0**  
O&M Grade: **0**  
Clock Start/From: **3**  
Clock To:  
1st Value: **4.000**  
2nd Value:  
Value Percent:  
Continuous Index:  
Within 8" of Joint:  
Remarks:

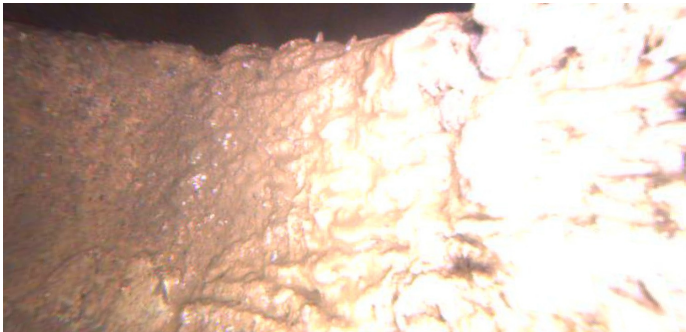
Code: **AMH**  
Description: **Manhole**

Distance (ft): **416.0**  
Structural Grade: **0**  
O&M Grade: **0**  
Clock Start/From:  
Clock To:  
1st Value:  
2nd Value:  
Value Percent:  
Continuous Index:  
Within 8" of Joint: **NO**  
Remarks: **M-506-038**
