Profile/Photo Observation Report

Street:	FOXCROFT STREET	Flow Control:	Not Controlled
City:	Hobart, IN	Year Renewed:	
Location:	Yard	Tape/Media #:	
Purpose:	Routine Assessment	Dia/Height:	8"
Use:	Sanitary	Material:	PVC
Drain Area:	NA	Lining:	
Category:	NA		
Comment:	Flow direction is marked wrong.

Location Details:		Direction of Survey:	Upstream
US MH:	M-506-038	DS MH:	M-506-037
		Total Length Surveyed (ft):	416.0

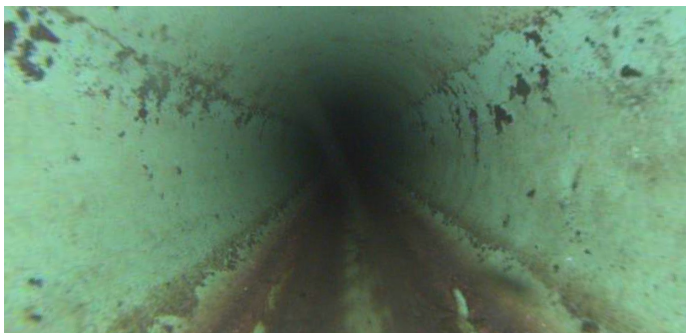
Code: **AMH**
Description: **Manhole**

Distance (ft): **.0**
Structural Grade: **0**
O&M Grade: **0**
Clock Start/From:
Clock To:
1st Value:
2nd Value:
Value Percent:
Continuous Index:
Within 8" of Joint: **NO**
Remarks: **M-506-037**

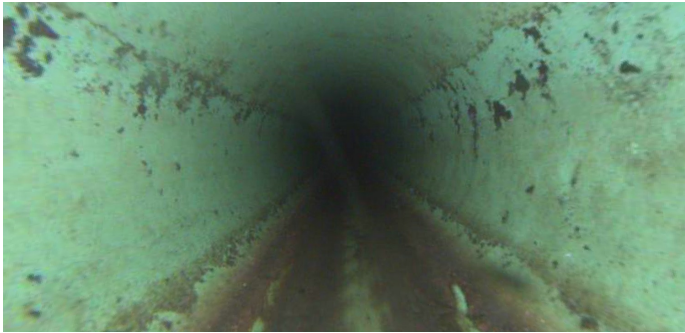
Code:	MWL
Description:	Water Level

Distance (ft):	.0
Structural Grade:	0
O&M Grade:	0
Clock Start/From:	
Clock To:	
1st Value:	
2nd Value:	
Value Percent:	5.000
Continuous Index:	
Within 8" of Joint:	NO
Remarks:

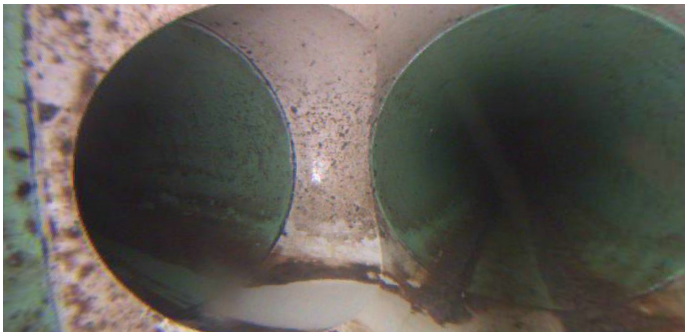
Code:	TFA
Description:	Tap Factory Active

Distance (ft):	7.1
Structural Grade:	0
O&M Grade:	0
Clock Start/From:	9
Clock To:	
1st Value:	4.000
2nd Value:	
Value Percent:	
Continuous Index:	
Within 8" of Joint:	
Remarks:

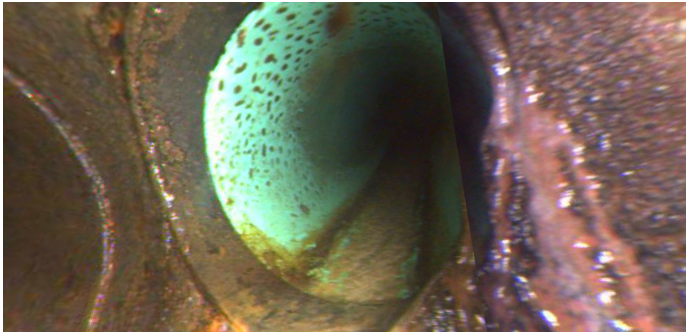
Code: **TB**
Description: **Tap Break-in**

Distance (ft): **69.8**
Structural Grade: **0**
O&M Grade: **0**
Clock Start/From: **10**
Clock To:
1st Value: **4.000**
2nd Value:
Value Percent:
Continuous Index:
Within 8" of Joint:
Remarks:

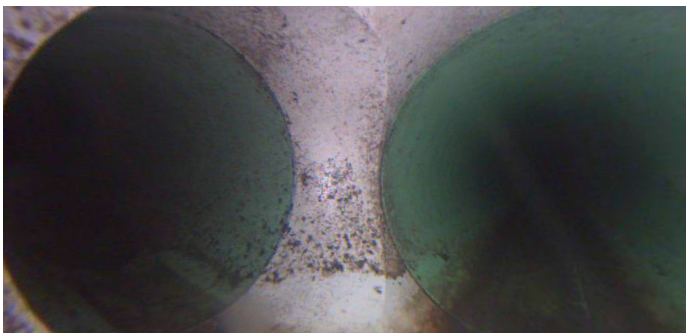
Code: **TF**
Description: **Tap Factory**

Distance (ft): **97.1**
Structural Grade: **0**
O&M Grade: **0**
Clock Start/From: **9**
Clock To:
1st Value: **4.000**
2nd Value:
Value Percent:
Continuous Index:
Within 8" of Joint:
Remarks:

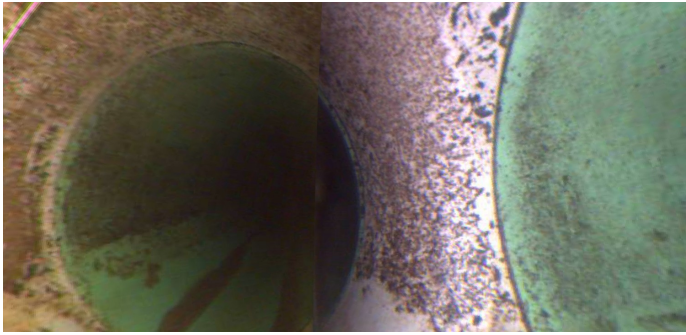
Code: **TF**
Description: **Tap Factory**

Distance (ft): **181.0**
Structural Grade: **0**
O&M Grade: **0**
Clock Start/From: **9**
Clock To:
1st Value: **4.000**
2nd Value:
Value Percent:
Continuous Index:
Within 8" of Joint:
Remarks:

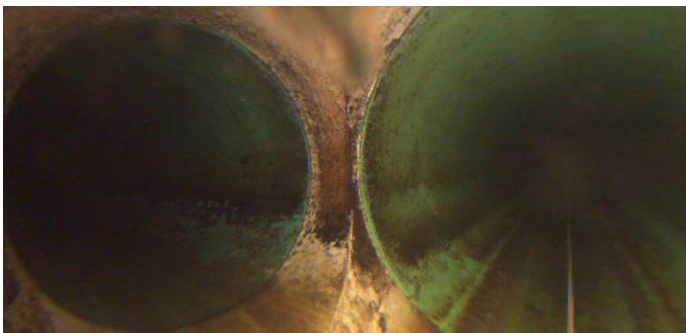
Code: **TF**
Description: **Tap Factory**

Distance (ft): **195.3**
Structural Grade: **0**
O&M Grade: **0**
Clock Start/From: **9**
Clock To:
1st Value: **4.000**
2nd Value:
Value Percent:
Continuous Index:
Within 8" of Joint:
Remarks:

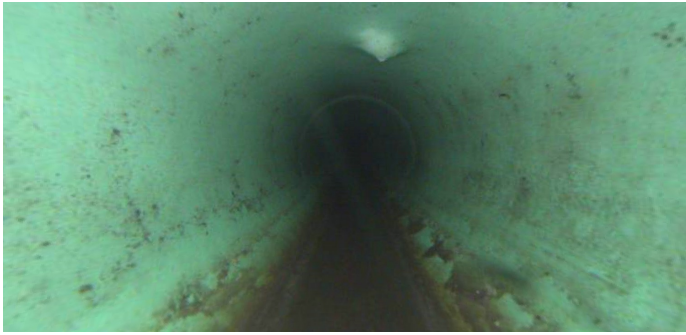
Code: **D**
Description: **Deformed**

Distance (ft): **240.6**
Structural Grade: **4**
O&M Grade: **0**
Clock Start/From:
Clock To:
1st Value:
2nd Value:
Value Percent: **5.000**
Continuous Index:
Within 8" of Joint: **NO**
Remarks:

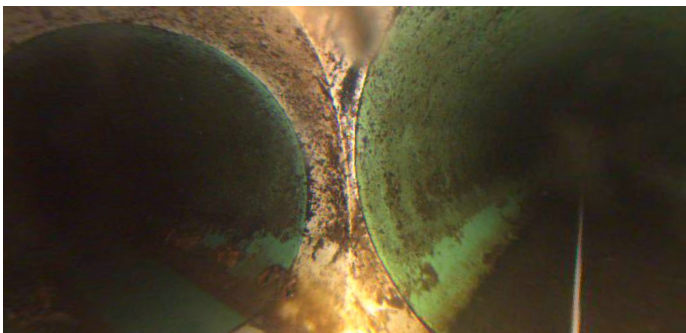
Code: **TF**
Description: **Tap Factory**

Distance (ft): **280.2**
Structural Grade: **0**
O&M Grade: **0**
Clock Start/From: **3**
Clock To:
1st Value: **4.000**
2nd Value:
Value Percent:
Continuous Index:
Within 8" of Joint:
Remarks:

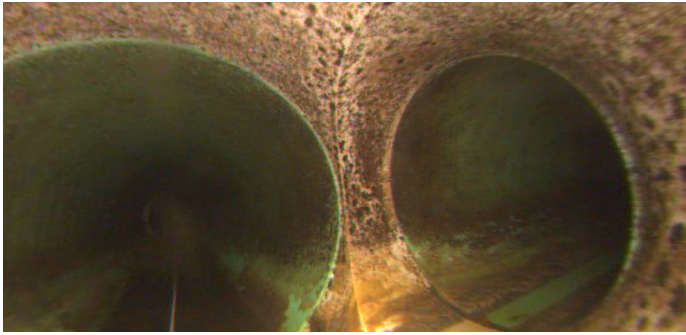
Code: **TF**
Description: **Tap Factory**

Distance (ft): **285.0**
Structural Grade: **0**
O&M Grade: **0**
Clock Start/From: **9**
Clock To:
1st Value: **4.000**
2nd Value:
Value Percent:
Continuous Index:
Within 8" of Joint:
Remarks:

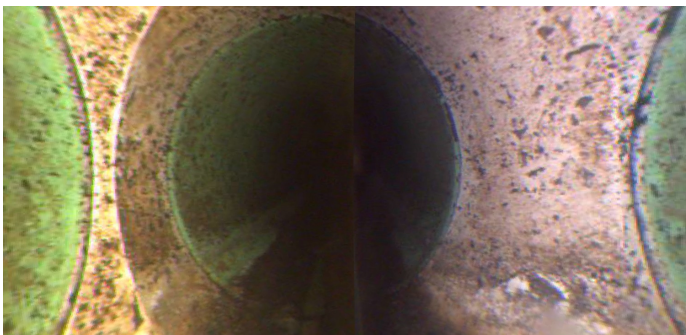
Code: **TF**
Description: **Tap Factory**

Distance (ft): **368.2**
Structural Grade: **0**
O&M Grade: **0**
Clock Start/From: **9**
Clock To:
1st Value: **4.000**
2nd Value:
Value Percent:
Continuous Index:
Within 8" of Joint:
Remarks:

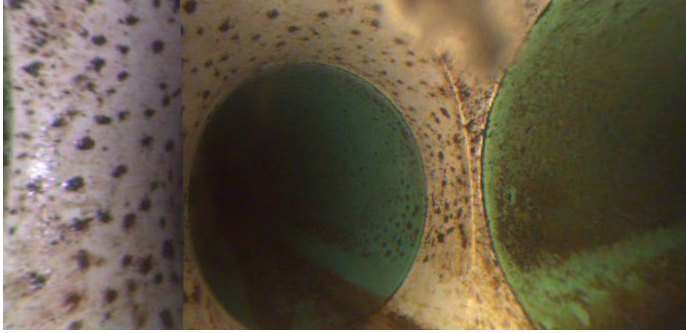
Code: **TFA**
Description: **Tap Factory Active**

Distance (ft): **373.0**
Structural Grade: **0**
O&M Grade: **0**
Clock Start/From: **3**
Clock To:
1st Value: **4.000**
2nd Value:
Value Percent:
Continuous Index:
Within 8" of Joint:
Remarks:

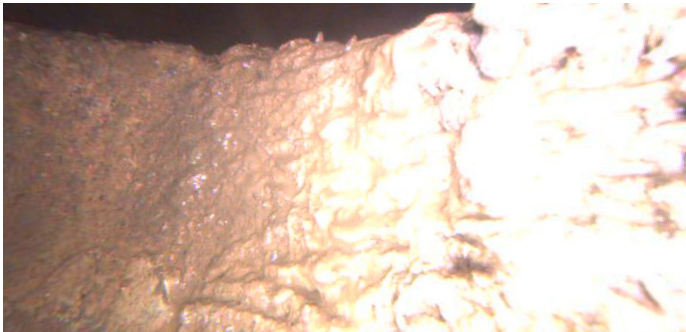
Code: **AMH**
Description: **Manhole**

Distance (ft): **416.0**
Structural Grade: **0**
O&M Grade: **0**
Clock Start/From:
Clock To:
1st Value:
2nd Value:
Value Percent:
Continuous Index:
Within 8" of Joint: **NO**
Remarks: **M-506-038**
