## Profile/Photo Observation Report

Street:	<b>FOXCROFT STREET</b>	Flow Control:	<b>Not Controlled</b>
City:	<b>Hobart, IN</b>	Year Renewed:	
Location:	<b>Light Highway</b>	Tape/Media #:	
Purpose:	<b>Routine Assessment</b>	Dia/Height:	<b>8"</b>
Use:	<b>Sanitary</b>	Material:	<b>VCP</b>
Drain Area:	<b>NA</b>	Lining:	
Category:	<b>NA</b>		
Comment:	<b>Flow direction wrong</b>

Location Details:		Direction of Survey:	<b>Upstream</b>
US MH:	<b>M-507-002</b>	DS MH:	<b>M-507-001</b>
		Total Length Surveyed (ft):	<b>307.8</b>

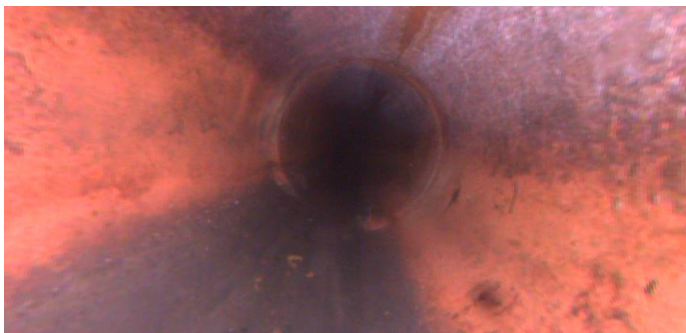
Code: **AMH**  
Description: **Manhole**

Distance (ft): **.0**  
Structural Grade: **0**  
O&M Grade: **0**  
Clock Start/From:  
Clock To:  
1st Value:  
2nd Value:  
Value Percent:  
Continuous Index:  
Within 8" of Joint: **NO**  
Remarks: **M-507-001**

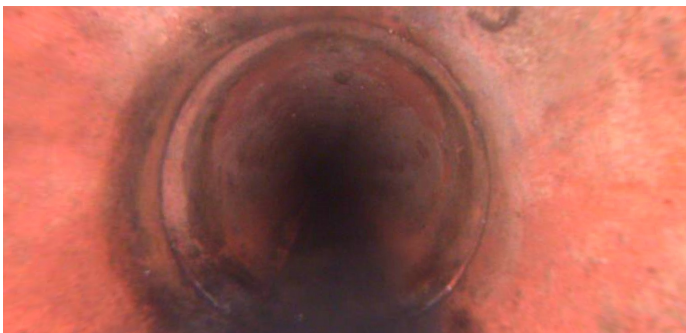
Code: **IS**  
Description: **Infil Stain**

Distance (ft): **102.2**  
Structural Grade: **0**  
O&M Grade: **0**  
Clock Start/From: **8**  
Clock To: **4**  
1st Value:  
2nd Value:  
Value Percent:  
Continuous Index:  
Within 8" of Joint: **YES**  
Remarks:

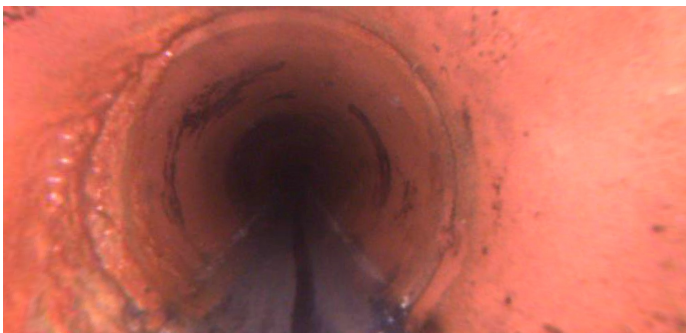
Code: **IW**  
Description: **Infil Weeper**

Distance (ft): **186.6**  
Structural Grade: **0**  
O&M Grade: **2**  
Clock Start/From: **7**  
Clock To: **11**  
1st Value:  
2nd Value:  
Value Percent:  
Continuous Index:  
Within 8" of Joint: **YES**  
Remarks:

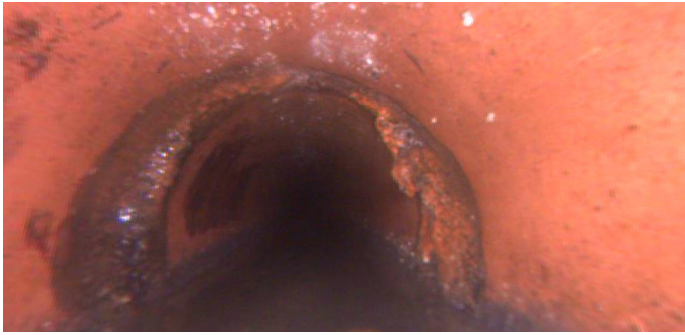
Code: **DAE**  
Description: **Deposits Attached Encrustation**

Distance (ft): **291.5**  
Structural Grade: **0**  
O&M Grade: **2**  
Clock Start/From: **7**  
Clock To: **5**  
1st Value:  
2nd Value:  
Value Percent: **5.000**  
Continuous Index:  
Within 8" of Joint: **YES**  
Remarks:

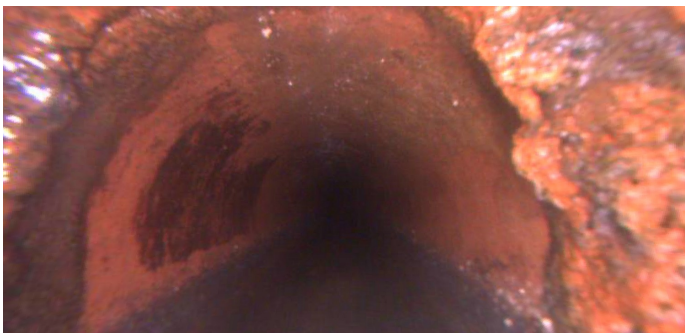
Code: **IW**  
Description: **Infil Weeper**

Distance (ft): **291.8**  
Structural Grade: **0**  
O&M Grade: **2**  
Clock Start/From: **8**  
Clock To: **4**  
1st Value:  
2nd Value:  
Value Percent:  
Continuous Index:  
Within 8" of Joint: **YES**  
Remarks:

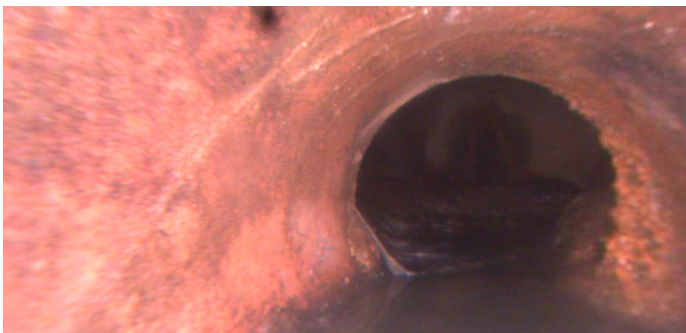
Code: **CS**  
Description: **Crack Spiral**

Distance (ft): **306.3**  
Structural Grade: **2**  
O&M Grade: **0**  
Clock Start/From: **8**  
Clock To: **12**  
1st Value:  
2nd Value:  
Value Percent:  
Continuous Index:  
Within 8" of Joint:  
Remarks:

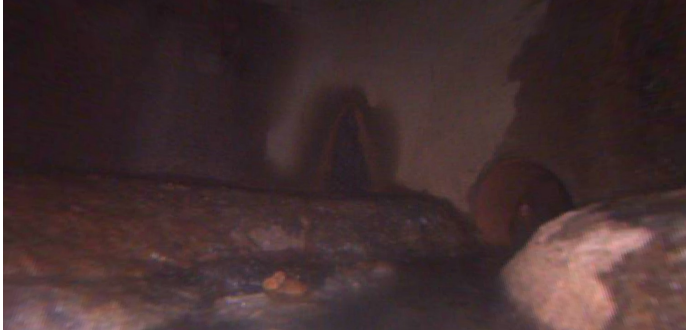
Code: **AMH**  
Description: **Manhole**

Distance (ft): **307.8**  
Structural Grade: **0**  
O&M Grade: **0**  
Clock Start/From:  
Clock To:  
1st Value:  
2nd Value:  
Value Percent:  
Continuous Index:  
Within 8" of Joint: **NO**  
Remarks: **M-507-002**

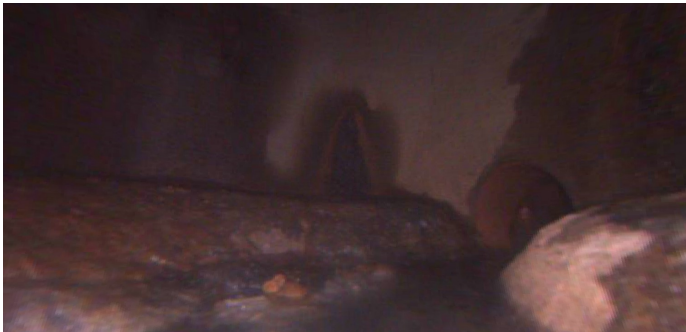
Code: **DAGS**  
Description: **Deposits Attached Grease**

Distance (ft): **307.8**  
Structural Grade: **0**  
O&M Grade: **2**  
Clock Start/From: **7**  
Clock To: **5**  
1st Value:  
2nd Value:  
Value Percent: **5.000**  
Continuous Index: **F02**  
Within 8" of Joint: **YES**  
Remarks: **WANDER**

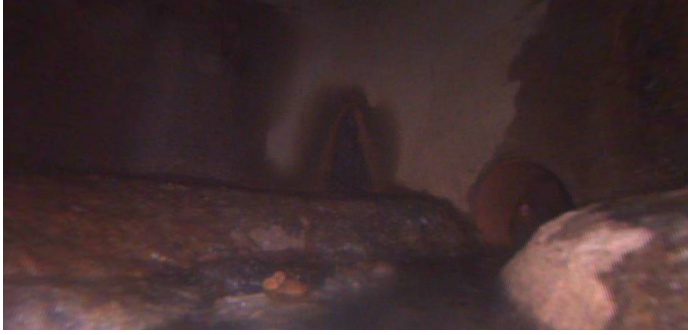
Code:	<b>DAZ</b>
Description:	<b>Deposits Attached Other</b>
Distance (ft):	<b>307.8</b>
Structural Grade:	<b>0</b>
O&M Grade:	<b>2</b>
Clock Start/From:	<b>6</b>
Clock To:	<b>6</b>
1st Value:	
2nd Value:	
Value Percent:	<b>5.000</b>
Continuous Index:	<b>F01</b>
Within 8" of Joint:	<b>YES</b>
Remarks:	<b>WANDER</b>
