## Profile/Photo Observation Report

Street:	<b>FOXCROFT STREET</b>	Flow Control:	<b>Not Controlled</b>
City:	<b>Hobart, IN</b>	Year Renewed:	
Location:	<b>Light Highway</b>	Tape/Media #:	
Purpose:	<b>Routine Assessment</b>	Dia/Height:	<b>8"</b>
Use:	<b>Sanitary</b>	Material:	<b>VCP</b>
Drain Area:	<b>NA</b>	Lining:	
Category:	<b>NA</b>		
Comment:

Location Details:		Direction of Survey:	<b>Downstream</b>
US MH:	<b>M-507-002</b>	DS MH:	<b>M-507-003</b>
		Total Length Surveyed (ft):	<b>158.7</b>

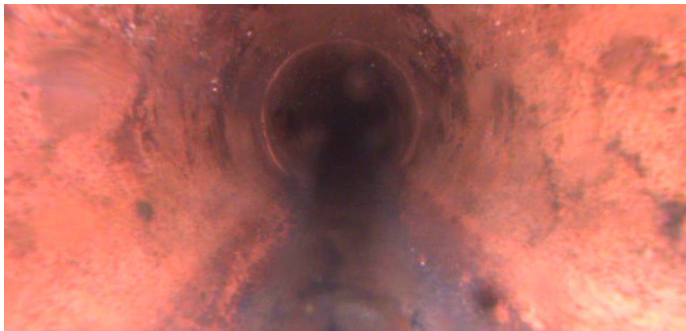
Code: **AMH**  
Description: **Manhole**

Distance (ft): **.0**  
Structural Grade: **0**  
O&M Grade: **0**  
Clock Start/From:  
Clock To:  
1st Value:  
2nd Value:  
Value Percent:  
Continuous Index:  
Within 8" of Joint: **NO**  
Remarks: **M-507-002**

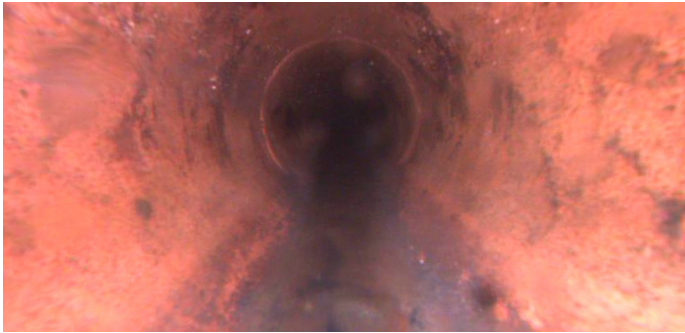
Code:	<b>MWL</b>
Description:	<b>Water Level</b>

Distance (ft):	<b>.0</b>
Structural Grade:	<b>0</b>
O&M Grade:	<b>0</b>
Clock Start/From:	
Clock To:	
1st Value:	
2nd Value:	
Value Percent:	<b>5.000</b>
Continuous Index:	
Within 8" of Joint:	<b>NO</b>
Remarks:

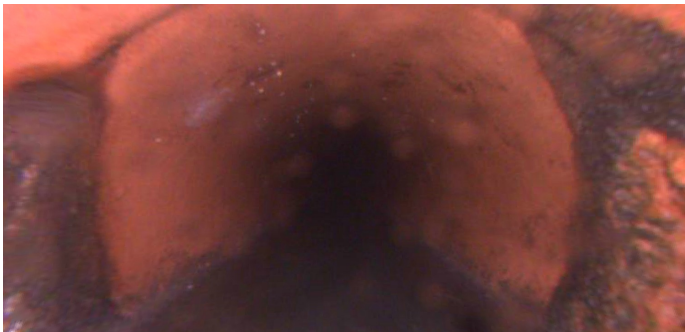
Code:	<b>IW</b>
Description:	<b>Infil Weeper</b>

Distance (ft):	<b>7.2</b>
Structural Grade:	<b>0</b>
O&M Grade:	<b>2</b>
Clock Start/From:	<b>8</b>
Clock To:	<b>4</b>
1st Value:	
2nd Value:	
Value Percent:	
Continuous Index:	
Within 8" of Joint:	<b>YES</b>
Remarks:

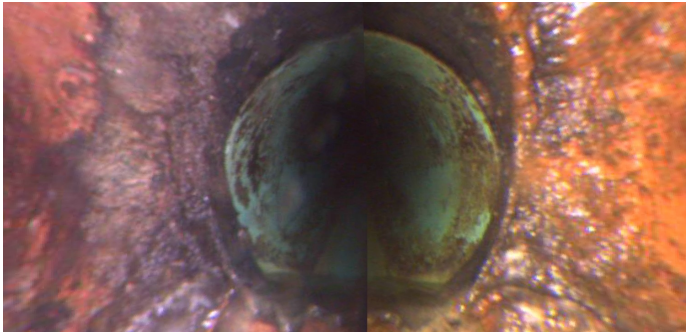
Code: **TBA**  
Description: **Tap Break-in Active**

Distance (ft): **38.6**  
Structural Grade: **0**  
O&M Grade: **0**  
Clock Start/From: **3**  
Clock To:  
1st Value: **4.000**  
2nd Value:  
Value Percent:  
Continuous Index:  
Within 8" of Joint:  
Remarks:

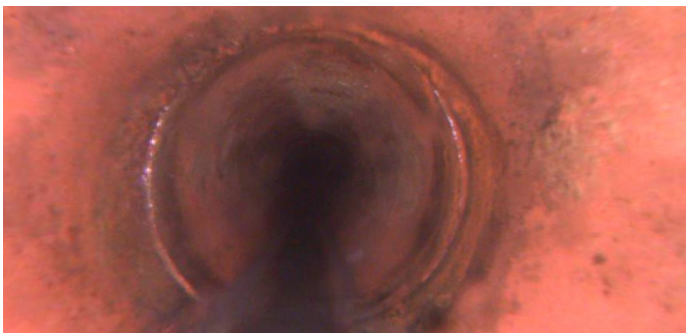
Code: **IW**  
Description: **Infil Weeper**

Distance (ft): **56.9**  
Structural Grade: **0**  
O&M Grade: **2**  
Clock Start/From: **8**  
Clock To: **4**  
1st Value:  
2nd Value:  
Value Percent:  
Continuous Index:  
Within 8" of Joint: **YES**  
Remarks:

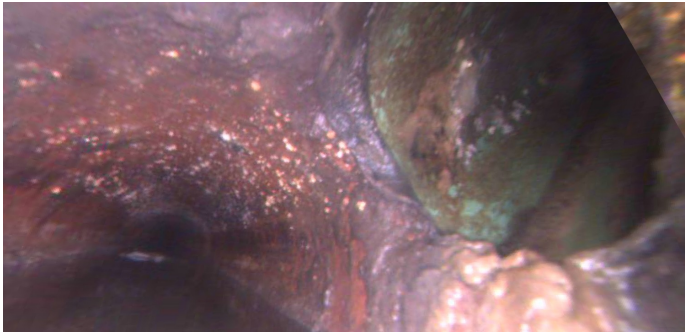
Code: **TBA**  
Description: **Tap Break-in Active**

Distance (ft): **108.6**  
Structural Grade: **0**  
O&M Grade: **0**  
Clock Start/From: **2**  
Clock To:  
1st Value: **4.000**  
2nd Value:  
Value Percent:  
Continuous Index:  
Within 8" of Joint:  
Remarks:

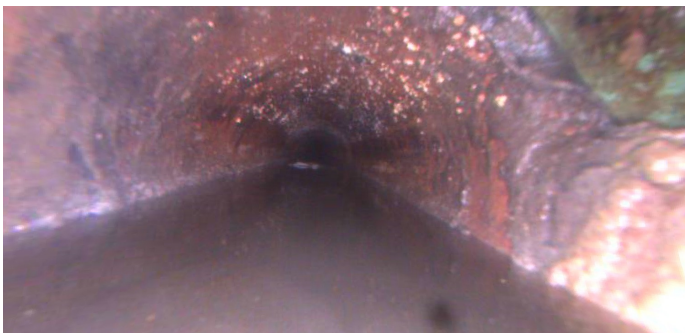
Code: **DAGS**  
Description: **Deposits Attached Grease**

Distance (ft): **108.6**  
Structural Grade: **0**  
O&M Grade: **2**  
Clock Start/From: **8**  
Clock To: **4**  
1st Value:  
2nd Value:  
Value Percent: **5.000**  
Continuous Index:  
Within 8" of Joint: **NO**  
Remarks:

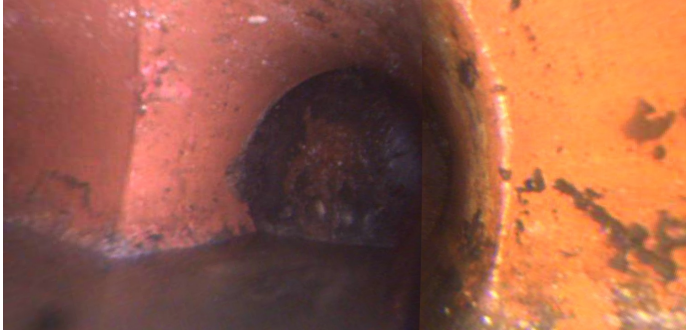
Code: **TFC**  
Description: **Tap Factory Capped**

Distance (ft): **117.6**  
Structural Grade: **0**  
O&M Grade: **0**  
Clock Start/From: **3**  
Clock To:  
1st Value: **4.000**  
2nd Value:  
Value Percent:  
Continuous Index:  
Within 8" of Joint:  
Remarks:

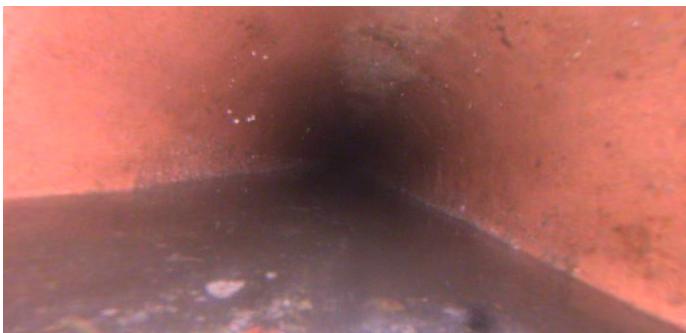
Code: **MWL**  
Description: **Water Level**

Distance (ft): **139.3**  
Structural Grade: **0**  
O&M Grade: **0**  
Clock Start/From:  
Clock To:  
1st Value:  
2nd Value:  
Value Percent: **40.000**  
Continuous Index:  
Within 8" of Joint: **NO**  
Remarks:

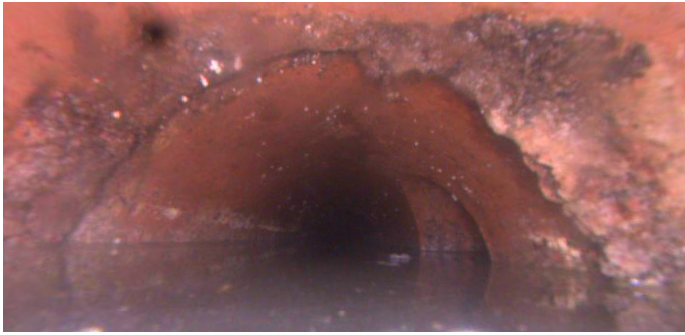
Code: **DAE**  
Description: **Deposits Attached Encrustation**

Distance (ft): **154.1**  
Structural Grade: **0**  
O&M Grade: **2**  
Clock Start/From: **8**  
Clock To: **4**  
1st Value:  
2nd Value:  
Value Percent: **10.000**  
Continuous Index:  
Within 8" of Joint: **YES**  
Remarks:

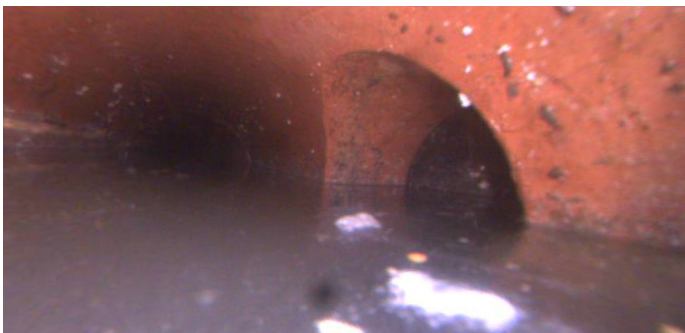
Code: **TFC**  
Description: **Tap Factory Capped**

Distance (ft): **154.7**  
Structural Grade: **0**  
O&M Grade: **0**  
Clock Start/From: **2**  
Clock To:  
1st Value: **4.000**  
2nd Value:  
Value Percent:  
Continuous Index:  
Within 8" of Joint:  
Remarks:

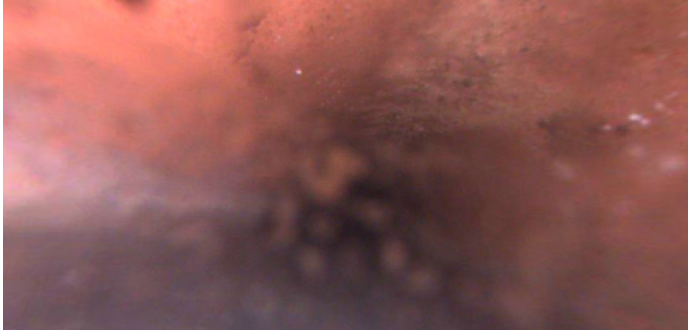
Code:	<b>MSA</b>
Description:	<b>Abandoned Survey</b>
Distance (ft):	<b>158.7</b>
Structural Grade:	<b>0</b>
O&M Grade:	<b>0</b>
Clock Start/From:	
Clock To:	
1st Value:	
2nd Value:	
Value Percent:	
Continuous Index:	
Within 8" of Joint:	<b>NO</b>
Remarks:	<b>HIGH WATER</b>
