Profile/Photo Observation Report

Street:	Csokasy Lane	Flow Control:	Not Controlled
City:	Hobart, IN	Year Renewed:	
Location:	Yard	Tape/Media #:	DEP205
Purpose:	Routine Assessment	Dia/Height:	12"
Use:	Sanitary	Material:	VCP
Drain Area:		Lining:	
Category:	NA		
Comment:	YES501824 Submittal 2		
Location Details:		Direction of Survey:	Upstream
US MH:	M-507-004	DS MH:	M-507-011
		Total Length Surveyed (ft):	83.9

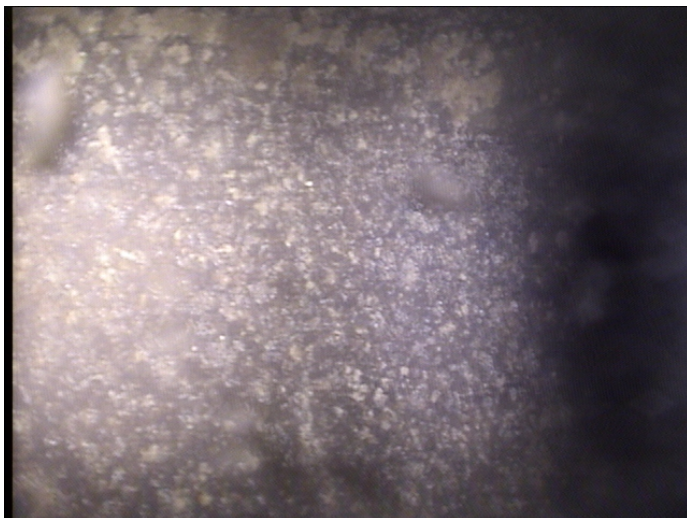
Code:	AMH
Description:	Manhole
Distance (ft):	.0
Structural Grade:	0
O&M Grade:	0
Clock Start/From:	
Clock To:	
1st Value:	
2nd Value:	
Value Percent:	
Continuous Index:	
Within 8" of Joint:	NO
Remarks:	M-507-004

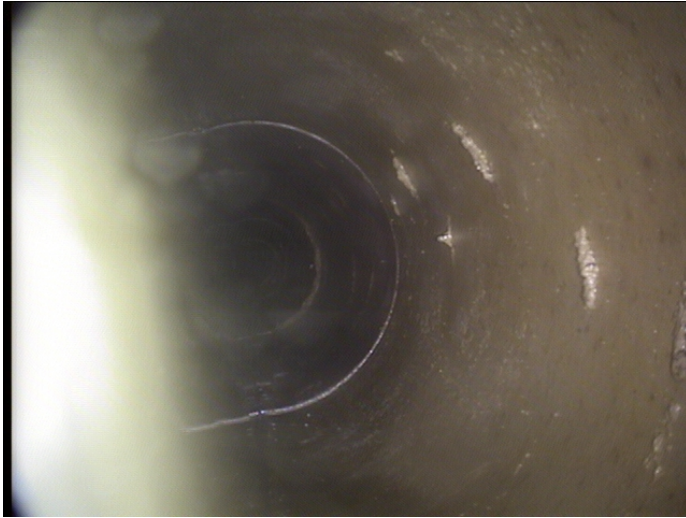
Code: **MWL**
Description: **Water Level**

Distance (ft): **.0**
Structural Grade: **0**
O&M Grade: **0**
Clock Start/From:
Clock To:
1st Value:
2nd Value:
Value Percent: **20.000**
Continuous Index:
Within 8" of Joint: **NO**
Remarks:

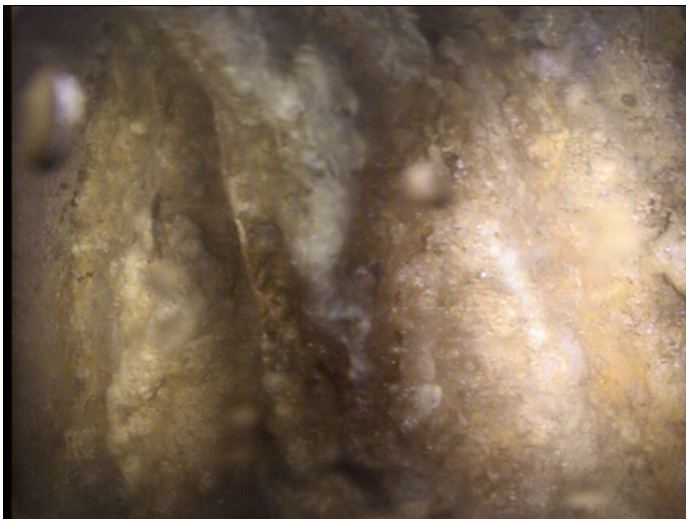
Code: **DAE**
Description: **Deposits Attached Encrustation**

Distance (ft): **2.3**
Structural Grade: **0**
O&M Grade: **3**
Clock Start/From: **7**
Clock To: **5**
1st Value:
2nd Value:
Value Percent: **15.000**
Continuous Index:
Within 8" of Joint: **YES**
Remarks:

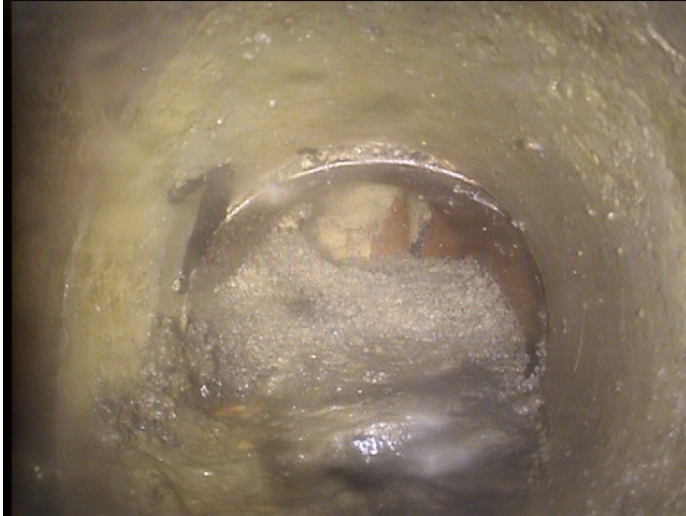
Code:	TFC
Description:	Tap Factory Capped
Distance (ft):	71.6
Structural Grade:	0
O&M Grade:	0
Clock Start/From:	3
Clock To:	
1st Value:	4.000
2nd Value:	
Value Percent:	
Continuous Index:	
Within 8" of Joint:	NO
Remarks:

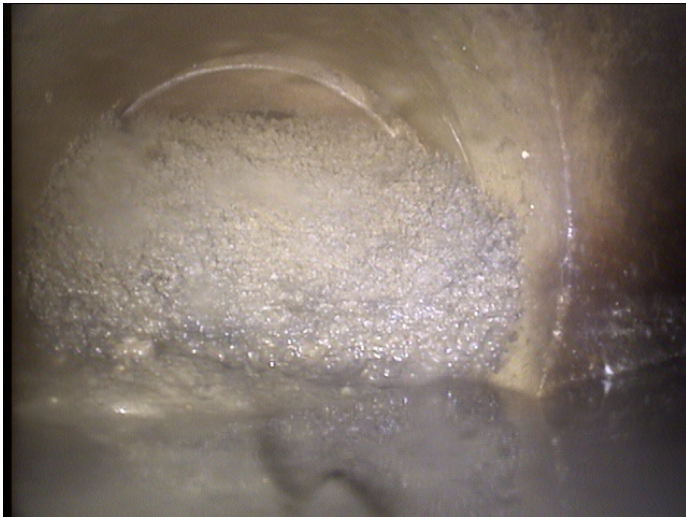
Code:	TFC
Description:	Tap Factory Capped
Distance (ft):	74.8
Structural Grade:	0
O&M Grade:	0
Clock Start/From:	9
Clock To:	
1st Value:	6.000
2nd Value:	
Value Percent:	
Continuous Index:	
Within 8" of Joint:	NO
Remarks:

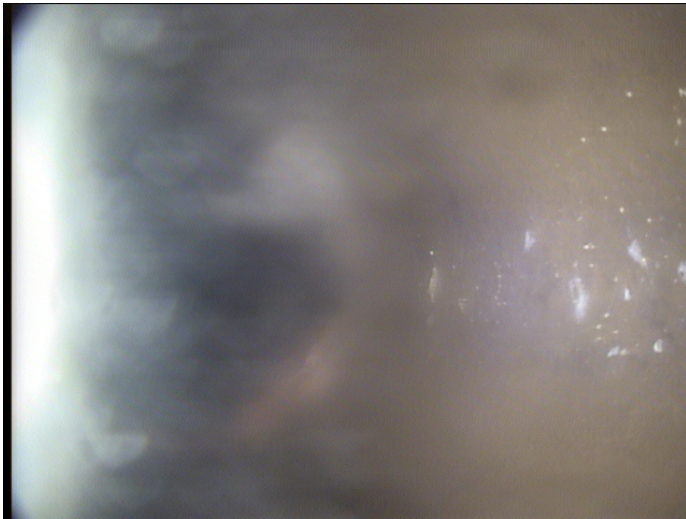
Code: **DSF**
Description: **Deposits Settled Fine**

Distance (ft): **82.6**
Structural Grade: **0**
O&M Grade: **2**
Clock Start/From: **5**
Clock To: **7**
1st Value:
2nd Value:
Value Percent: **5.000**
Continuous Index:
Within 8" of Joint: **NO**
Remarks:

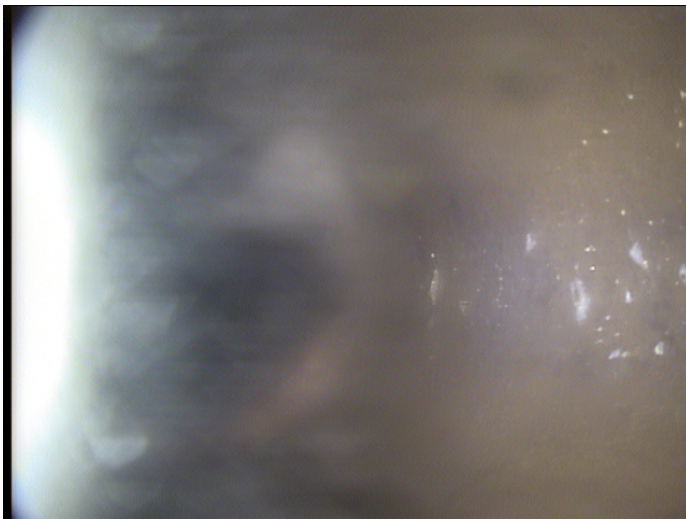
Code: **MSA**
Description: **Abandoned Survey**

Distance (ft): **82.7**
Structural Grade: **0**
O&M Grade: **0**
Clock Start/From:
Clock To:
1st Value:
2nd Value:
Value Percent:
Continuous Index:
Within 8" of Joint: **NO**
Remarks: **Cannot pass debris**
