Profile/Photo Observation Report

Street:	S DELAWARE ST	Flow Control:	Not Controlled
City:	Hobart, IN	Year Renewed:	
Location:	Light Highway	Tape/Media #:	
Purpose:	Routine Assessment	Dia/Height:	12"
Use:	Sanitary	Material:	VCP
Drain Area:	NA	Lining:	
Category:	NA		
Comment:	P_C at 18 ft nothing visible . Flow direction wrong		
Location Details:		Direction of Survey:	Downstream
US MH:	M-507-006	DS MH:	M-507-007
		Total Length Surveyed (ft):	19.7

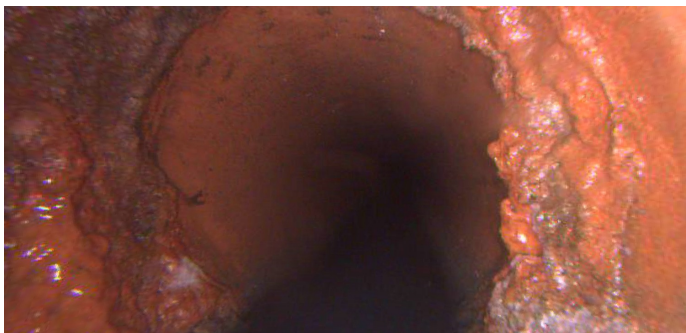
Code: **AMH**
Description: **Manhole**

Distance (ft): **.0**
Structural Grade: **0**
O&M Grade: **0**
Clock Start/From:
Clock To:
1st Value:
2nd Value:
Value Percent:
Continuous Index:
Within 8" of Joint: **NO**
Remarks: **M-507-006**

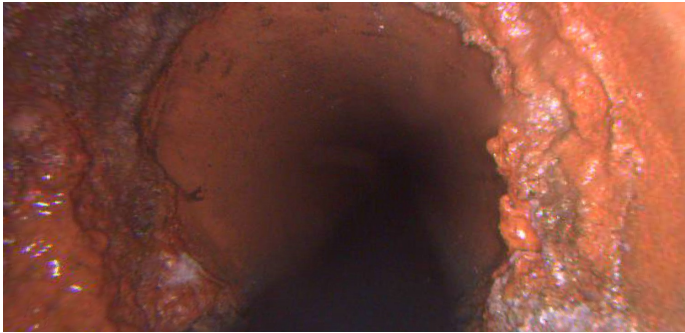
Code:	MWL
Description:	Water Level

Distance (ft):	.0
Structural Grade:	0
O&M Grade:	0
Clock Start/From:	
Clock To:	
1st Value:	
2nd Value:	
Value Percent:	10.000
Continuous Index:	
Within 8" of Joint:	NO
Remarks:

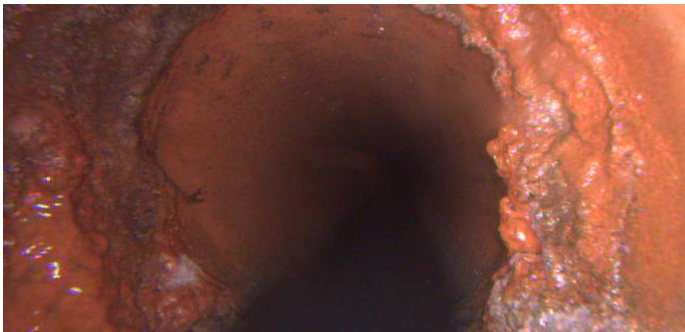
Code:	DAE
Description:	Deposits Attached Encrustation

Distance (ft):	.0
Structural Grade:	0
O&M Grade:	3
Clock Start/From:	8
Clock To:	4
1st Value:	
2nd Value:	
Value Percent:	20.000
Continuous Index:	
Within 8" of Joint:	YES
Remarks:

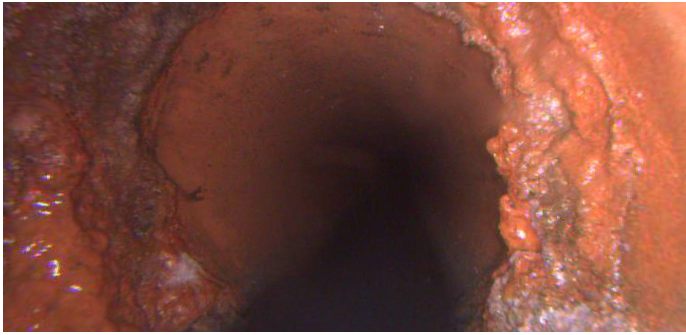
Code: **IW**
Description: **Infil Weeper**

Distance (ft): **.0**
Structural Grade: **0**
O&M Grade: **2**
Clock Start/From: **8**
Clock To: **4**
1st Value:
2nd Value:
Value Percent:
Continuous Index: **S01**
Within 8" of Joint:
Remarks:

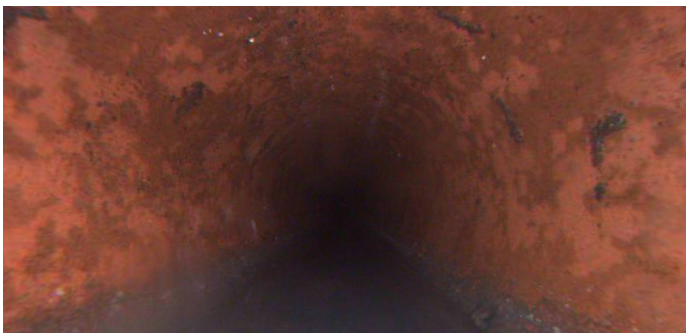
Code: **MSA**
Description: **Abandoned Survey**

Distance (ft): **19.7**
Structural Grade: **0**
O&M Grade: **0**
Clock Start/From:
Clock To:
1st Value:
2nd Value:
Value Percent:
Continuous Index:
Within 8" of Joint: **NO**
Remarks: **unknown**

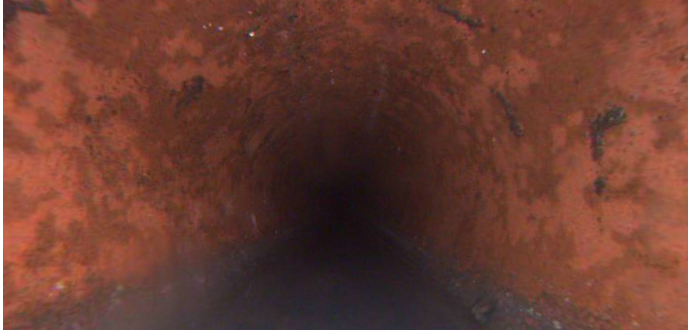
Code:	IW
Description:	Infil Weeper
Distance (ft):	19.7
Structural Grade:	0
O&M Grade:	2
Clock Start/From:	8
Clock To:	4
1st Value:	
2nd Value:	
Value Percent:	
Continuous Index:	F01
Within 8" of Joint:	
Remarks:
