## Profile/Photo Observation Report

Street:	<b>FOXCROFT STREET</b>	Flow Control:	<b>Not Controlled</b>
City:	<b>Hobart, IN</b>	Year Renewed:	
Location:	<b>Light Highway</b>	Tape/Media #:	
Purpose:	<b>Routine Assessment</b>	Dia/Height:	<b>12"</b>
Use:	<b>Sanitary</b>	Material:	<b>VCP</b>
Drain Area:	<b>NA</b>	Lining:	
Category:	<b>NA</b>		
Comment:	<b>P_C at 18 ft nothing visible . Flow direction wrong</b>		
Location Details:		Direction of Survey:	<b>Downstream</b>
US MH:	<b>M-507-006</b>	DS MH:	<b>M-507-007</b>
		Total Length Surveyed (ft):	<b>19.7</b>

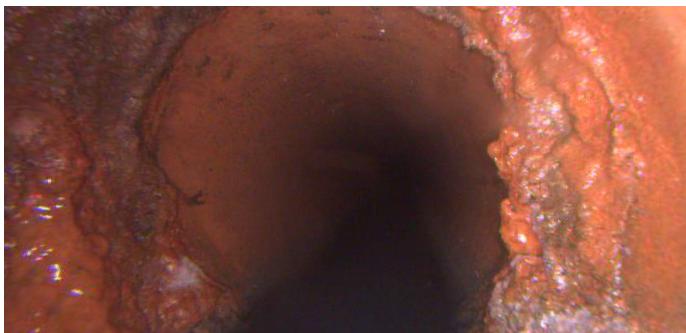
Code: **AMH**  
Description: **Manhole**

Distance (ft): **.0**  
Structural Grade: **0**  
O&M Grade: **0**  
Clock Start/From:  
Clock To:  
1st Value:  
2nd Value:  
Value Percent:  
Continuous Index:  
Within 8" of Joint: **NO**  
Remarks: **M-507-006**

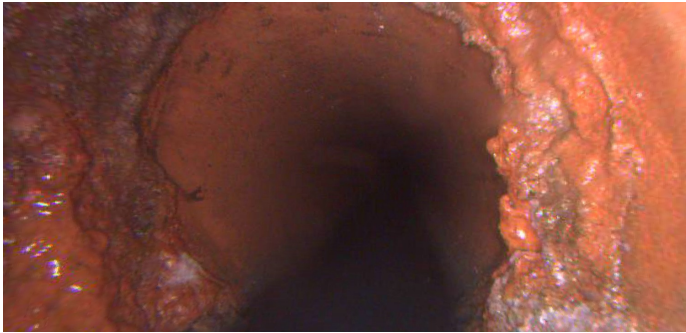
Code:	<b>MWL</b>
Description:	<b>Water Level</b>

Distance (ft):	<b>.0</b>
Structural Grade:	<b>0</b>
O&M Grade:	<b>0</b>
Clock Start/From:	
Clock To:	
1st Value:	
2nd Value:	
Value Percent:	<b>10.000</b>
Continuous Index:	
Within 8" of Joint:	<b>NO</b>
Remarks:

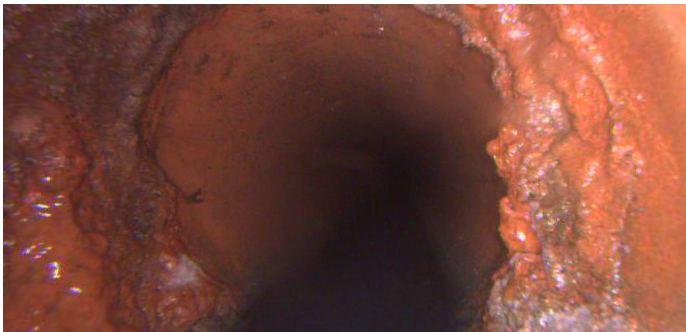
Code:	<b>DAE</b>
Description:	<b>Deposits Attached Encrustation</b>

Distance (ft):	<b>.0</b>
Structural Grade:	<b>0</b>
O&M Grade:	<b>3</b>
Clock Start/From:	<b>8</b>
Clock To:	<b>4</b>
1st Value:	
2nd Value:	
Value Percent:	<b>20.000</b>
Continuous Index:	
Within 8" of Joint:	<b>YES</b>
Remarks:

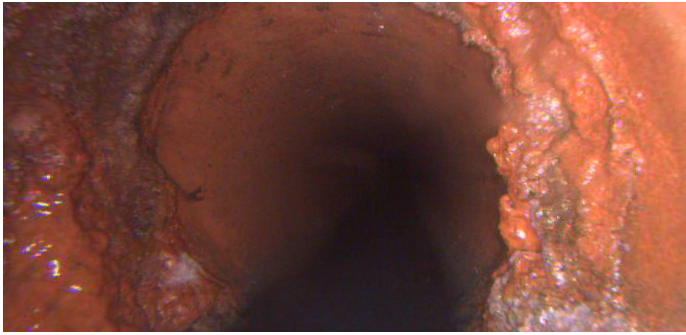
Code: **IW**  
Description: **Infil Weeper**

Distance (ft): **.0**  
Structural Grade: **0**  
O&M Grade: **2**  
Clock Start/From: **8**  
Clock To: **4**  
1st Value:  
2nd Value:  
Value Percent:  
Continuous Index: **S01**  
Within 8" of Joint:  
Remarks:

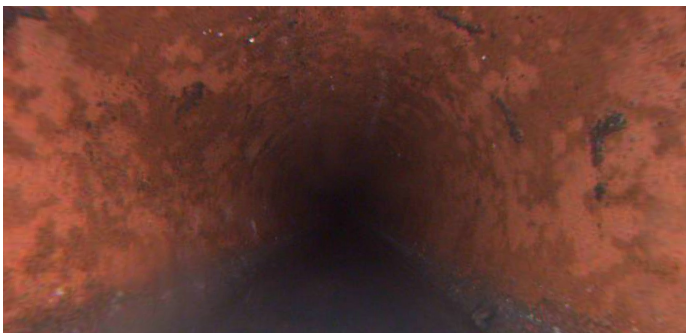
Code: **MSA**  
Description: **Abandoned Survey**

Distance (ft): **19.7**  
Structural Grade: **0**  
O&M Grade: **0**  
Clock Start/From:  
Clock To:  
1st Value:  
2nd Value:  
Value Percent:  
Continuous Index:  
Within 8" of Joint: **NO**  
Remarks: **unknown**

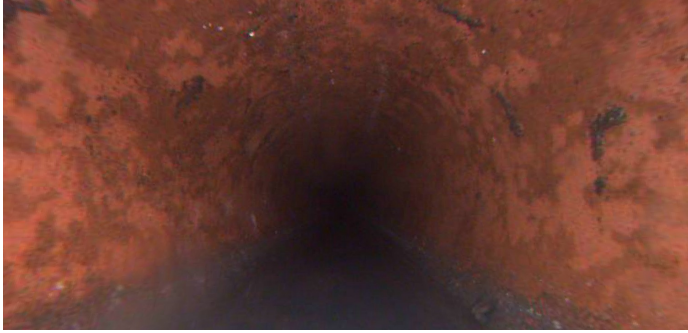
Code:	<b>IW</b>
Description:	<b>Infil Weeper</b>
Distance (ft):	<b>19.7</b>
Structural Grade:	<b>0</b>
O&M Grade:	<b>2</b>
Clock Start/From:	<b>8</b>
Clock To:	<b>4</b>
1st Value:	
2nd Value:	
Value Percent:	
Continuous Index:	<b>F01</b>
Within 8" of Joint:	
Remarks:
