## Profile/Photo Observation Report

Street:	<b>S DELAWARE ST</b>	Flow Control:	<b>Not Controlled</b>
City:	<b>Hobart, IN</b>	Year Renewed:	
Location:	<b>Light Highway</b>	Tape/Media #:	
Purpose:	<b>Routine Assessment</b>	Dia/Height:	<b>12"</b>
Use:	<b>Sanitary</b>	Material:	<b>VCP</b>
Drain Area:	<b>NA</b>	Lining:	
Category:	<b>NA</b>		
Comment:

Location Details:		Direction of Survey:	<b>Downstream</b>
US MH:	<b>M-507-006</b>	DS MH:	<b>M-507-007</b>
		Total Length Surveyed (ft):	<b>63.7</b>

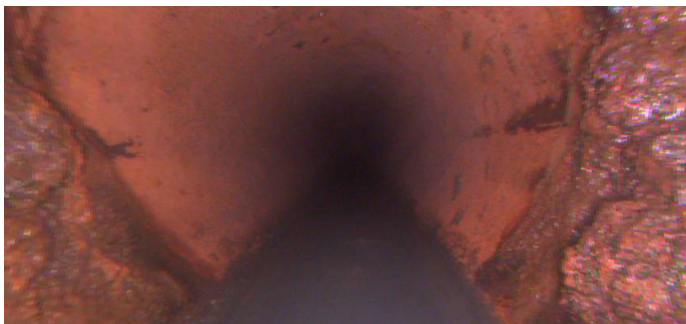
Code: **AMH**  
Description: **Manhole**

Distance (ft): **.0**  
Structural Grade: **0**  
O&M Grade: **0**  
Clock Start/From:  
Clock To:  
1st Value:  
2nd Value:  
Value Percent:  
Continuous Index:  
Within 8" of Joint: **NO**  
Remarks: **M-507-006**

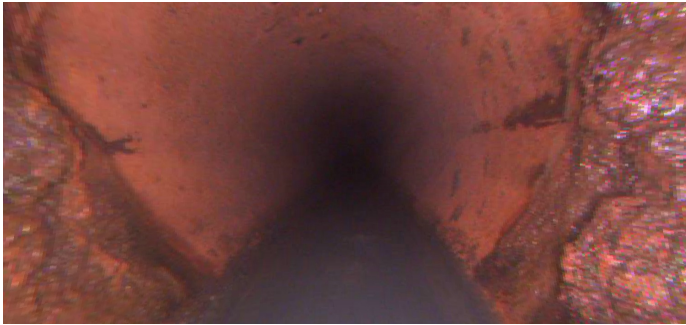
Code:	<b>MWL</b>
Description:	<b>Water Level</b>

Distance (ft):	<b>.0</b>
Structural Grade:	<b>0</b>
O&M Grade:	<b>0</b>
Clock Start/From:	
Clock To:	
1st Value:	
2nd Value:	
Value Percent:	<b>5.000</b>
Continuous Index:	
Within 8" of Joint:	<b>NO</b>
Remarks:

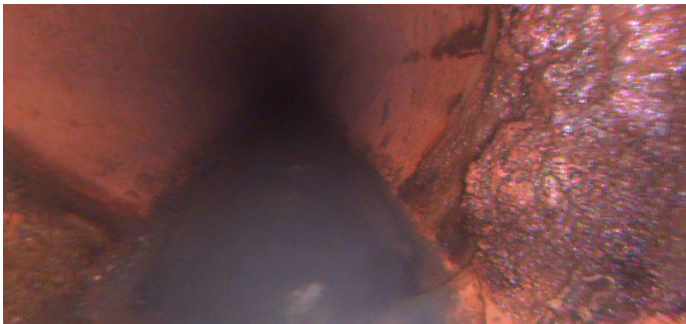
Code:	<b>DAE</b>
Description:	<b>Deposits Attached Encrustation</b>

Distance (ft):	<b>.0</b>
Structural Grade:	<b>0</b>
O&M Grade:	<b>3</b>
Clock Start/From:	<b>7</b>
Clock To:	<b>5</b>
1st Value:	
2nd Value:	
Value Percent:	<b>20.000</b>
Continuous Index:	
Within 8" of Joint:	<b>YES</b>
Remarks:

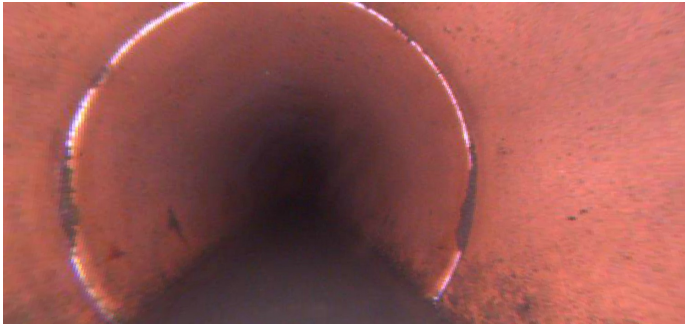
Code: **RFJ**  
Description: **Roots Fine Joint**

Distance (ft): **7.1**  
Structural Grade: **0**  
O&M Grade: **1**  
Clock Start/From: **8**  
Clock To: **4**  
1st Value:  
2nd Value:  
Value Percent:  
Continuous Index:  
Within 8" of Joint: **YES**  
Remarks:

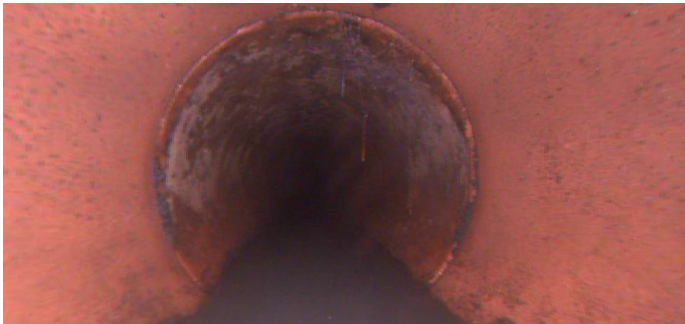
Code: **RFJ**  
Description: **Roots Fine Joint**

Distance (ft): **13.1**  
Structural Grade: **0**  
O&M Grade: **1**  
Clock Start/From: **8**  
Clock To: **4**  
1st Value:  
2nd Value:  
Value Percent:  
Continuous Index:  
Within 8" of Joint: **YES**  
Remarks:

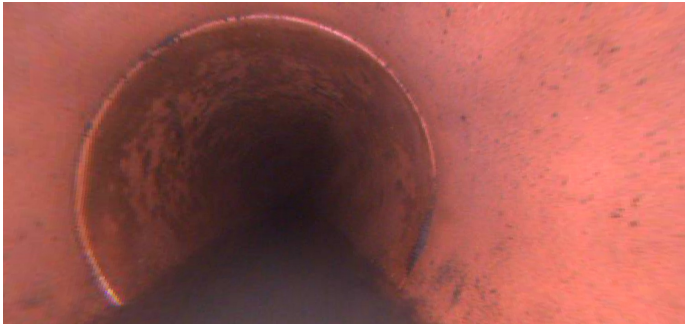
Code: **RFJ**  
Description: **Roots Fine Joint**

Distance (ft): **19.3**  
Structural Grade: **0**  
O&M Grade: **1**  
Clock Start/From: **9**  
Clock To: **4**  
1st Value:  
2nd Value:  
Value Percent:  
Continuous Index:  
Within 8" of Joint: **YES**  
Remarks:

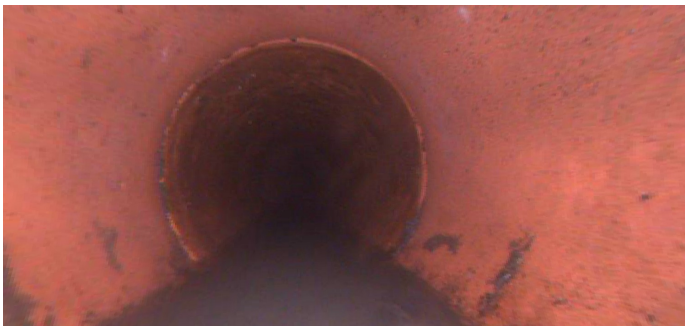
Code: **RFJ**  
Description: **Roots Fine Joint**

Distance (ft): **25.2**  
Structural Grade: **0**  
O&M Grade: **1**  
Clock Start/From: **8**  
Clock To: **4**  
1st Value:  
2nd Value:  
Value Percent:  
Continuous Index:  
Within 8" of Joint: **YES**  
Remarks:

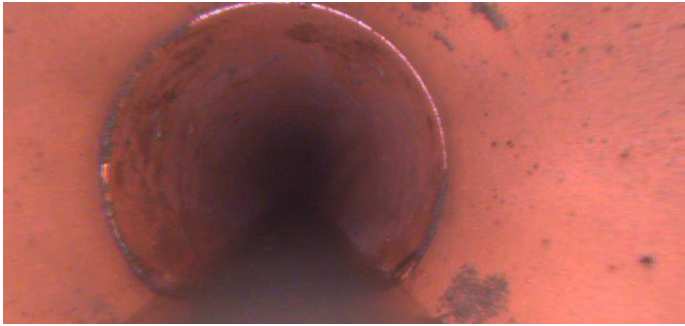
Code: **RFJ**  
Description: **Roots Fine Joint**

Distance (ft): **31.6**  
Structural Grade: **0**  
O&M Grade: **1**  
Clock Start/From: **7**  
Clock To: **5**  
1st Value:  
2nd Value:  
Value Percent:  
Continuous Index:  
Within 8" of Joint: **YES**  
Remarks:

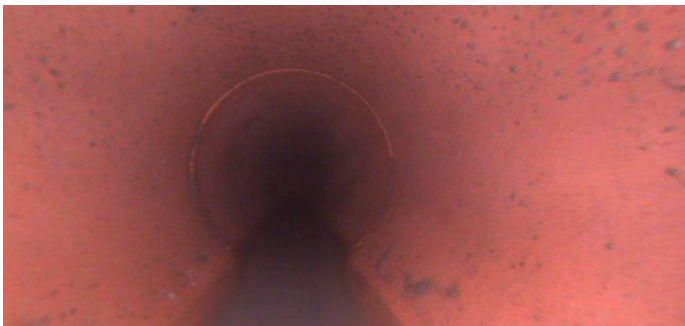
Code: **RFJ**  
Description: **Roots Fine Joint**

Distance (ft): **37.2**  
Structural Grade: **0**  
O&M Grade: **1**  
Clock Start/From: **7**  
Clock To: **5**  
1st Value:  
2nd Value:  
Value Percent:  
Continuous Index:  
Within 8" of Joint: **YES**  
Remarks:

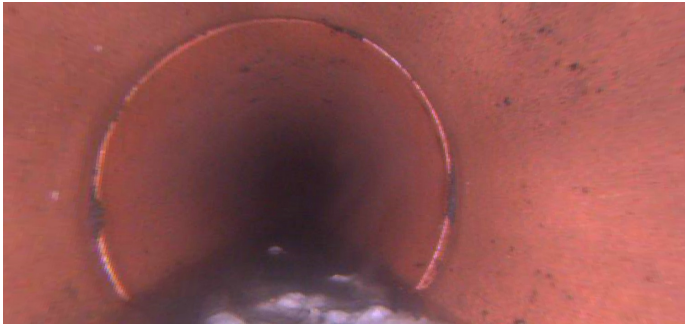
Code: **RFJ**  
Description: **Roots Fine Joint**

Distance (ft): **56.5**  
Structural Grade: **0**  
O&M Grade: **1**  
Clock Start/From: **8**  
Clock To: **4**  
1st Value:  
2nd Value:  
Value Percent:  
Continuous Index:  
Within 8" of Joint: **YES**  
Remarks:

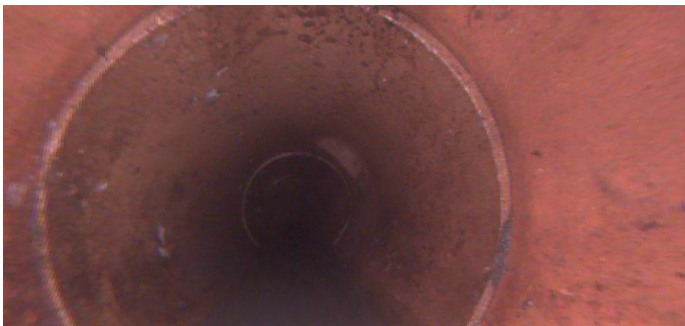
Code: **RFJ**  
Description: **Roots Fine Joint**

Distance (ft): **62.9**  
Structural Grade: **0**  
O&M Grade: **1**  
Clock Start/From: **4**  
Clock To:  
1st Value:  
2nd Value:  
Value Percent:  
Continuous Index:  
Within 8" of Joint: **YES**  
Remarks:

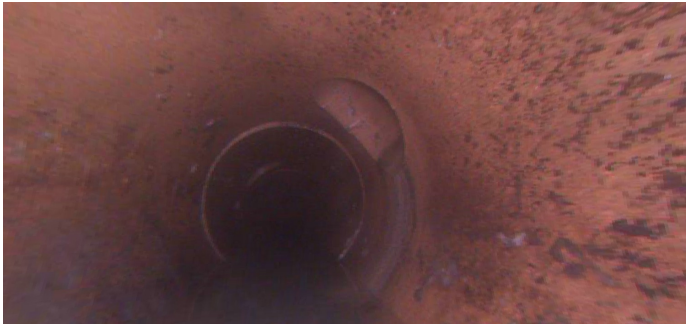
Code: **TF**  
Description: **Tap Factory**

Distance (ft): **63.7**  
Structural Grade: **0**  
O&M Grade: **0**  
Clock Start/From: **1**  
Clock To:  
1st Value: **4.000**  
2nd Value:  
Value Percent:  
Continuous Index:  
Within 8" of Joint:  
Remarks:

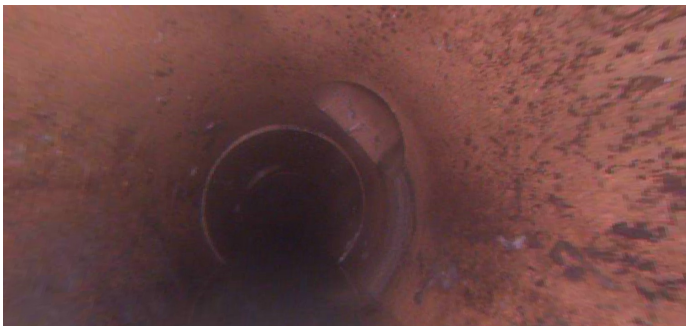
Code: **MSA**  
Description: **Abandoned Survey**

Distance (ft): **63.7**  
Structural Grade: **0**  
O&M Grade: **0**  
Clock Start/From:  
Clock To:  
1st Value:  
2nd Value:  
Value Percent:  
Continuous Index:  
Within 8" of Joint: **NO**  
Remarks: **camera stopped**
