Profile/Photo Observation Report

Date:	10/09/2018	Weather:		Coding:	PACP 6.0
Pipe Length (ft):	163.3	Owner:	NA	Pre Clean:	Not Known
P.O.#:		Surveyor:	Selasie Honu	PSR:	P-507-007-006
Customer:		Clean Date:	01/01/1900	Shape:	C

Street:	Delaware St.	Flow Control:	Not Controlled
City:	Hobart, IN	Year Renewed:	
Location:	Light Highway	Tape/Media #:	
Purpose:	Routine Assessment	Dia/Height:	12"
Use:	Sanitary	Material:	VCP
Drain Area:	NA	Lining:	
Category:	NA		
Comment:

Location Details:		Direction of Survey:	Downstream
US MH:	M-507-006	DS MH:	M-507-007
		Total Length Surveyed (ft):	63.7

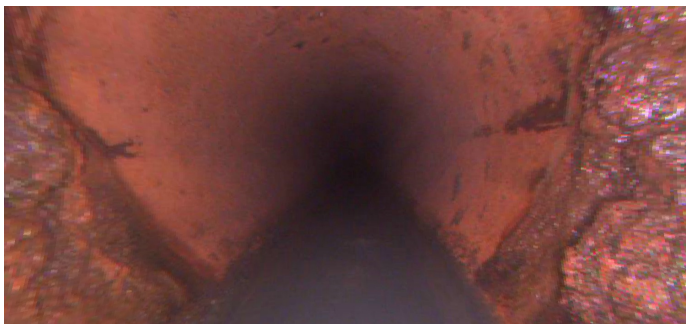
Code: **AMH**
Description: **Manhole**

Distance (ft): **.0**
Structural Grade: **0**
O&M Grade: **0**
Clock Start/From:
Clock To:
1st Value:
2nd Value:
Value Percent:
Continuous Index:
Within 8" of Joint: **NO**
Remarks: **M-507-006**

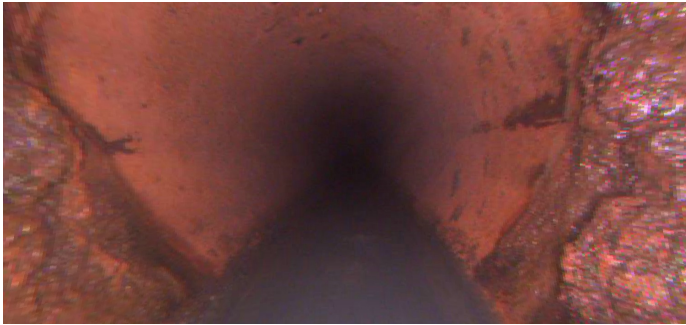
Code:	MWL
Description:	Water Level

Distance (ft):	.0
Structural Grade:	0
O&M Grade:	0
Clock Start/From:	
Clock To:	
1st Value:	
2nd Value:	
Value Percent:	5.000
Continuous Index:	
Within 8" of Joint:	NO
Remarks:

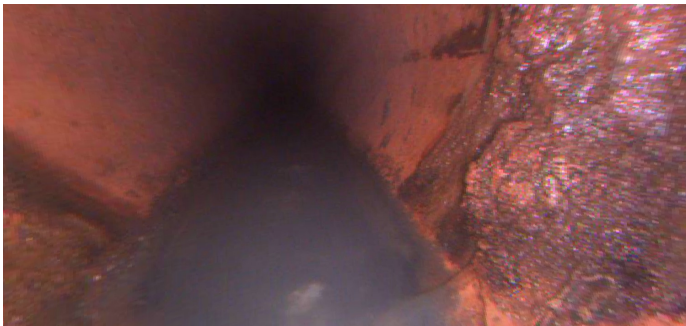
Code:	DAE
Description:	Deposits Attached Encrustation

Distance (ft):	.0
Structural Grade:	0
O&M Grade:	3
Clock Start/From:	7
Clock To:	5
1st Value:	
2nd Value:	
Value Percent:	20.000
Continuous Index:	
Within 8" of Joint:	YES
Remarks:

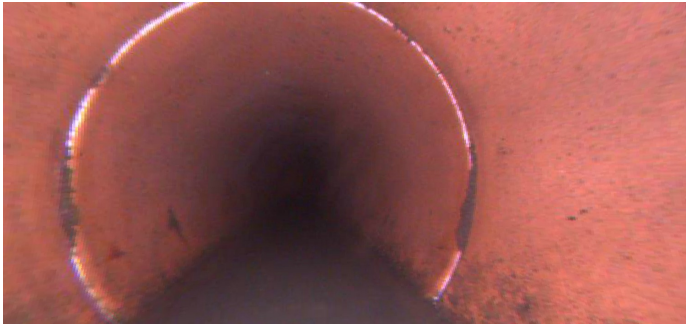
Code: **RFJ**
Description: **Roots Fine Joint**

Distance (ft): **7.1**
Structural Grade: **0**
O&M Grade: **1**
Clock Start/From: **8**
Clock To: **4**
1st Value:
2nd Value:
Value Percent:
Continuous Index:
Within 8" of Joint: **YES**
Remarks:

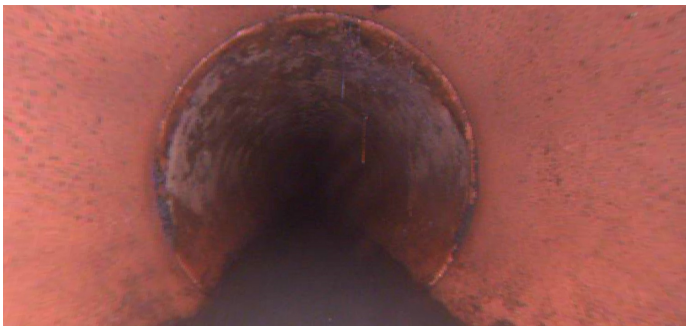
Code: **RFJ**
Description: **Roots Fine Joint**

Distance (ft): **13.1**
Structural Grade: **0**
O&M Grade: **1**
Clock Start/From: **8**
Clock To: **4**
1st Value:
2nd Value:
Value Percent:
Continuous Index:
Within 8" of Joint: **YES**
Remarks:

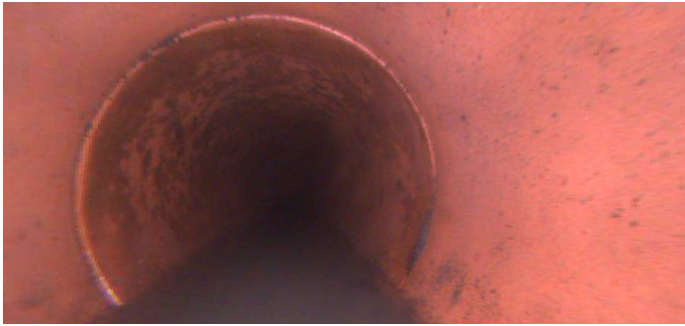
Code: **RFJ**
Description: **Roots Fine Joint**

Distance (ft): **19.3**
Structural Grade: **0**
O&M Grade: **1**
Clock Start/From: **9**
Clock To: **4**
1st Value:
2nd Value:
Value Percent:
Continuous Index:
Within 8" of Joint: **YES**
Remarks:

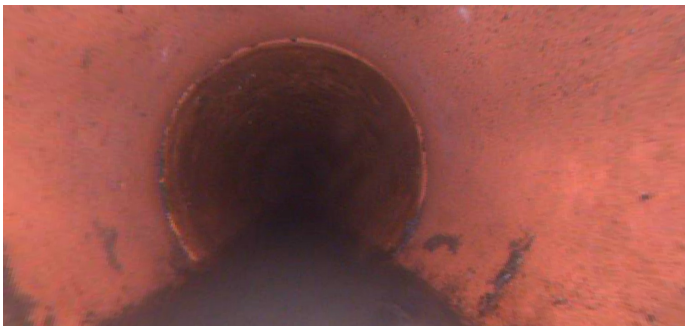
Code: **RFJ**
Description: **Roots Fine Joint**

Distance (ft): **25.2**
Structural Grade: **0**
O&M Grade: **1**
Clock Start/From: **8**
Clock To: **4**
1st Value:
2nd Value:
Value Percent:
Continuous Index:
Within 8" of Joint: **YES**
Remarks:

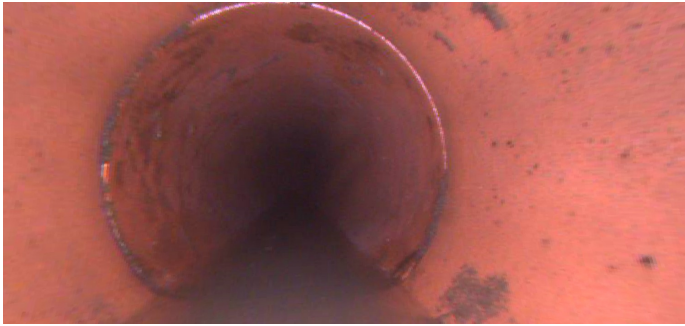
Code: **RFJ**
Description: **Roots Fine Joint**

Distance (ft): **31.6**
Structural Grade: **0**
O&M Grade: **1**
Clock Start/From: **7**
Clock To: **5**
1st Value:
2nd Value:
Value Percent:
Continuous Index:
Within 8" of Joint: **YES**
Remarks:

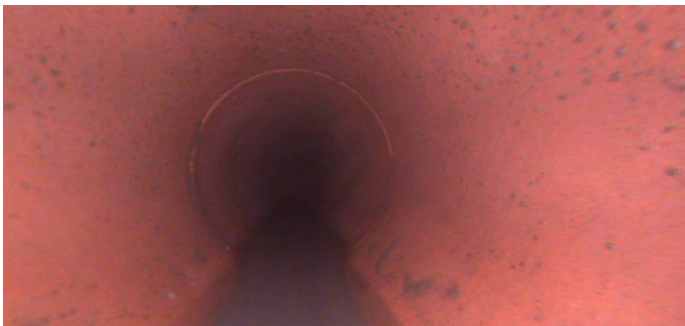
Code: **RFJ**
Description: **Roots Fine Joint**

Distance (ft): **37.2**
Structural Grade: **0**
O&M Grade: **1**
Clock Start/From: **7**
Clock To: **5**
1st Value:
2nd Value:
Value Percent:
Continuous Index:
Within 8" of Joint: **YES**
Remarks:

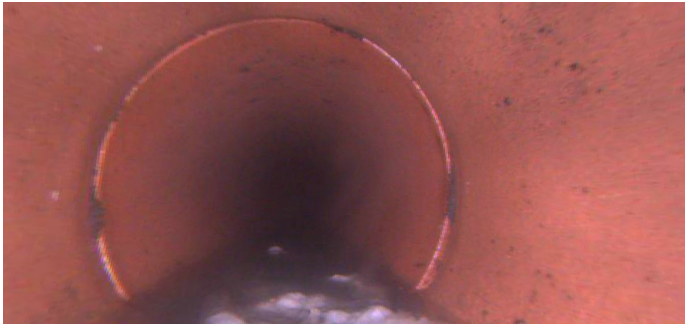
Code: **RFJ**
Description: **Roots Fine Joint**

Distance (ft): **56.5**
Structural Grade: **0**
O&M Grade: **1**
Clock Start/From: **8**
Clock To: **4**
1st Value:
2nd Value:
Value Percent:
Continuous Index:
Within 8" of Joint: **YES**
Remarks:

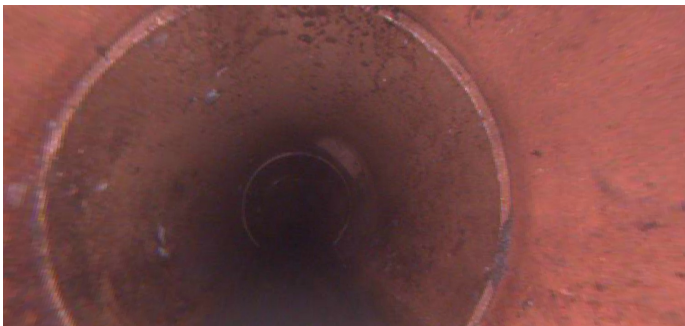
Code: **RFJ**
Description: **Roots Fine Joint**

Distance (ft): **62.9**
Structural Grade: **0**
O&M Grade: **1**
Clock Start/From: **4**
Clock To:
1st Value:
2nd Value:
Value Percent:
Continuous Index:
Within 8" of Joint: **YES**
Remarks:

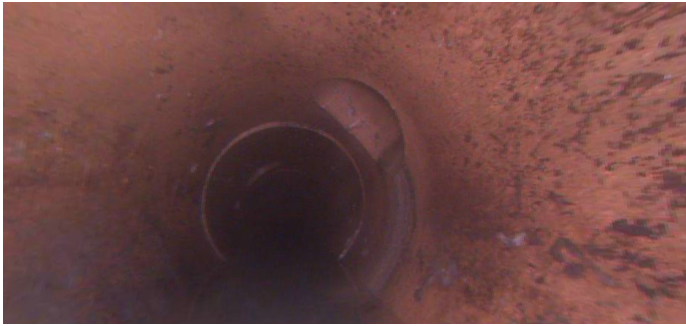
Code: **TF**
Description: **Tap Factory**

Distance (ft): **63.7**
Structural Grade: **0**
O&M Grade: **0**
Clock Start/From: **1**
Clock To:
1st Value: **4.000**
2nd Value:
Value Percent:
Continuous Index:
Within 8" of Joint:
Remarks:

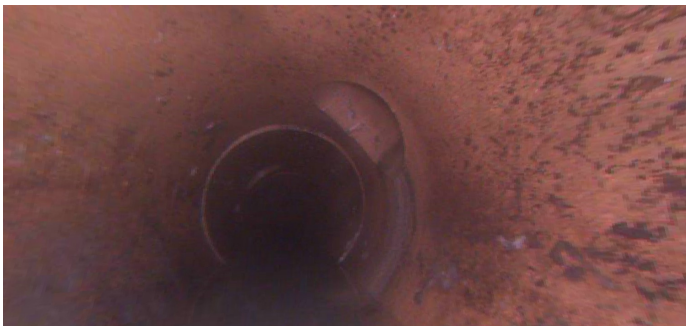
Code: **MSA**
Description: **Abandoned Survey**

Distance (ft): **63.7**
Structural Grade: **0**
O&M Grade: **0**
Clock Start/From:
Clock To:
1st Value:
2nd Value:
Value Percent:
Continuous Index:
Within 8" of Joint: **NO**
Remarks: **camera stopped**
