Profile/Photo Observation Report

Date:	10/08/2018	Weather:		Coding:	PACP 6.0
Pipe Length (ft):	419.1	Owner:	NA	Pre Clean:	Not Known
P.O.#:		Surveyor:	Selasie Honu	PSR:	P-507-010-009
Customer:		Clean Date:	01/01/1900	Shape:	C

Street:	CSOKASY LN	Flow Control:	Not Controlled
City:	Hobart, IN	Year Renewed:	
Location:	Light Highway	Tape/Media #:	
Purpose:	Routine Assessment	Dia/Height:	10"
Use:	Sanitary	Material:	VCP
Drain Area:	NA	Lining:	
Category:	NA		
Comment:

Location Details:		Direction of Survey:	Upstream
US MH:	M-507-009	DS MH:	M-507-010
		Total Length Surveyed (ft):	403.2

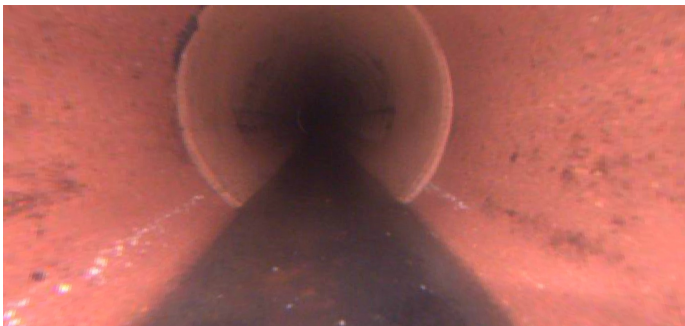
Code: **MWL**
Description: **Water Level**

Distance (ft): **.0**
Structural Grade: **0**
O&M Grade: **0**
Clock Start/From:
Clock To:
1st Value:
2nd Value:
Value Percent: **5.000**
Continuous Index:
Within 8" of Joint: **NO**
Remarks:

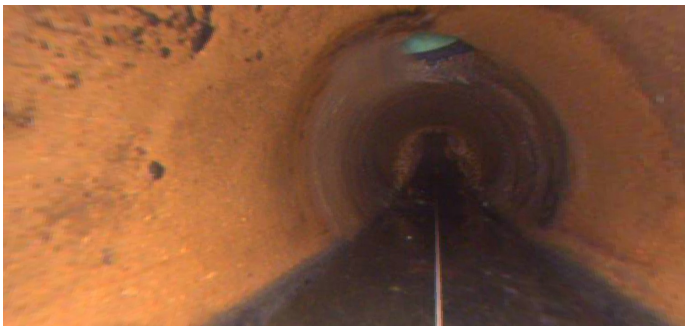
Code: **MGO**
Description: **General Observation**

Distance (ft): **94.1**
Structural Grade: **0**
O&M Grade: **0**
Clock Start/From:
Clock To:
1st Value:
2nd Value:
Value Percent:
Continuous Index:
Within 8" of Joint: **NO**
Remarks: **switching to rear view**

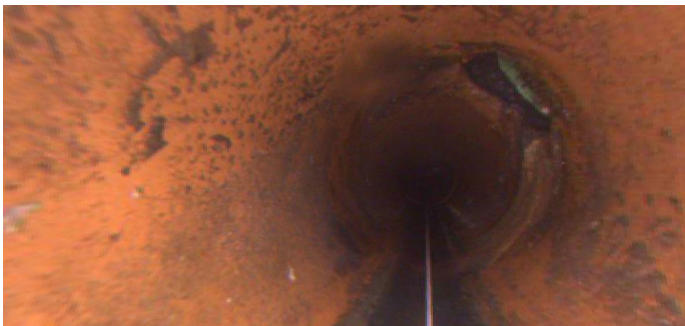
Code: **TF**
Description: **Tap Factory**

Distance (ft): **105.0**
Structural Grade: **0**
O&M Grade: **0**
Clock Start/From: **2**
Clock To:
1st Value: **4.000**
2nd Value:
Value Percent:
Continuous Index:
Within 8" of Joint:
Remarks:

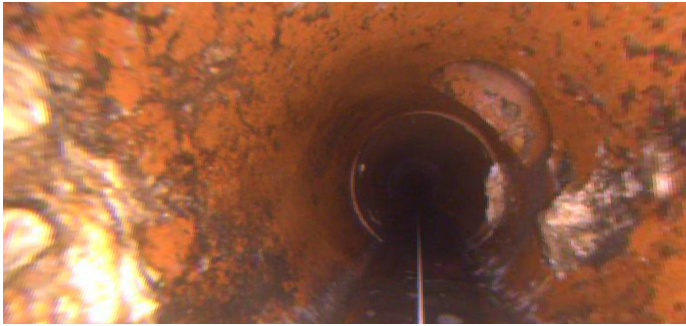
Code: **TF**
Description: **Tap Factory**

Distance (ft): **146.6**
Structural Grade: **0**
O&M Grade: **0**
Clock Start/From: **2**
Clock To:
1st Value: **4.000**
2nd Value:
Value Percent:
Continuous Index:
Within 8" of Joint:
Remarks:

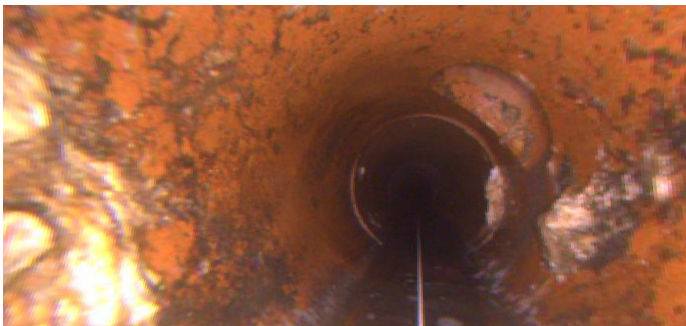
Code: **DAGS**
Description: **Deposits Attached Grease**

Distance (ft): **146.6**
Structural Grade: **0**
O&M Grade: **2**
Clock Start/From: **3**
Clock To: **4**
1st Value:
2nd Value:
Value Percent: **10.000**
Continuous Index:
Within 8" of Joint: **YES**
Remarks:

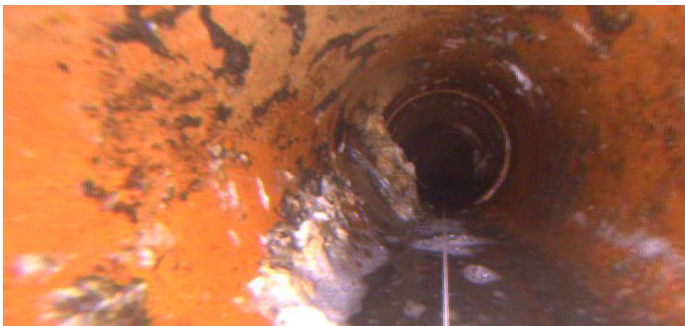
Code: **DAGS**
Description: **Deposits Attached Grease**

Distance (ft): **149.0**
Structural Grade: **0**
O&M Grade: **3**
Clock Start/From: **7**
Clock To: **5**
1st Value:
2nd Value:
Value Percent: **15.000**
Continuous Index:
Within 8" of Joint: **NO**
Remarks:

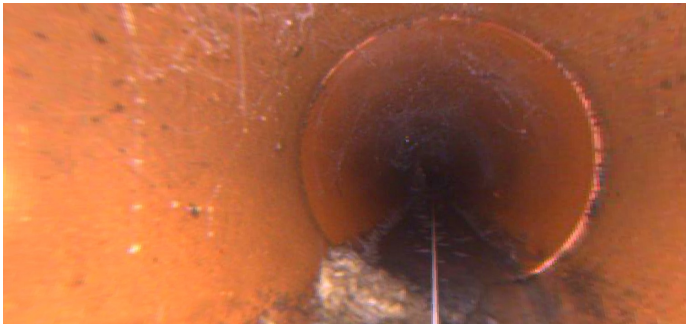
Code: **DAGS**
Description: **Deposits Attached Grease**

Distance (ft): **154.6**
Structural Grade: **0**
O&M Grade: **2**
Clock Start/From: **6**
Clock To: **7**
1st Value:
2nd Value:
Value Percent: **5.000**
Continuous Index:
Within 8" of Joint: **YES**
Remarks:

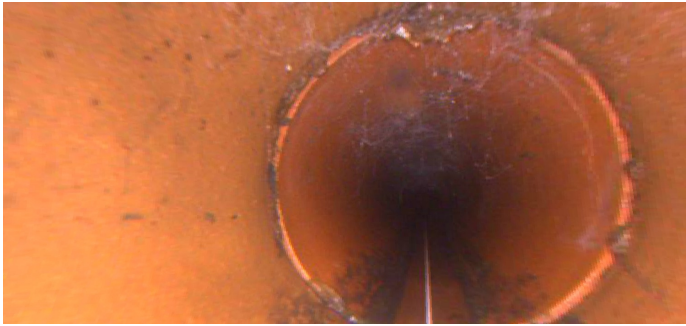
Code: **DAE**
Description: **Deposits Attached Encrustation**

Distance (ft): **169.2**
Structural Grade: **0**
O&M Grade: **2**
Clock Start/From: **7**
Clock To: **5**
1st Value:
2nd Value:
Value Percent: **5.000**
Continuous Index:
Within 8" of Joint: **YES**
Remarks:

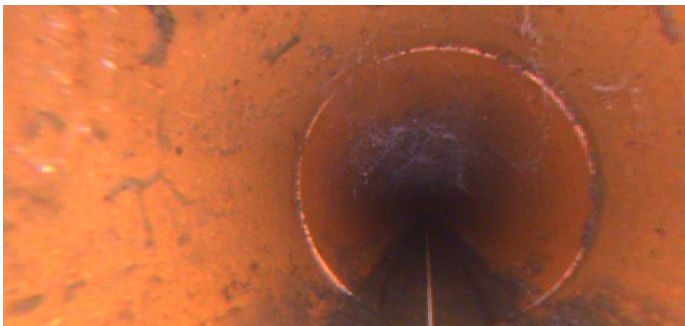
Code: **RFJ**
Description: **Roots Fine Joint**

Distance (ft): **198.7**
Structural Grade: **0**
O&M Grade: **1**
Clock Start/From: **8**
Clock To: **4**
1st Value:
2nd Value:
Value Percent:
Continuous Index:
Within 8" of Joint: **YES**
Remarks:

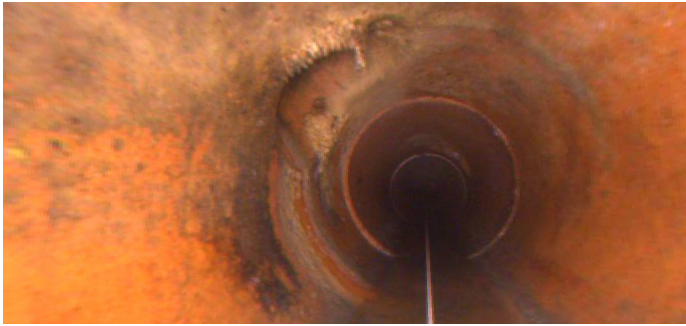
Code: **TF**
Description: **Tap Factory**

Distance (ft): **230.8**
Structural Grade: **0**
O&M Grade: **0**
Clock Start/From: **10**
Clock To:
1st Value: **4.000**
2nd Value:
Value Percent:
Continuous Index:
Within 8" of Joint:
Remarks:

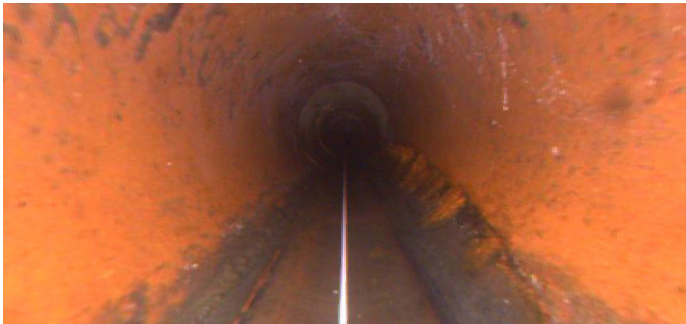
Code: **FL**
Description: **Fracture Longitudinal**

Distance (ft): **234.0**
Structural Grade: **3**
O&M Grade: **0**
Clock Start/From: **4**
Clock To:
1st Value:
2nd Value:
Value Percent:
Continuous Index:
Within 8" of Joint: **YES**
Remarks:

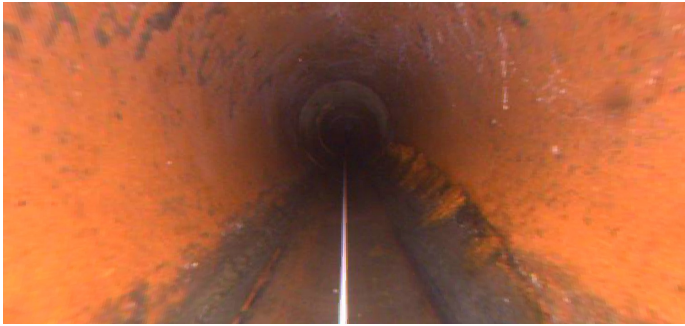
Code: **DAE**
Description: **Deposits Attached Encrustation**

Distance (ft): **234.0**
Structural Grade: **0**
O&M Grade: **3**
Clock Start/From: **4**
Clock To: **5**
1st Value:
2nd Value:
Value Percent: **20.000**
Continuous Index:
Within 8" of Joint: **YES**
Remarks:

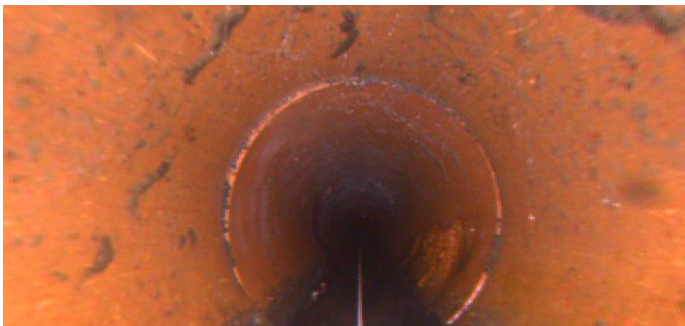
Code: **RFJ**
Description: **Roots Fine Joint**

Distance (ft): **237.1**
Structural Grade: **0**
O&M Grade: **1**
Clock Start/From: **8**
Clock To: **4**
1st Value:
2nd Value:
Value Percent:
Continuous Index:
Within 8" of Joint: **YES**
Remarks:

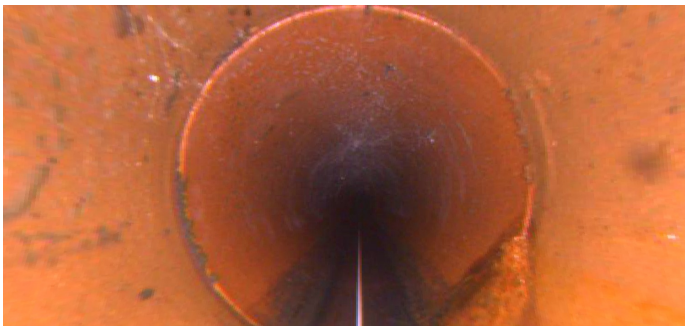
Code: **DAE**
Description: **Deposits Attached Encrustation**

Distance (ft): **241.9**
Structural Grade: **0**
O&M Grade: **2**
Clock Start/From: **4**
Clock To: **5**
1st Value:
2nd Value:
Value Percent: **10.000**
Continuous Index:
Within 8" of Joint: **YES**
Remarks:

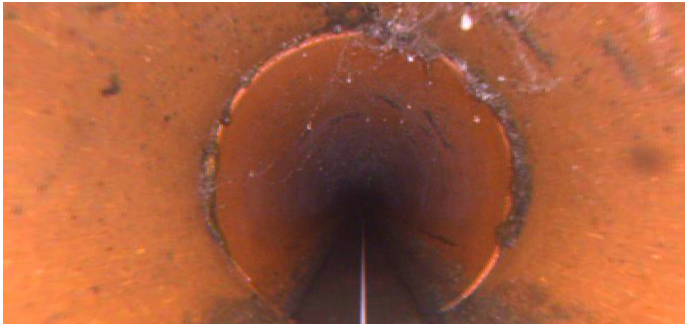
Code: **DAE**
Description: **Deposits Attached Encrustation**

Distance (ft): **276.6**
Structural Grade: **0**
O&M Grade: **2**
Clock Start/From: **8**
Clock To: **4**
1st Value:
2nd Value:
Value Percent: **5.000**
Continuous Index:
Within 8" of Joint: **YES**
Remarks:

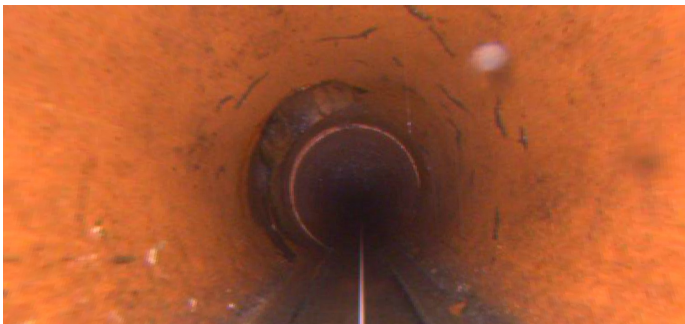
Code: **TF**
Description: **Tap Factory**

Distance (ft): **307.2**
Structural Grade: **0**
O&M Grade: **0**
Clock Start/From: **11**
Clock To:
1st Value: **4.000**
2nd Value:
Value Percent:
Continuous Index:
Within 8" of Joint:
Remarks:
