Profile/Photo Observation Report

Street:	CSOKASY LN	Flow Control:	Not Controlled
City:	Hobart, IN	Year Renewed:	
Location:	Yard	Tape/Media #:	
Purpose:	Not Known	Dia/Height:	10"
Use:	Sanitary	Material:	VCP
Drain Area:	NA	Lining:	
Category:	NA		
Comment:	P_C at 50 ft nothing visible . Flow direction wrong		
Location Details:		Direction of Survey:	Downstream
US MH:	M-507-013	DS MH:	M-507-014
		Total Length Surveyed (ft):	51.8

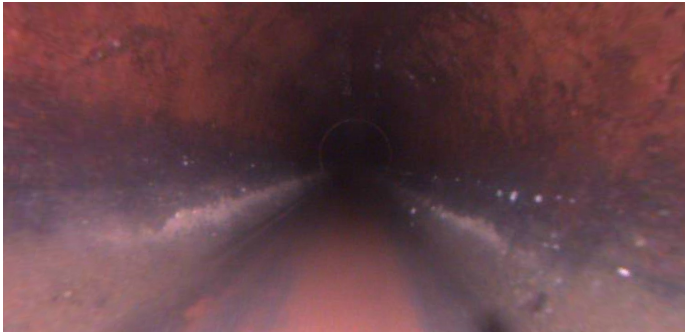
Code:	MWL
Description:	Water Level

Distance (ft):	.0
Structural Grade:	0
O&M Grade:	0
Clock Start/From:	
Clock To:	
1st Value:	
2nd Value:	
Value Percent:	10.000
Continuous Index:	
Within 8" of Joint:	NO
Remarks:

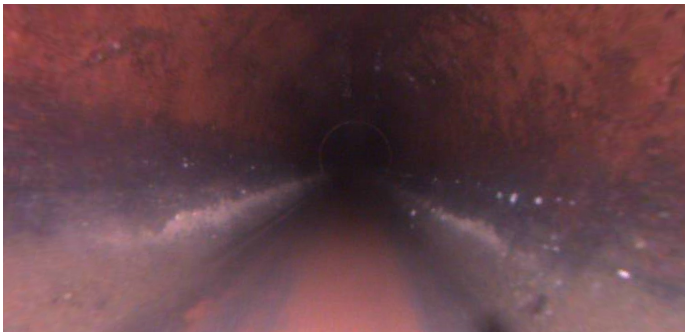
Code:	DAGS
Description:	Deposits Attached Grease

Distance (ft):	.0
Structural Grade:	0
O&M Grade:	2
Clock Start/From:	7
Clock To:	5
1st Value:	
2nd Value:	
Value Percent:	5.000
Continuous Index:	S01
Within 8" of Joint:	NO
Remarks:

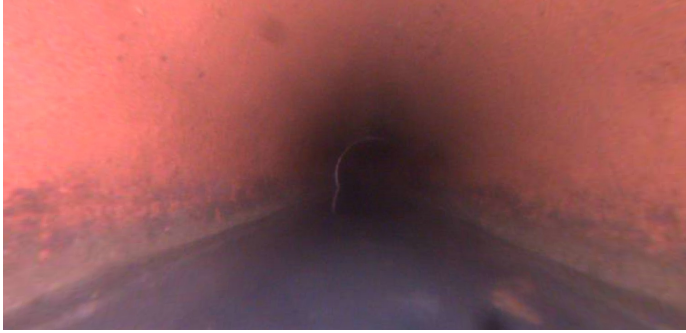
Code: **MWL**
Description: **Water Level**

Distance (ft): **26.4**
Structural Grade: **0**
O&M Grade: **0**
Clock Start/From:
Clock To:
1st Value:
2nd Value:
Value Percent: **30.000**
Continuous Index:
Within 8" of Joint: **NO**
Remarks:

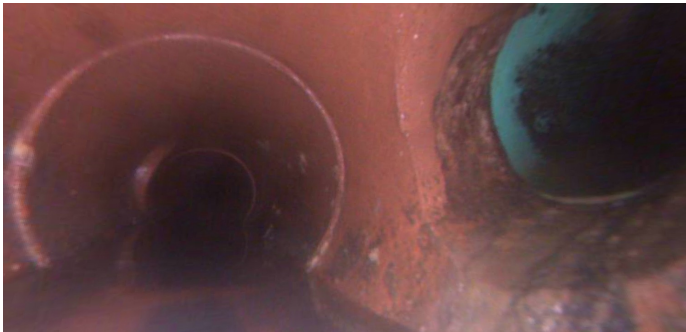
Code: **TF**
Description: **Tap Factory**

Distance (ft): **40.8**
Structural Grade: **0**
O&M Grade: **0**
Clock Start/From: **3**
Clock To:
1st Value: **4.000**
2nd Value:
Value Percent:
Continuous Index:
Within 8" of Joint:
Remarks:

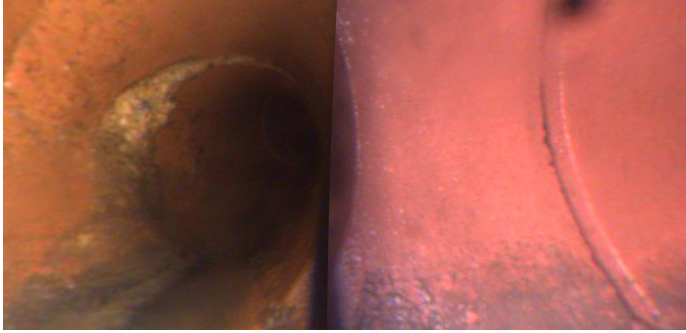
Code: **TF**
Description: **Tap Factory**

Distance (ft): **43.2**
Structural Grade: **0**
O&M Grade: **0**
Clock Start/From: **9**
Clock To:
1st Value: **4.000**
2nd Value:
Value Percent:
Continuous Index:
Within 8" of Joint:
Remarks:

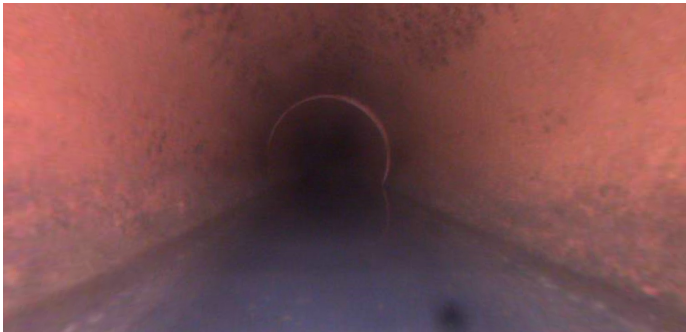
Code: **MSA**
Description: **Abandoned Survey**

Distance (ft): **51.8**
Structural Grade: **0**
O&M Grade: **0**
Clock Start/From:
Clock To:
1st Value:
2nd Value:
Value Percent:
Continuous Index:
Within 8" of Joint: **NO**
Remarks: **DEBRIS UNDER WATER**

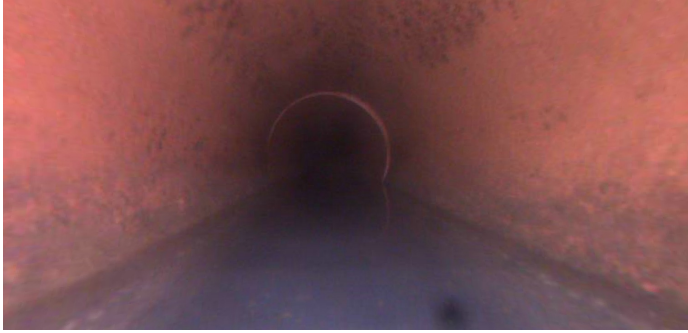
Code:	DAGS
Description:	Deposits Attached Grease
Distance (ft):	51.8
Structural Grade:	0
O&M Grade:	2
Clock Start/From:	7
Clock To:	5
1st Value:	
2nd Value:	
Value Percent:	5.000
Continuous Index:	F01
Within 8" of Joint:	NO
Remarks:
