## Profile/Photo Observation Report

Street:	<b>Csokasy Ln.</b>	Flow Control:	<b>Not Controlled</b>
City:	<b>Hobart, IN</b>	Year Renewed:	
Location:	<b>Light Highway</b>	Tape/Media #:	
Purpose:	<b>Routine Assessment</b>	Dia/Height:	<b>10"</b>
Use:	<b>Sanitary</b>	Material:	<b>VCP</b>
Drain Area:	<b>NA</b>	Lining:	
Category:	<b>NA</b>		
Comment:

Location Details:		Direction of Survey:	<b>Downstream</b>
US MH:	<b>M-507-013</b>	DS MH:	<b>M-507-014</b>
		Total Length Surveyed (ft):	<b>76.1</b>

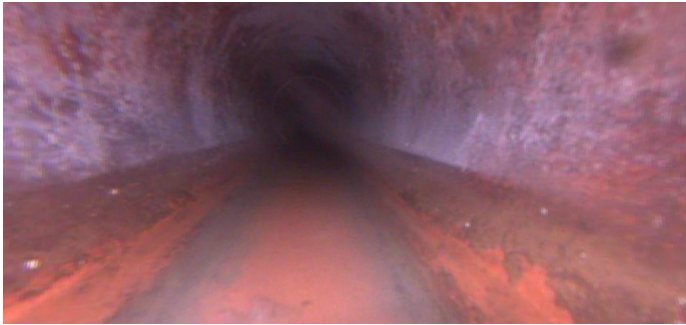
Code:	<b>MWL</b>
Description:	<b>Water Level</b>

Distance (ft):	<b>.0</b>
Structural Grade:	<b>0</b>
O&M Grade:	<b>0</b>
Clock Start/From:	
Clock To:	
1st Value:	
2nd Value:	
Value Percent:	<b>5.000</b>
Continuous Index:	
Within 8" of Joint:	<b>NO</b>
Remarks:

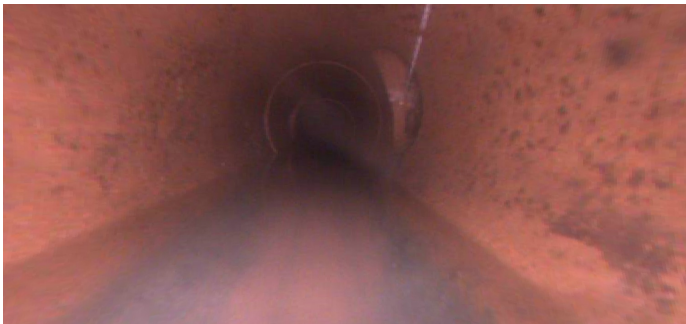
Code:	<b>TF</b>
Description:	<b>Tap Factory</b>

Distance (ft):	<b>39.1</b>
Structural Grade:	<b>0</b>
O&M Grade:	<b>0</b>
Clock Start/From:	<b>3</b>
Clock To:	
1st Value:	<b>4.000</b>
2nd Value:	
Value Percent:	
Continuous Index:	
Within 8" of Joint:	
Remarks:

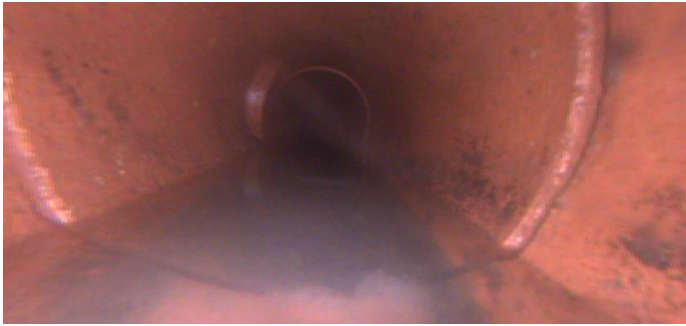
Code: **TF**  
Description: **Tap Factory**

Distance (ft): **40.7**  
Structural Grade: **0**  
O&M Grade: **0**  
Clock Start/From: **9**  
Clock To:  
1st Value: **4.000**  
2nd Value:  
Value Percent:  
Continuous Index:  
Within 8" of Joint:  
Remarks:

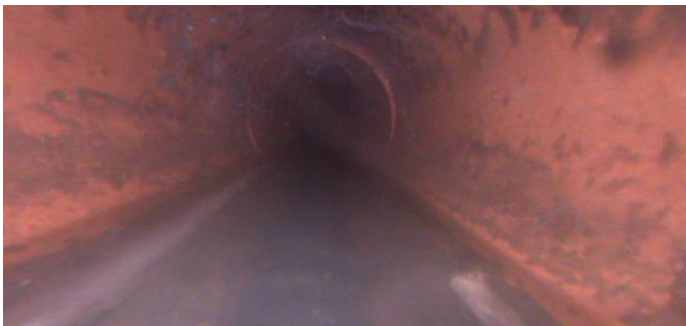
Code: **MSA**  
Description: **Abandoned Survey**

Distance (ft): **76.1**  
Structural Grade: **0**  
O&M Grade: **0**  
Clock Start/From:  
Clock To:  
1st Value:  
2nd Value:  
Value Percent:  
Continuous Index:  
Within 8" of Joint: **NO**  
Remarks: **camera stopped**
