Profile/Photo Observation Report

Date:	10/10/2018	Weather:		Coding:	PACP 6.0
Pipe Length (ft):	248.6	Owner:	NA	Pre Clean:	Not Known
P.O.#:		Surveyor:	Selasie Honu	PSR:	P-507-014-013
Customer:		Clean Date:	01/01/1900	Shape:	C

Street:	CSOKASY LN	Flow Control:	Not Controlled
City:	Hobart, IN	Year Renewed:	
Location:	Light Highway	Tape/Media #:	
Purpose:	Routine Assessment	Dia/Height:	10"
Use:	Sanitary	Material:	VCP
Drain Area:	NA	Lining:	
Category:	NA		
Comment:	NULL - DC @ MH-M-507-059

Location Details:		Direction of Survey:	Upstream
US MH:	M-507-013	DS MH:	M-507-014
		Total Length Surveyed (ft):	243.6

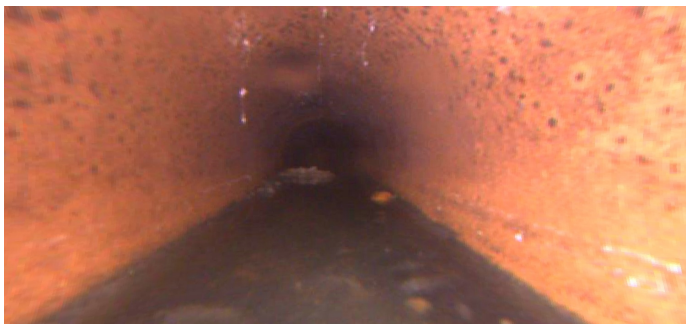
Code: **AMH**
Description: **Manhole**

Distance (ft): **.0**
Structural Grade: **0**
O&M Grade: **0**
Clock Start/From:
Clock To:
1st Value:
2nd Value:
Value Percent:
Continuous Index:
Within 8" of Joint: **NO**
Remarks: **M-507-014**

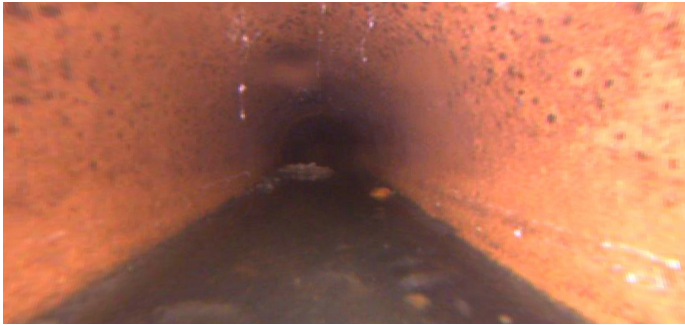
Code:	MWL
Description:	Water Level

Distance (ft):	.0
Structural Grade:	0
O&M Grade:	0
Clock Start/From:	
Clock To:	
1st Value:	
2nd Value:	
Value Percent:	5.000
Continuous Index:	
Within 8" of Joint:	NO
Remarks:

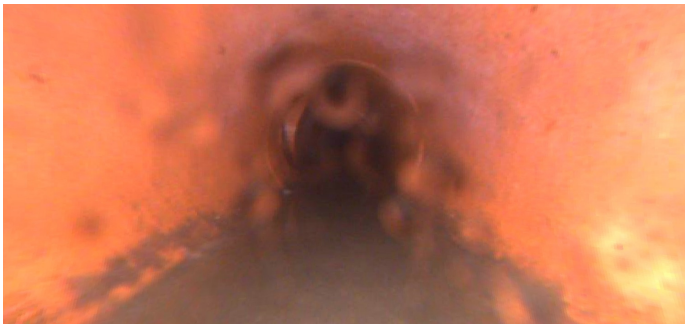
Code:	TF
Description:	Tap Factory

Distance (ft):	41.7
Structural Grade:	0
O&M Grade:	0
Clock Start/From:	9
Clock To:	
1st Value:	4.000
2nd Value:	
Value Percent:	
Continuous Index:	
Within 8" of Joint:	
Remarks:

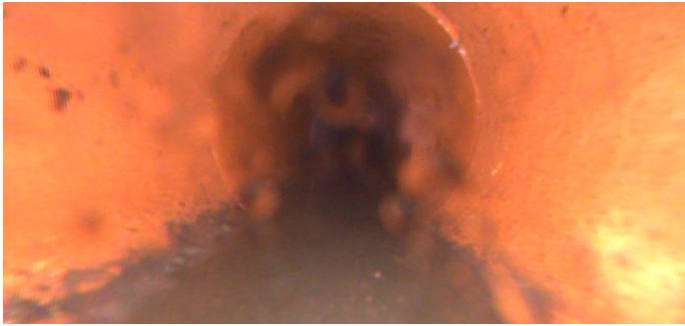
Code: **TF**
Description: **Tap Factory**

Distance (ft): **44.3**
Structural Grade: **0**
O&M Grade: **0**
Clock Start/From: **3**
Clock To:
1st Value: **4.000**
2nd Value:
Value Percent:
Continuous Index:
Within 8" of Joint:
Remarks:

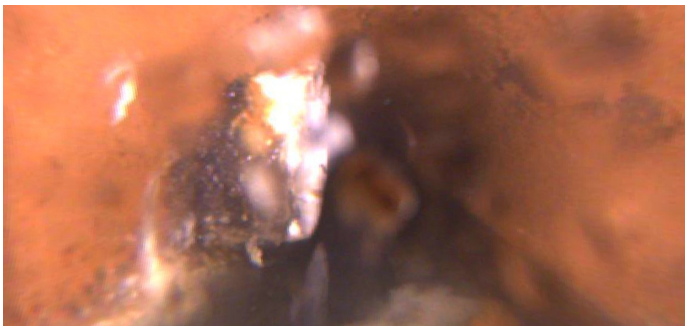
Code: **DAE**
Description: **Deposits Attached Encrustation**

Distance (ft): **122.4**
Structural Grade: **0**
O&M Grade: **2**
Clock Start/From: **8**
Clock To: **9**
1st Value:
2nd Value:
Value Percent: **10.000**
Continuous Index:
Within 8" of Joint: **NO**
Remarks:

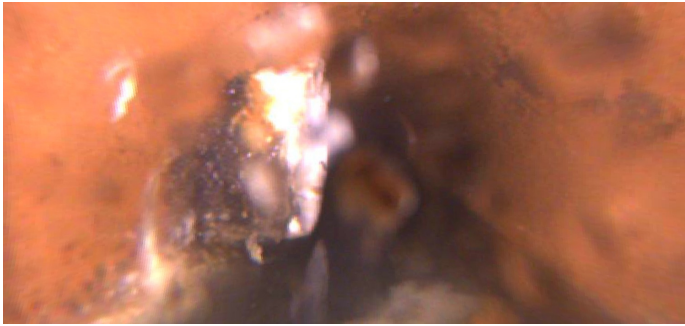
Code: **RFB**
Description: **Roots Fine Barrel**

Distance (ft): **122.4**
Structural Grade: **0**
O&M Grade: **2**
Clock Start/From: **8**
Clock To: **9**
1st Value:
2nd Value:
Value Percent:
Continuous Index:
Within 8" of Joint: **NO**
Remarks:

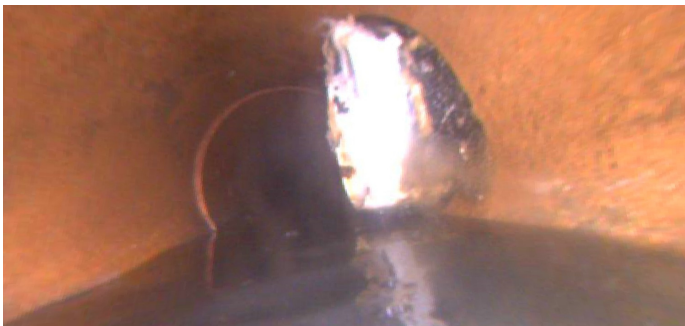
Code: **MGO**
Description: **General Observation**

Distance (ft): **124.1**
Structural Grade: **0**
O&M Grade: **0**
Clock Start/From:
Clock To:
1st Value:
2nd Value:
Value Percent:
Continuous Index:
Within 8" of Joint: **NO**
Remarks: **switching to rear view**

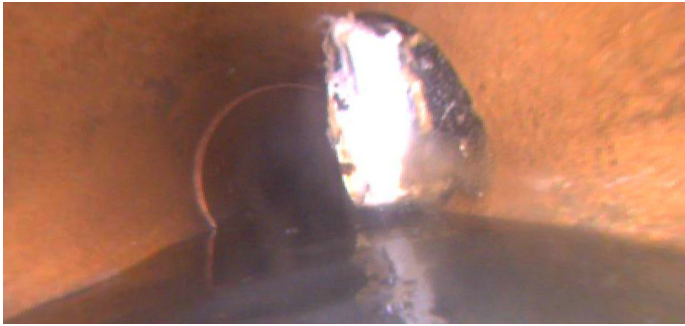
Code: **TBI**
Description: **Tap Break-in Intruding**

Distance (ft): **124.1**
Structural Grade: **0**
O&M Grade: **2**
Clock Start/From: **3**
Clock To:
1st Value: **6.000**
2nd Value: **3.000**
Value Percent:
Continuous Index:
Within 8" of Joint:
Remarks:

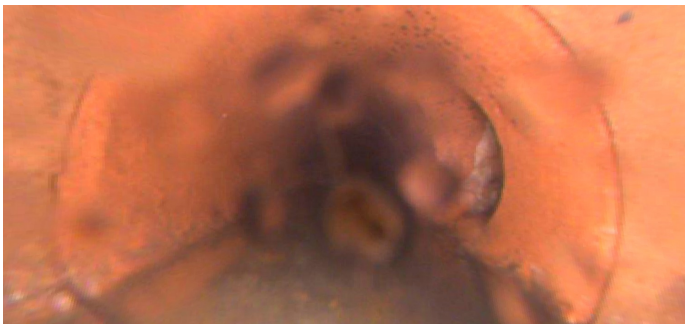
Code: **TF**
Description: **Tap Factory**

Distance (ft): **124.3**
Structural Grade: **0**
O&M Grade: **0**
Clock Start/From: **3**
Clock To:
1st Value: **4.000**
2nd Value:
Value Percent:
Continuous Index:
Within 8" of Joint:
Remarks:

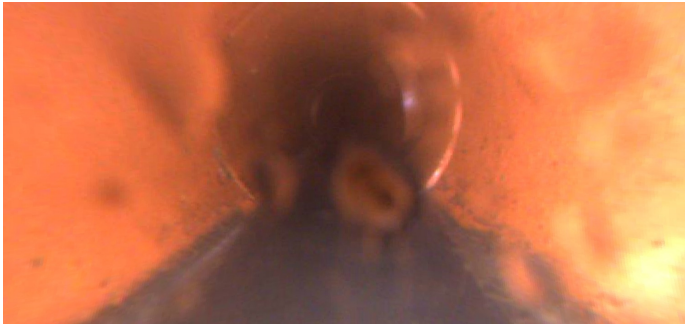
Code: **TF**
Description: **Tap Factory**

Distance (ft): **196.3**
Structural Grade: **0**
O&M Grade: **0**
Clock Start/From: **3**
Clock To:
1st Value: **4.000**
2nd Value:
Value Percent:
Continuous Index:
Within 8" of Joint:
Remarks:

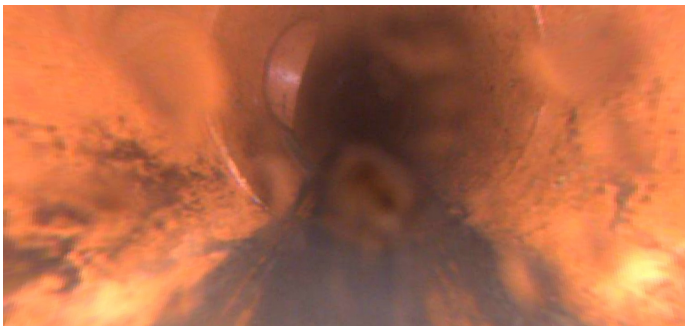
Code: **TF**
Description: **Tap Factory**

Distance (ft): **198.5**
Structural Grade: **0**
O&M Grade: **0**
Clock Start/From: **9**
Clock To:
1st Value: **4.000**
2nd Value:
Value Percent:
Continuous Index:
Within 8" of Joint:
Remarks:

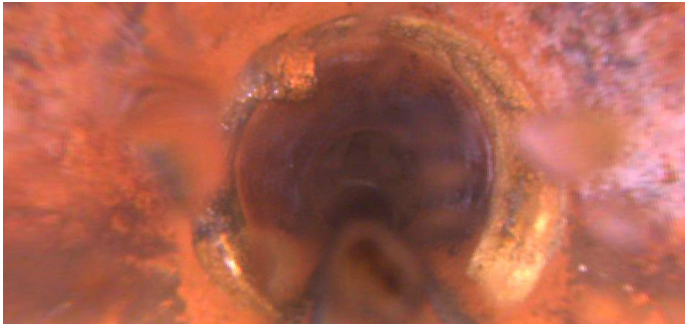
Code: **DAE**
Description: **Deposits Attached Encrustation**

Distance (ft): **239.7**
Structural Grade: **0**
O&M Grade: **3**
Clock Start/From: **7**
Clock To: **4**
1st Value:
2nd Value:
Value Percent: **20.000**
Continuous Index:
Within 8" of Joint: **YES**
Remarks:

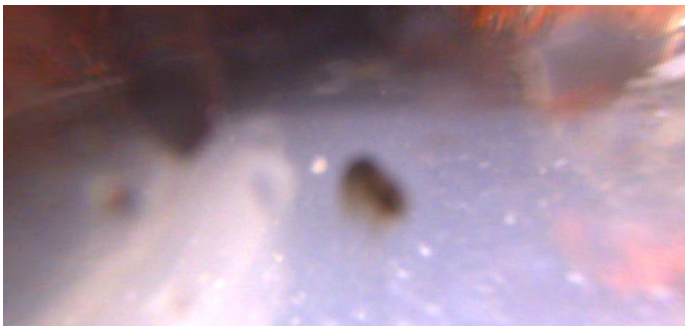
Code: **AMH**
Description: **Manhole**

Distance (ft): **243.6**
Structural Grade: **0**
O&M Grade: **0**
Clock Start/From:
Clock To:
1st Value:
2nd Value:
Value Percent:
Continuous Index:
Within 8" of Joint: **NO**
Remarks: **M-507-013**
