## Profile/Photo Observation Report

Date:	<b>10/10/2018</b>	Weather:		Coding:	<b>PACP 6.0</b>
Pipe Length (ft):	<b>248.6</b>	Owner:	<b>NA</b>	Pre Clean:	<b>Not Known</b>
P.O.#:		Surveyor:	<b>Selasie Honu</b>	PSR:	<b>P-507-014-013</b>
Customer:		Clean Date:	<b>01/01/1900</b>	Shape:	<b>C</b>

Street:	<b>Csokasy Ln.</b>	Flow Control:	<b>Not Controlled</b>
City:	<b>Hobart, IN</b>	Year Renewed:	
Location:	<b>Light Highway</b>	Tape/Media #:	
Purpose:	<b>Routine Assessment</b>	Dia/Height:	<b>10"</b>
Use:	<b>Sanitary</b>	Material:	<b>VCP</b>
Drain Area:	<b>NA</b>	Lining:	
Category:	<b>NA</b>		
Comment:	<b>NULL - DC @ MH-M-507-059</b>

Location Details:		Direction of Survey:	<b>Upstream</b>
US MH:	<b>M-507-013</b>	DS MH:	<b>M-507-014</b>
		Total Length Surveyed (ft):	<b>243.6</b>

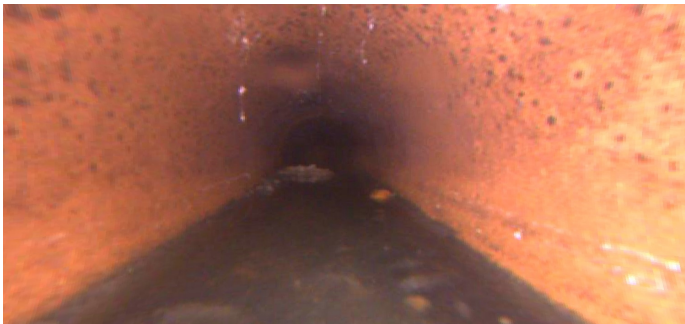
Code: **AMH**  
Description: **Manhole**

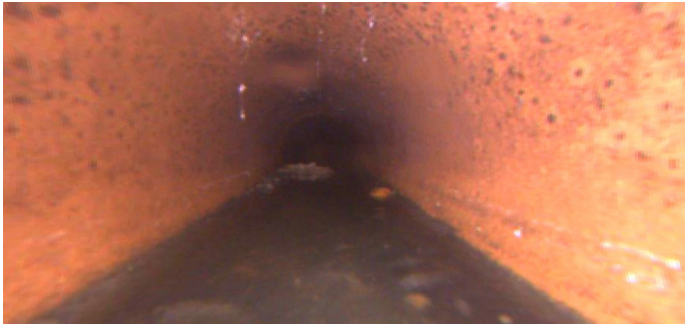
Code:	<b>MWL</b>
Description:	<b>Water Level</b>

Distance (ft):	<b>.0</b>
Structural Grade:	<b>0</b>
O&M Grade:	<b>0</b>
Clock Start/From:	
Clock To:	
1st Value:	
2nd Value:	
Value Percent:	<b>5.000</b>
Continuous Index:	
Within 8" of Joint:	<b>NO</b>
Remarks:

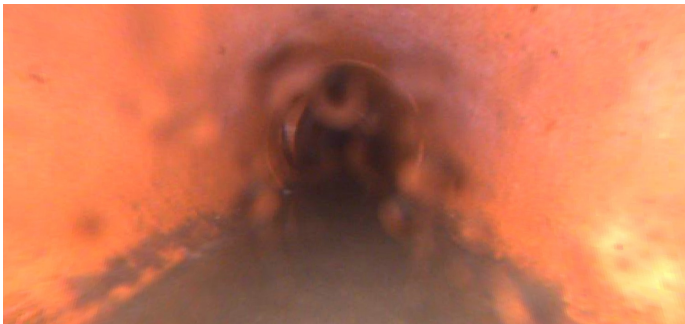
Code:	<b>TF</b>
Description:	<b>Tap Factory</b>

Distance (ft):	<b>41.7</b>
Structural Grade:	<b>0</b>
O&M Grade:	<b>0</b>
Clock Start/From:	<b>9</b>
Clock To:	
1st Value:	<b>4.000</b>
2nd Value:	
Value Percent:	
Continuous Index:	
Within 8" of Joint:	
Remarks:

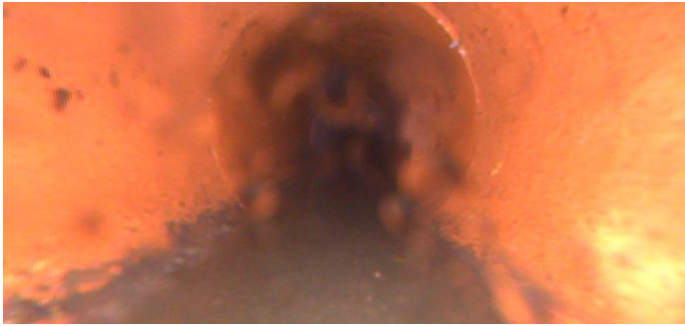
Code: **TF**  
Description: **Tap Factory**

Distance (ft): **44.3**  
Structural Grade: **0**  
O&M Grade: **0**  
Clock Start/From: **3**  
Clock To:  
1st Value: **4.000**  
2nd Value:  
Value Percent:  
Continuous Index:  
Within 8" of Joint:  
Remarks:

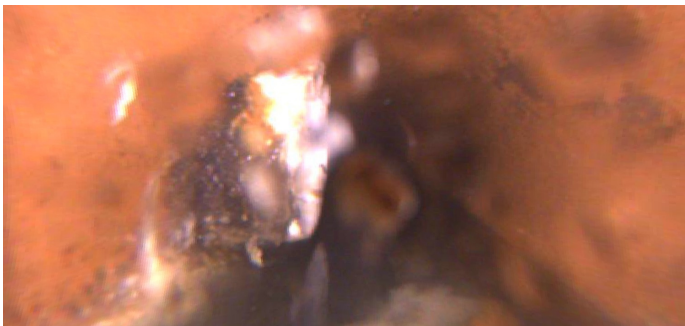
Code: **DAE**  
Description: **Deposits Attached Encrustation**

Distance (ft): **122.4**  
Structural Grade: **0**  
O&M Grade: **2**  
Clock Start/From: **8**  
Clock To: **9**  
1st Value:  
2nd Value:  
Value Percent: **10.000**  
Continuous Index:  
Within 8" of Joint: **NO**  
Remarks:

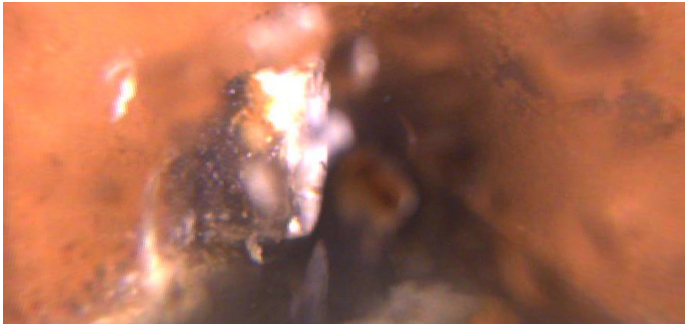
Code: **RFB**  
Description: **Roots Fine Barrel**

Distance (ft): **122.4**  
Structural Grade: **0**  
O&M Grade: **2**  
Clock Start/From: **8**  
Clock To: **9**  
1st Value:  
2nd Value:  
Value Percent:  
Continuous Index:  
Within 8" of Joint: **NO**  
Remarks:

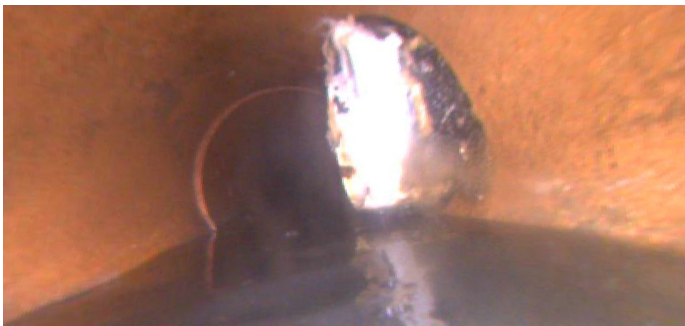
Code: **MGO**  
Description: **General Observation**

Distance (ft): **124.1**  
Structural Grade: **0**  
O&M Grade: **0**  
Clock Start/From:  
Clock To:  
1st Value:  
2nd Value:  
Value Percent:  
Continuous Index:  
Within 8" of Joint: **NO**  
Remarks: **switching to rear view**

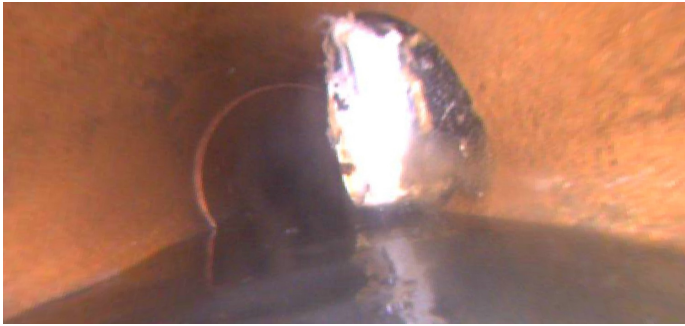
Code: **TBI**  
Description: **Tap Break-in Intruding**

Distance (ft): **124.1**  
Structural Grade: **0**  
O&M Grade: **2**  
Clock Start/From: **3**  
Clock To:  
1st Value: **6.000**  
2nd Value: **3.000**  
Value Percent:  
Continuous Index:  
Within 8" of Joint:  
Remarks:

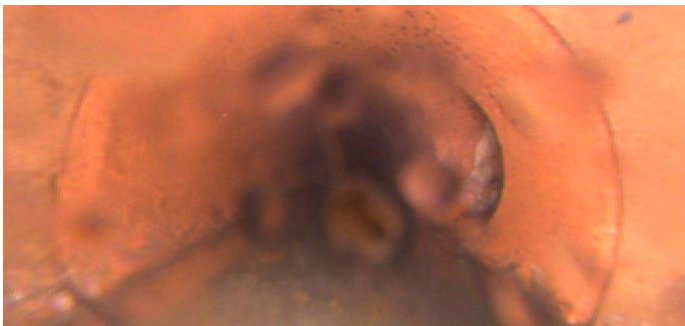
Code: **TF**  
Description: **Tap Factory**

Distance (ft): **124.3**  
Structural Grade: **0**  
O&M Grade: **0**  
Clock Start/From: **3**  
Clock To:  
1st Value: **4.000**  
2nd Value:  
Value Percent:  
Continuous Index:  
Within 8" of Joint:  
Remarks:

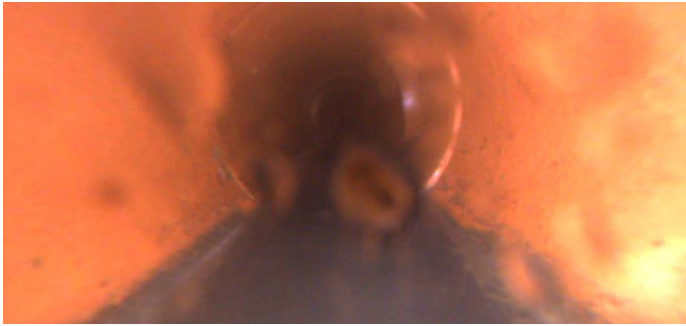
Code: **TF**  
Description: **Tap Factory**

Distance (ft): **196.3**  
Structural Grade: **0**  
O&M Grade: **0**  
Clock Start/From: **3**  
Clock To:  
1st Value: **4.000**  
2nd Value:  
Value Percent:  
Continuous Index:  
Within 8" of Joint:  
Remarks:

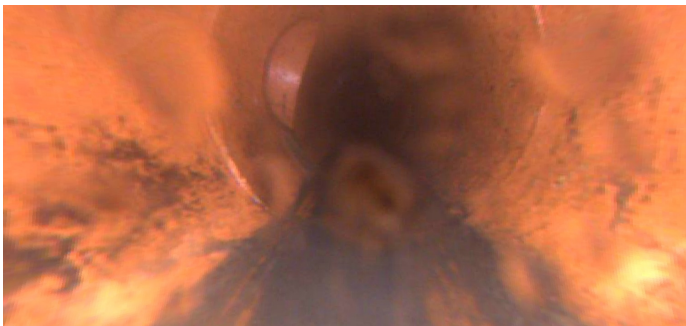
Code: **TF**  
Description: **Tap Factory**

Distance (ft): **198.5**  
Structural Grade: **0**  
O&M Grade: **0**  
Clock Start/From: **9**  
Clock To:  
1st Value: **4.000**  
2nd Value:  
Value Percent:  
Continuous Index:  
Within 8" of Joint:  
Remarks:

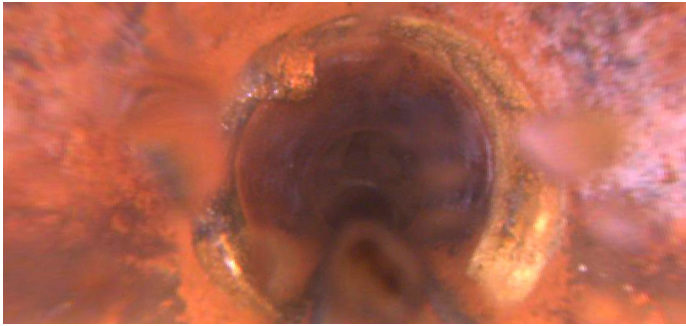
Code: **DAE**  
Description: **Deposits Attached Encrustation**

Distance (ft): **239.7**  
Structural Grade: **0**  
O&M Grade: **3**  
Clock Start/From: **7**  
Clock To: **4**  
1st Value:  
2nd Value:  
Value Percent: **20.000**  
Continuous Index:  
Within 8" of Joint: **YES**  
Remarks:

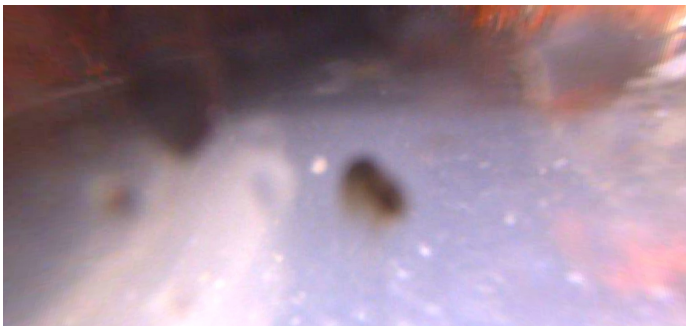
Code: **AMH**  
Description: **Manhole**

Distance (ft): **243.6**  
Structural Grade: **0**  
O&M Grade: **0**  
Clock Start/From:  
Clock To:  
1st Value:  
2nd Value:  
Value Percent:  
Continuous Index:  
Within 8" of Joint: **NO**  
Remarks: **M-507-013**
