Profile/Photo Observation Report

Street:	FOXCROFT STREET	Flow Control:	Not Controlled
City:	Hobart, IN	Year Renewed:	
Location:	Light Highway	Tape/Media #:	
Purpose:	Routine Assessment	Dia/Height:	10"
Use:	Sanitary	Material:	VCP
Drain Area:	NA	Lining:	
Category:	NA		
Comment:	F_S_P_C at 3 ft debris. Flow direction wrong		
Location Details:		Direction of Survey:	Upstream
US MH:	M-507-013	DS MH:	M-507-023
		Total Length Surveyed (ft):	4.0

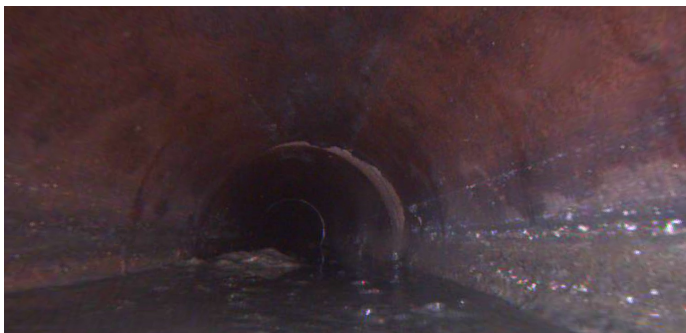
Code: **AMH**
Description: **Manhole**

Distance (ft): **.0**
Structural Grade: **0**
O&M Grade: **0**
Clock Start/From:
Clock To:
1st Value:
2nd Value:
Value Percent:
Continuous Index:
Within 8" of Joint: **NO**
Remarks: **M-507-023**

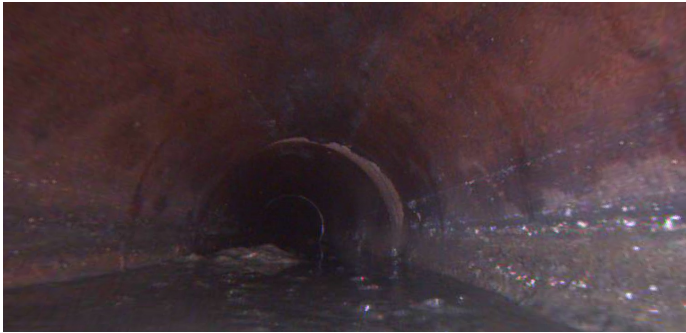
Code:	MWL
Description:	Water Level

Distance (ft):	.0
Structural Grade:	0
O&M Grade:	0
Clock Start/From:	
Clock To:	
1st Value:	
2nd Value:	
Value Percent:	40.000
Continuous Index:	
Within 8" of Joint:	NO
Remarks:

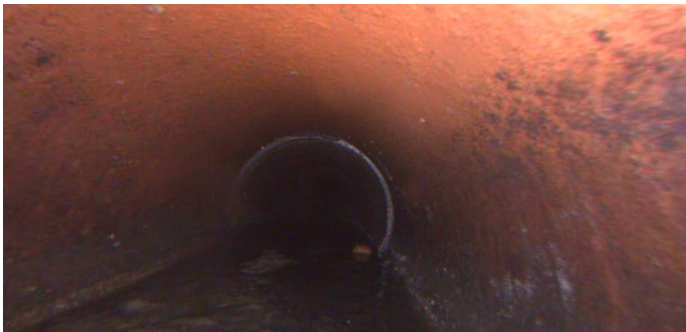
Code:	MSA
Description:	Abandoned Survey

Distance (ft):	4.0
Structural Grade:	0
O&M Grade:	0
Clock Start/From:	
Clock To:	
1st Value:	
2nd Value:	
Value Percent:	
Continuous Index:	
Within 8" of Joint:	NO
Remarks:	debris under water
