## Profile/Photo Observation Report

Date:	<b>03/27/2018</b>	Weather:		Coding:	<b>PACP 6.0</b>
Pipe Length (ft):	<b>145.7</b>	Owner:	<b>NA</b>	Pre Clean:	<b>No Pre-Cleaning</b>
P.O.#:		Surveyor:	<b>Jen Costello</b>	PSR:	<b>P-507-015-014</b>
Customer:		Clean Date:	<b>01/01/1900</b>	Shape:	<b>C</b>

Street:	<b>ALLEY BETWEEN S DELAWARE ST &amp; S</b>	Flow Control:	<b>Not Controlled</b>
City:	<b>Hobart, IN</b>	Year Renewed:	
Location:	<b>Yard</b>	Tape/Media #:	
Purpose:	<b>Routine Assessment</b>	Dia/Height:	<b>10"</b>
Use:	<b>Sanitary</b>	Material:	<b>VCP</b>
Drain Area:	<b>NA</b>	Lining:	
Category:	<b>NA</b>		
Comment:	<b>Flow direction wrong</b>		
Location Details:		Direction of Survey:	<b>Downstream</b>
US MH:	<b>M-507-014</b>	DS MH:	<b>M-507-015</b>
		Total Length Surveyed (ft):	<b>142.7</b>

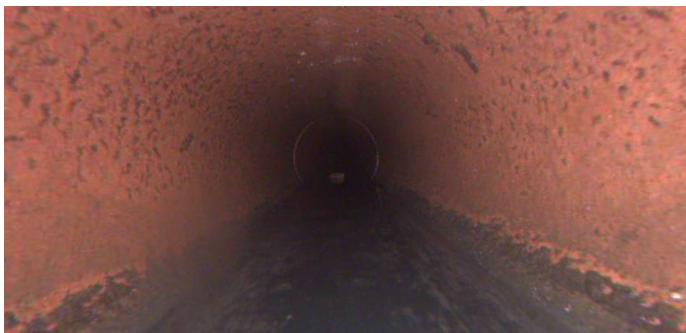
Code: **AMH**  
Description: **Manhole**

Distance (ft): **.0**  
Structural Grade: **0**  
O&M Grade: **0**  
Clock Start/From:  
Clock To:  
1st Value:  
2nd Value:  
Value Percent:  
Continuous Index:  
Within 8" of Joint: **NO**  
Remarks: **M-507-014**

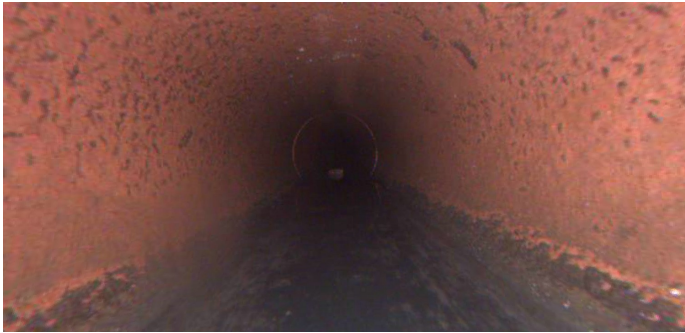
Code:	<b>MWL</b>
Description:	<b>Water Level</b>

Distance (ft):	<b>.0</b>
Structural Grade:	<b>0</b>
O&M Grade:	<b>0</b>
Clock Start/From:	
Clock To:	
1st Value:	
2nd Value:	
Value Percent:	<b>10.000</b>
Continuous Index:	
Within 8" of Joint:	<b>NO</b>
Remarks:

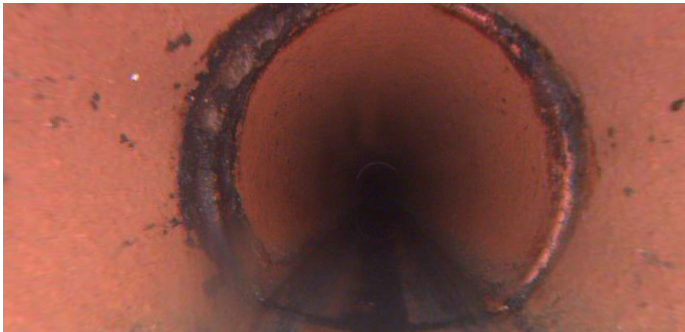
Code: **IW**  
Description: **Infil Weeper**

Distance (ft): **61.8**  
Structural Grade: **0**  
O&M Grade: **2**  
Clock Start/From: **8**  
Clock To: **4**  
1st Value:  
2nd Value:  
Value Percent:  
Continuous Index:  
Within 8" of Joint: **YES**  
Remarks:

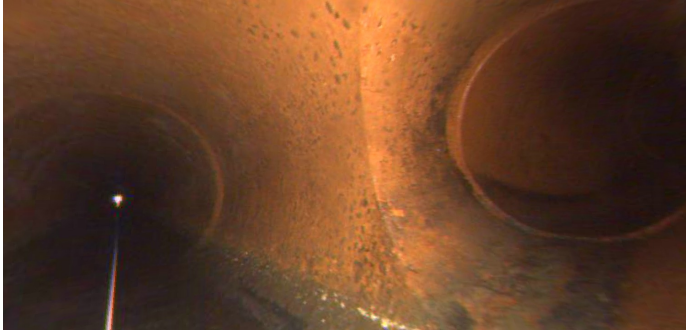
Code: **TF**  
Description: **Tap Factory**

Distance (ft): **93.7**  
Structural Grade: **0**  
O&M Grade: **0**  
Clock Start/From: **9**  
Clock To:  
1st Value: **4.000**  
2nd Value:  
Value Percent:  
Continuous Index:  
Within 8" of Joint:  
Remarks:

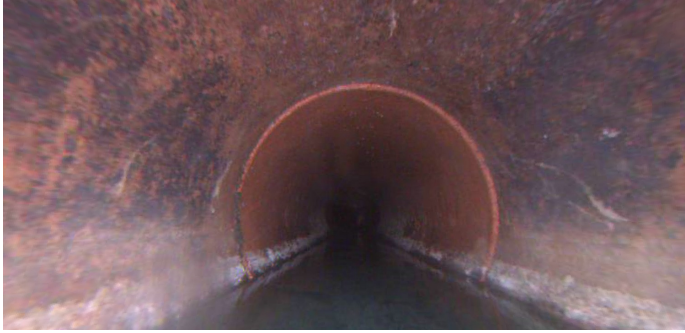
Code: **CM**  
Description: **Crack Multiple**

Distance (ft): **134.7**  
Structural Grade: **3**  
O&M Grade: **0**  
Clock Start/From: **8**  
Clock To: **4**  
1st Value:  
2nd Value:  
Value Percent:  
Continuous Index:  
Within 8" of Joint: **YES**  
Remarks:
